CIVIL AERONAUTICS BOARD

ACCIDENT INVESTIGATION REPORT

UNITED AIR LINES, ELK MOUNTAIN, WYOMING - January 31, 1946

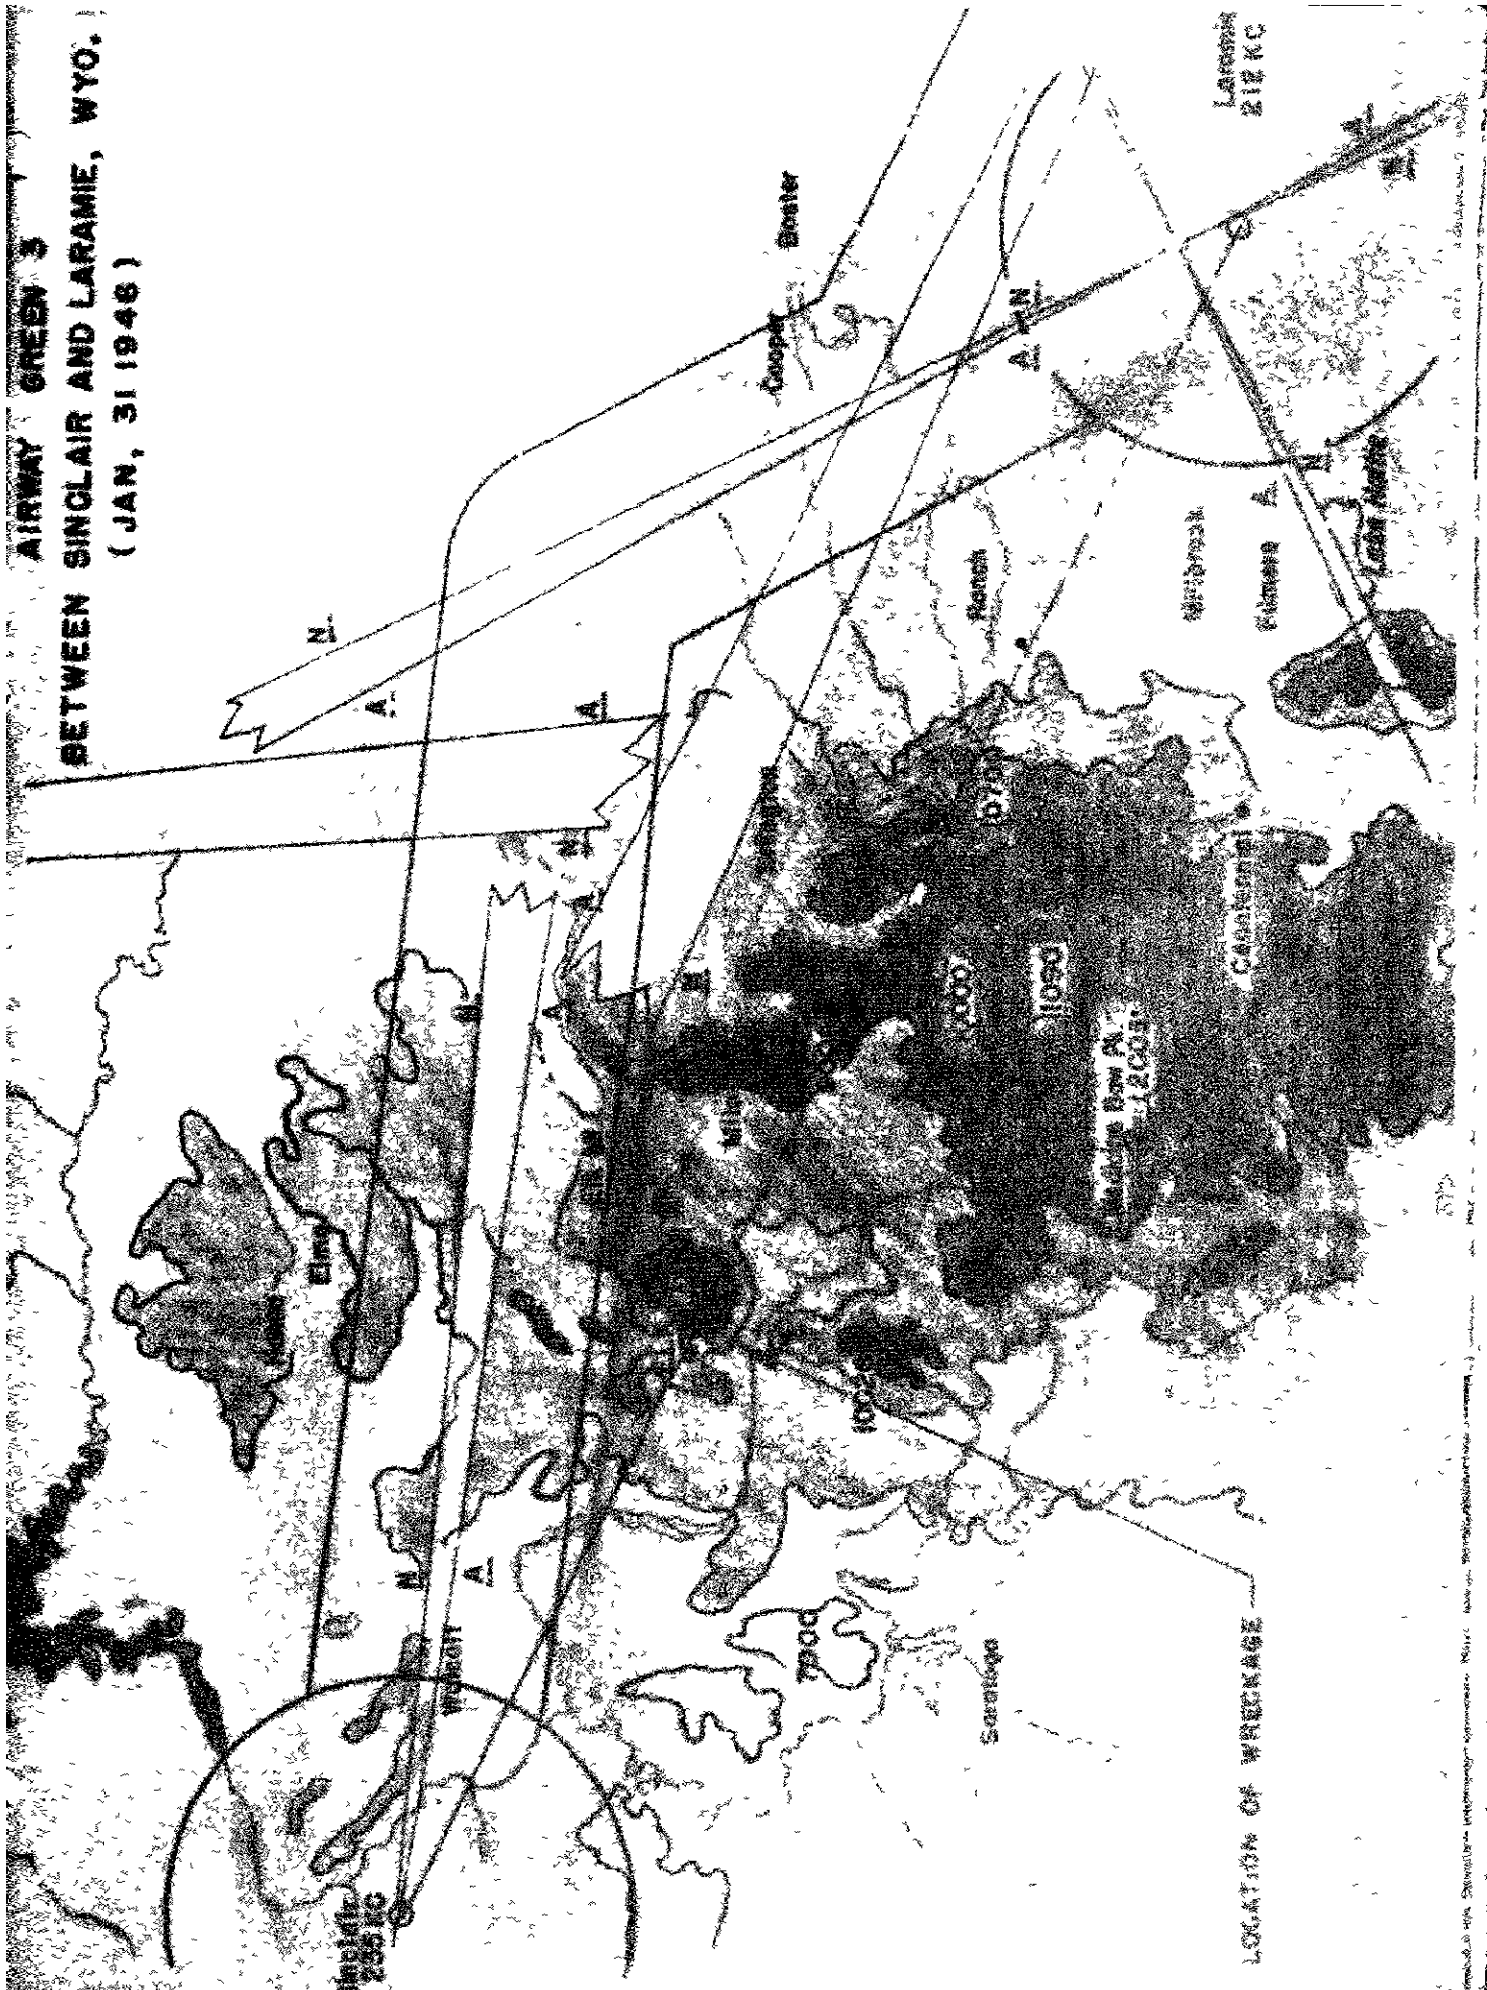
**AIRWAY GREEN 3
BETWEEN SINCLAIR AND LARAMIE, WYO.
(JAN, 31 1946)**

Laramie range. From this point it bends sharply to the right toward Laramie on a heading of 137 degrees. The distance between Sinclair and Laramie via airway Green 3 is 88 miles while the distance between the two range stations on a direct course is 79 miles. The point of impact on the southwest corner of Elk Mountain at an elevation of approximately 10,822 feet is located on a direct line between the Sinclair and Laramie radio range stations. The flight path of the aircraft in the vicinity of the accident had deviated south of the airway a distance of approximately 4-1/2 miles. Elk Mountain represents the highest terrain between Sinclair and Laramie within an area of 15 miles on either side of the direct course. The dog-legged airway was so designed in order to provide most effective clearance from the high terrain to the south.

7. At 0247, Flight 14 collided with Elk Mountain at an elevation approximately 180 feet below its assigned cruising altitude and $4\frac{1}{2}$ miles south of Airway Green 3, and was demolished by impact and fire.

LOCATION OF WRECKAGE
