## CIVIL AERONAUTICS BOARD

## ACCIDENT INVESTIGATION REPORT

PAN AMERICAN AIRWAYS--FLOYD BENNETT FIELD, BROOKLYN, NEW YORK--  
SEPTEMBER 20, 1947

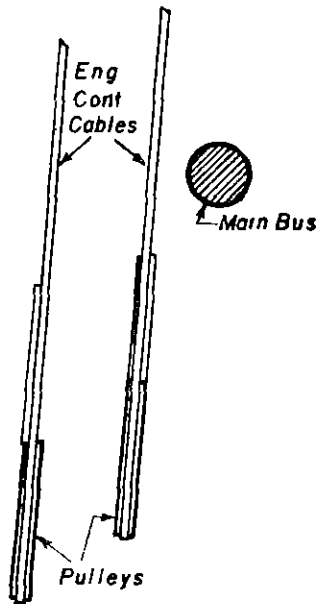
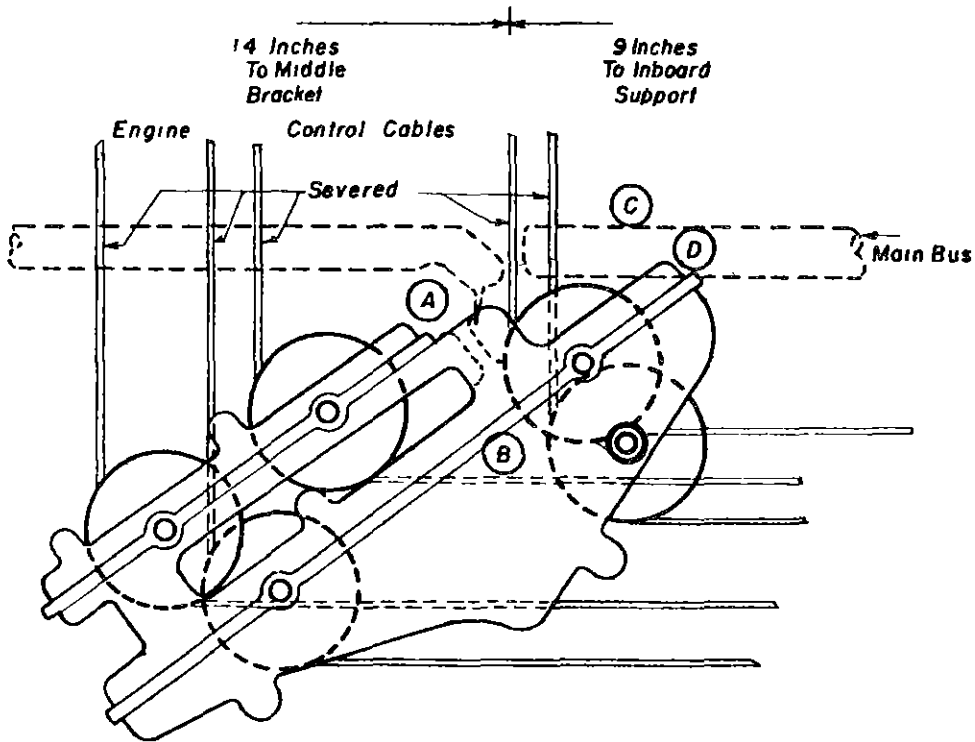
The C-54 has mounted forward of the front wing spar (zone 3) in engine nacelles 3 and 4 a battery "bus,"<sup>4</sup> a solid electrical line of 5/8" aluminum covered with fire resisting fabric insulation. Below this "bus," also mounted on the front wing spar in the No. 3 engine nacelle is a magnesium engine control pulley bracket. In NC-88911 at a point directly above the pulley bracket, the battery "bus" had melted in two from electrical arcing. The bracket also had burned and melted from electrical arcing, and many of the engine control cables which it held had been fused together. From this particular area to all points within zone 3 of this nacelle, there was evidence of fire.<sup>5</sup> The aluminum conduit which carried the magneto ground leads for engines 3 and 4 was burned in two, part of the insulation was destroyed, and the magneto ground leads for engines 3 and 4 grounded. Many other electrical lines had been either burnt in two or grounded.

<sup>4</sup>This "bus" connects all four generators to the batteries. See Appendix II for diagrams of this installation.
