CIVIL AERONAUTICS BOARD
ACCIDENT INVESTIGATION REPORTAdopted: April 6, 1951Released: April 9, 1951

NEW TRIBES MISSION, FONSECA, COLOMBIA, SOUTH AMERICA, JUNE 9, 1950

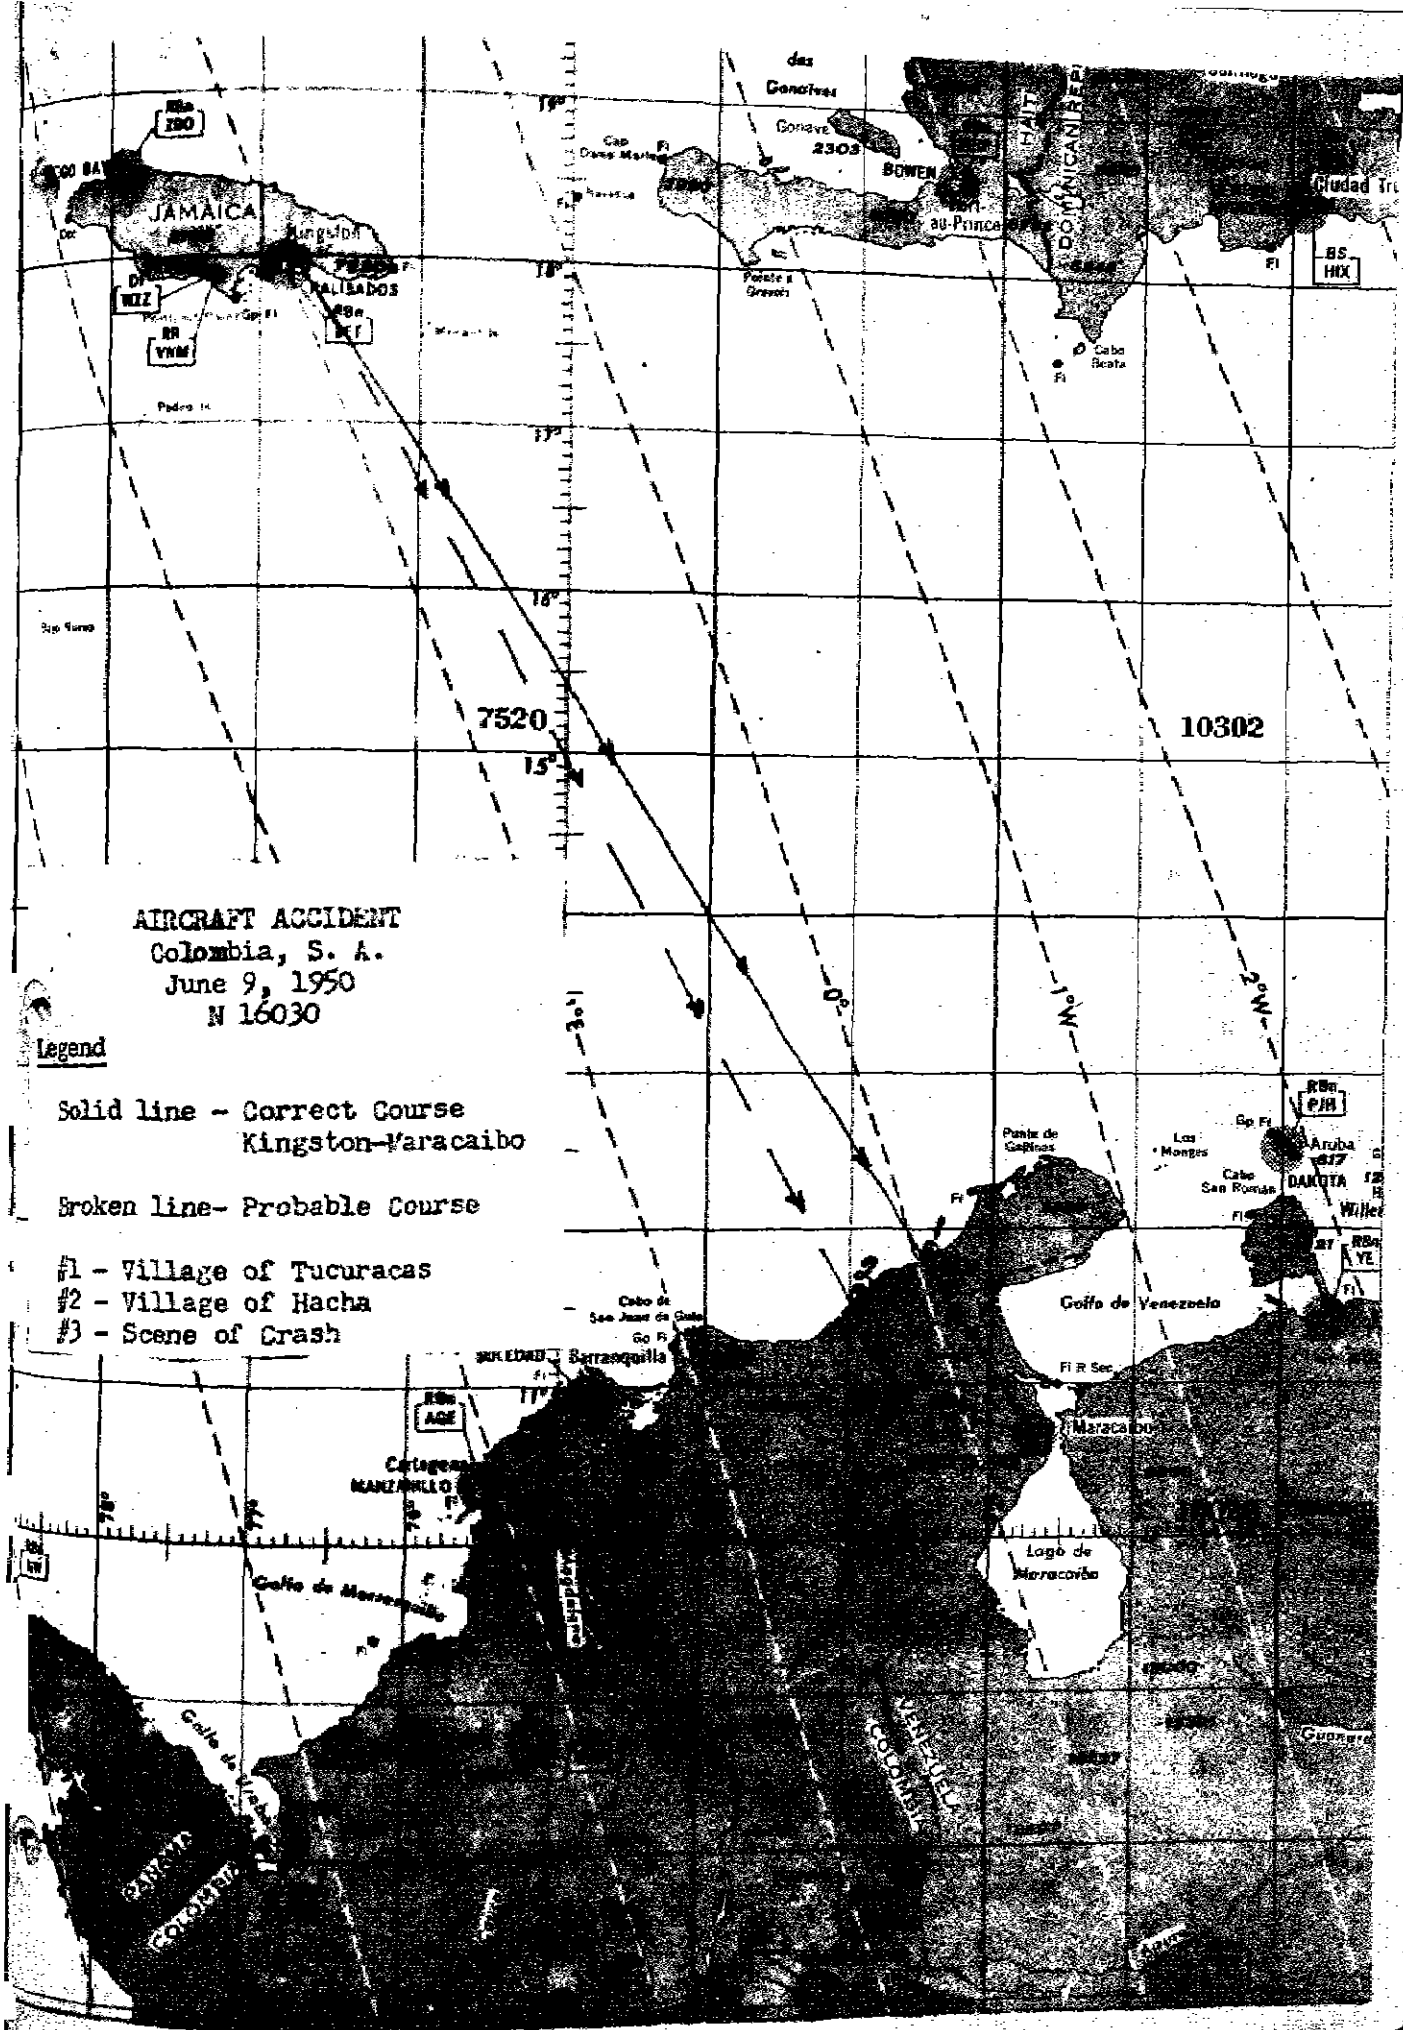
AIRCRAFT ACCIDENT
 Colombia, S. A.
 June 9, 1950
 N 16030

Had the aircraft followed a direct course from Kingston to Maracaibo, it would have intersected the Colombian coast line near the village of Tucuracas, approximately 95 miles northwest of Maracaibo, from which position on to its destination no point of the terrain exceeds 1,000 feet elevation.* However, it now appears likely that the flight intersected the coast line near the village of Rio Hacha instead, which is approximately 30 miles west of Tucuracas. To have followed a southerly heading from this position would have brought the flight to the easterly end of the Valledupar mountain range where the wrecked aircraft was found.

expectation that the flight would terminate successfully at Maracaibo. Instead the aircraft crashed on the easterly end of the mountain range 42 miles west of the Kingston-Maracaibo course. *
