*This document is an English translation of the Final Report on the fatal accident involving the Falcon 50EX aircraft registered F-GLSA that occurred on October 20, 2014 at Vnukovo Airport, Moscow.*

## **INTERSTATE AVIATION COMMITTEE**

### **AIR ACCIDENT INVESTIGATION COMMISSION**

#### **FINAL REPORT**

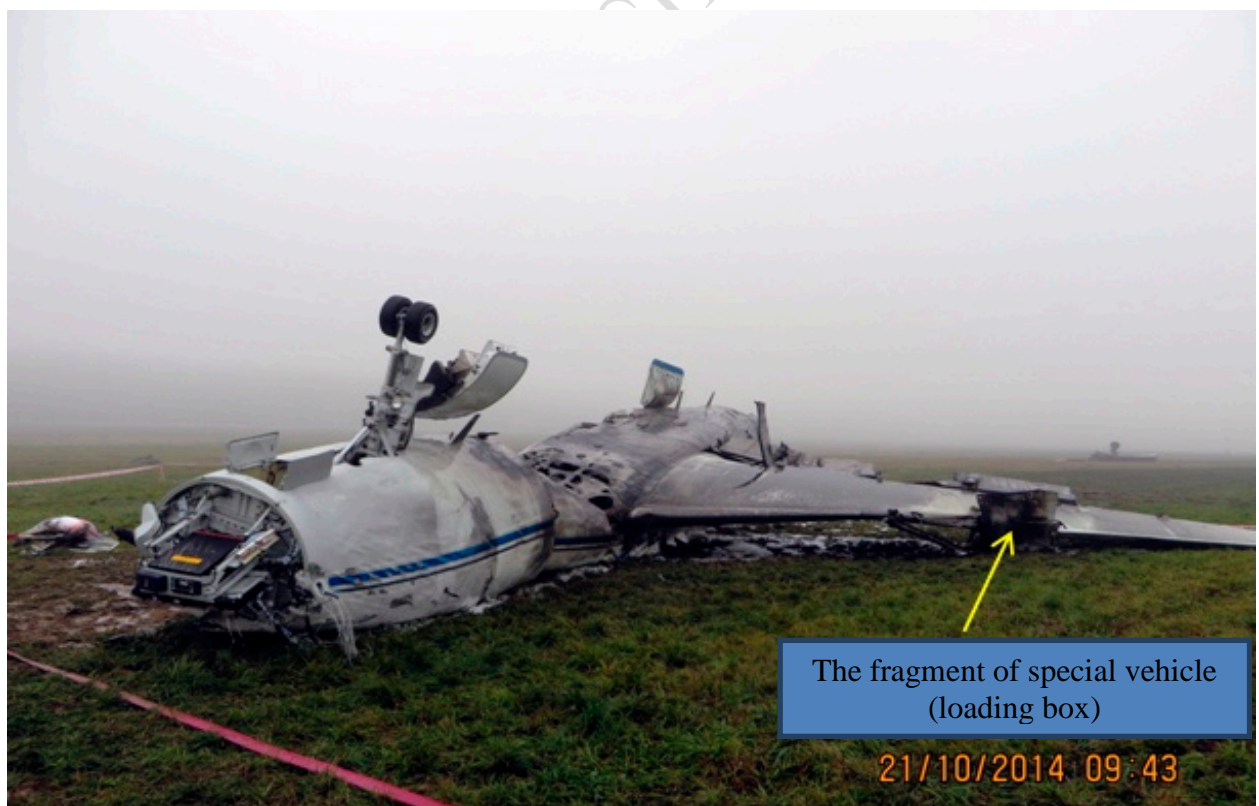
The collapsed aircraft is shown in Figure 1.

Figure 1. Falcon 50EX F-GLSA airplane at the accident site

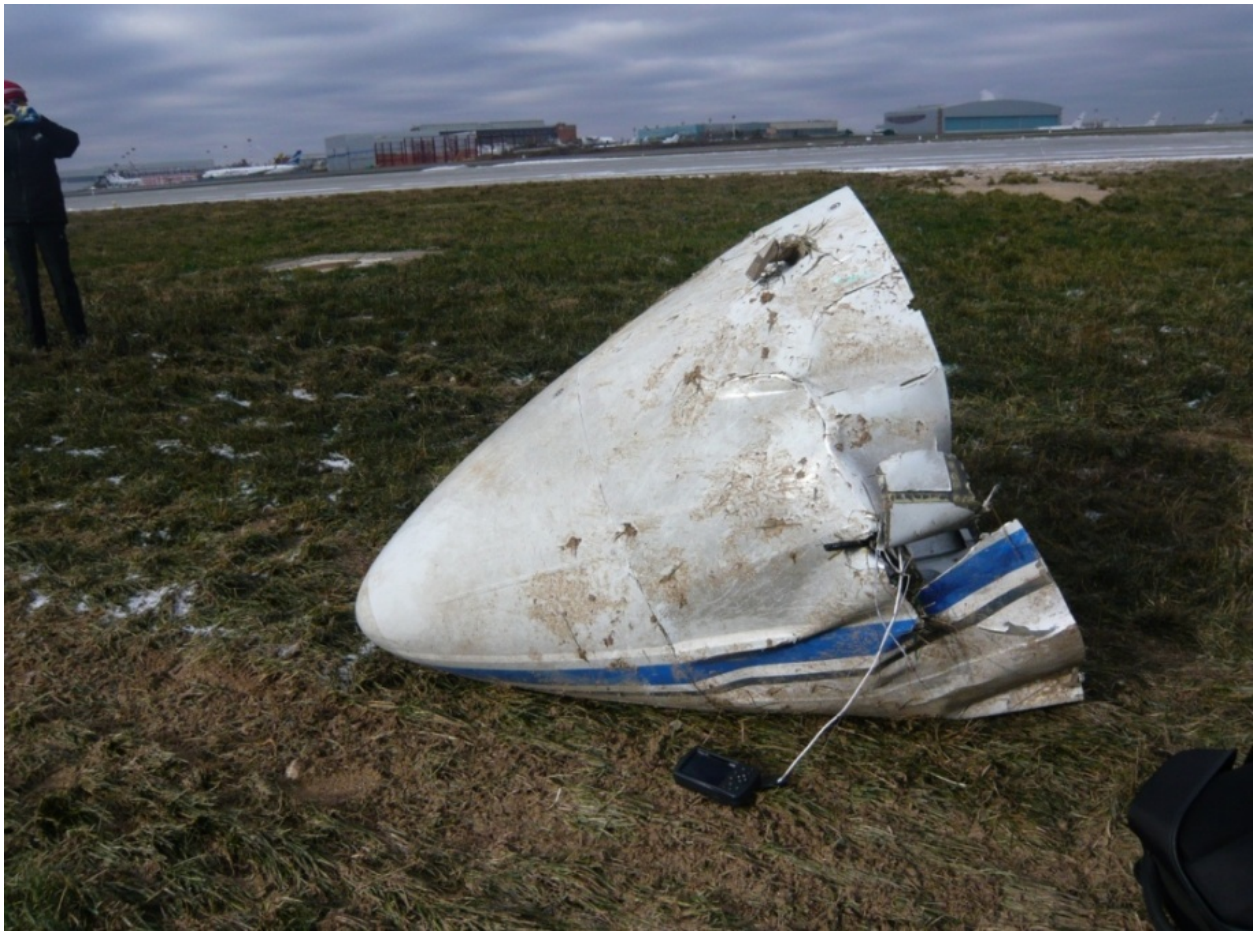
Inverted (Figure 32), deformed in the lower part, skin and rib fractured on the right side. A part of the rib at the attachment of the radome turning mechanism was missing. All radar units were secured as per design and had no external damage. All visible socket connectors were connected to the respective units.

Figure 32. Radome.

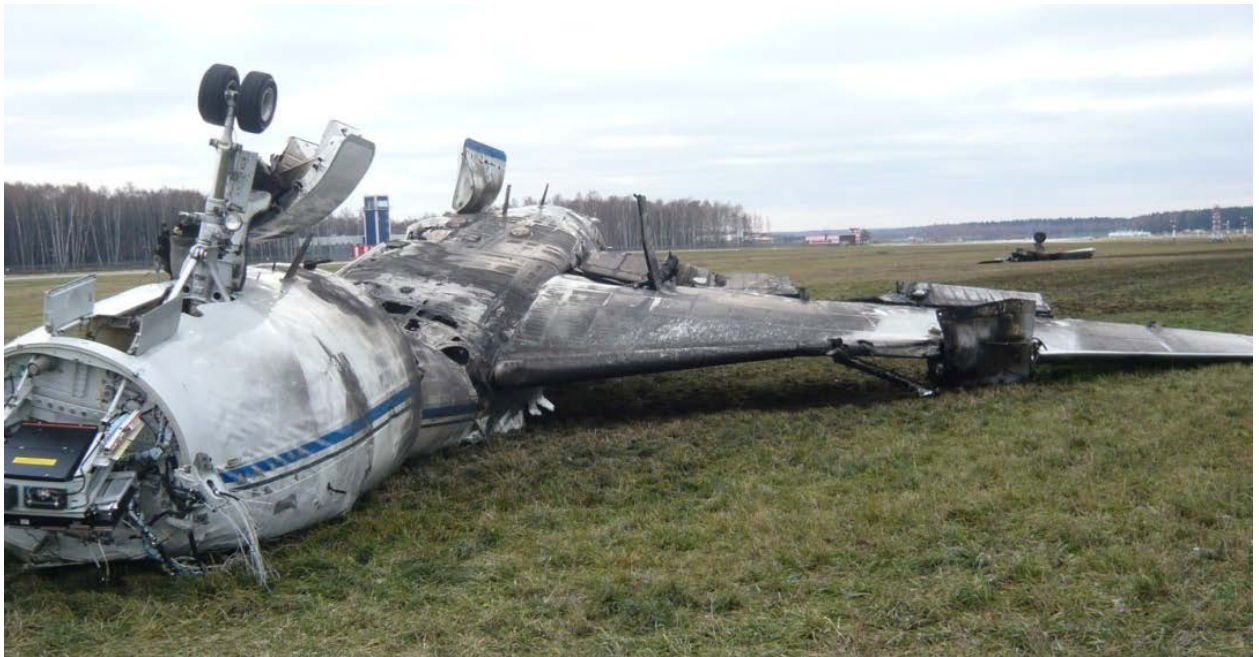
Fuselage and right wing with a fragment of right main landing gear was found inverted (Figure 33) and broken into two parts along the rib behind the door. The rivets were torn up on ground impact. A geometric fracture in the middle part of the fuselage had appeared due to the skin being burnt out and ribs and stringers being damaged by high temperature during the fire. The high temperature impact at that place was confirmed by round flattened solidified drops of melted metal up to 15 mm in diameter. The right wing tip was touching the ground. The junctions of central wing to the left wing were destroyed.

Figure 33. Fuselage and right wing

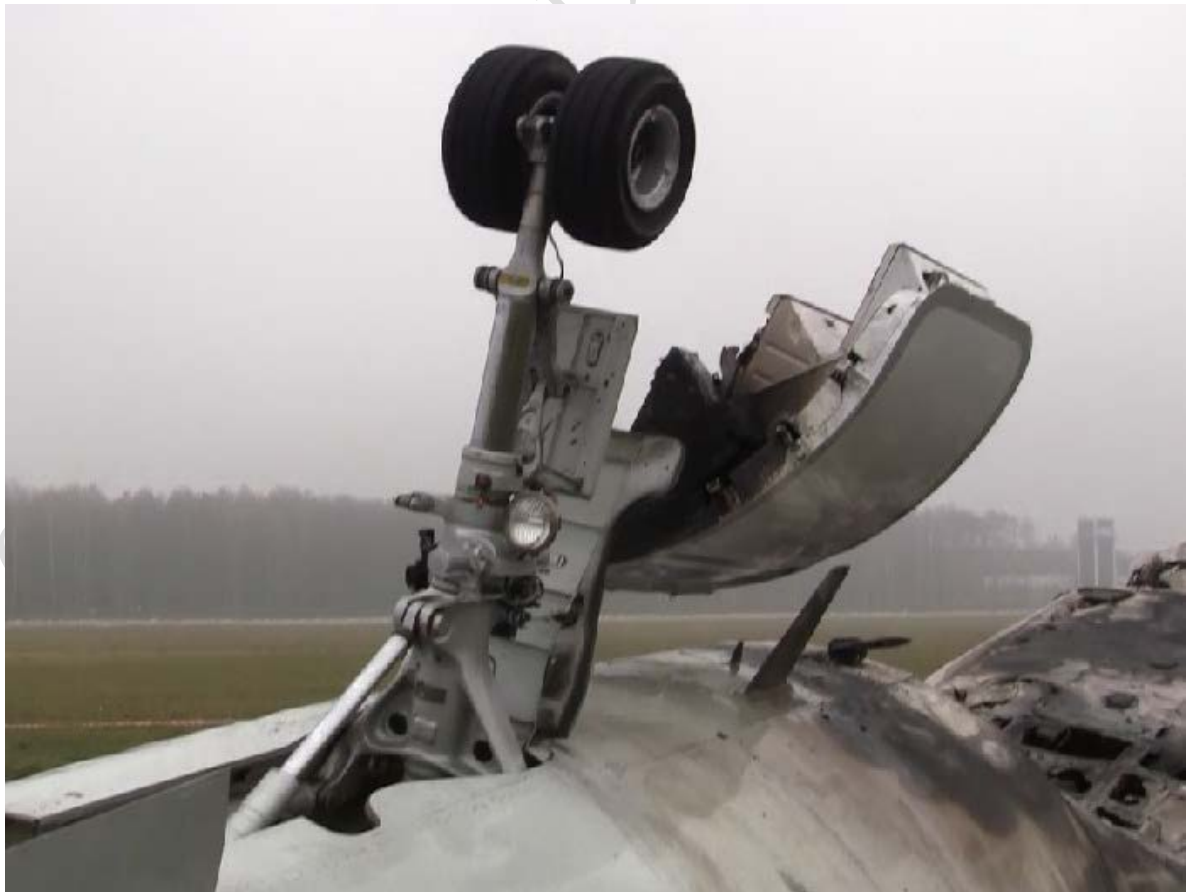
The nose landing gear was extended, showing no mechanical damage or fire traces (Figure 34).

Figure 34. Nose landing gear

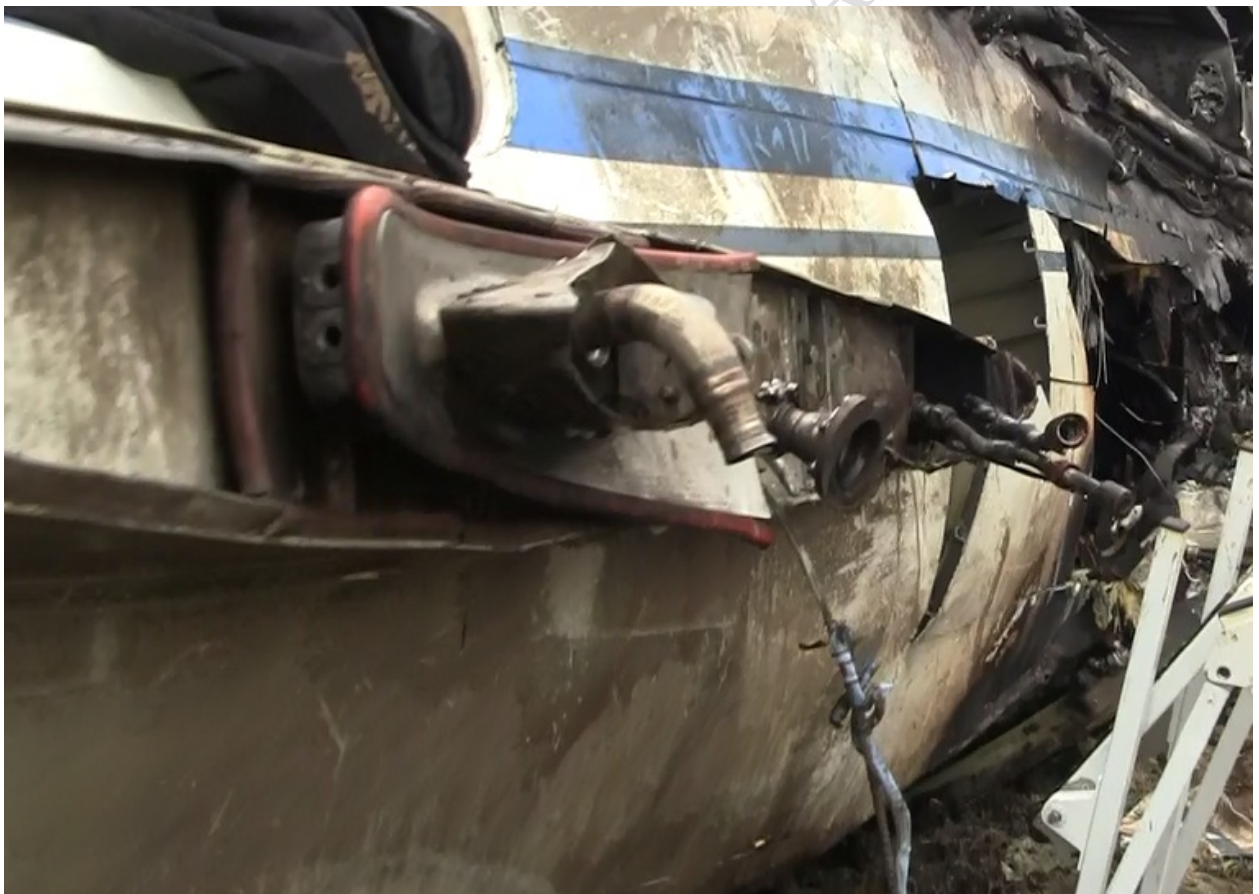
The fittings of Engine № 1 and Engine № 3 were damaged, wirings and ducts torn out (Figure 35 and Figure 36).

Figure 35. Engine № 1 Fitting

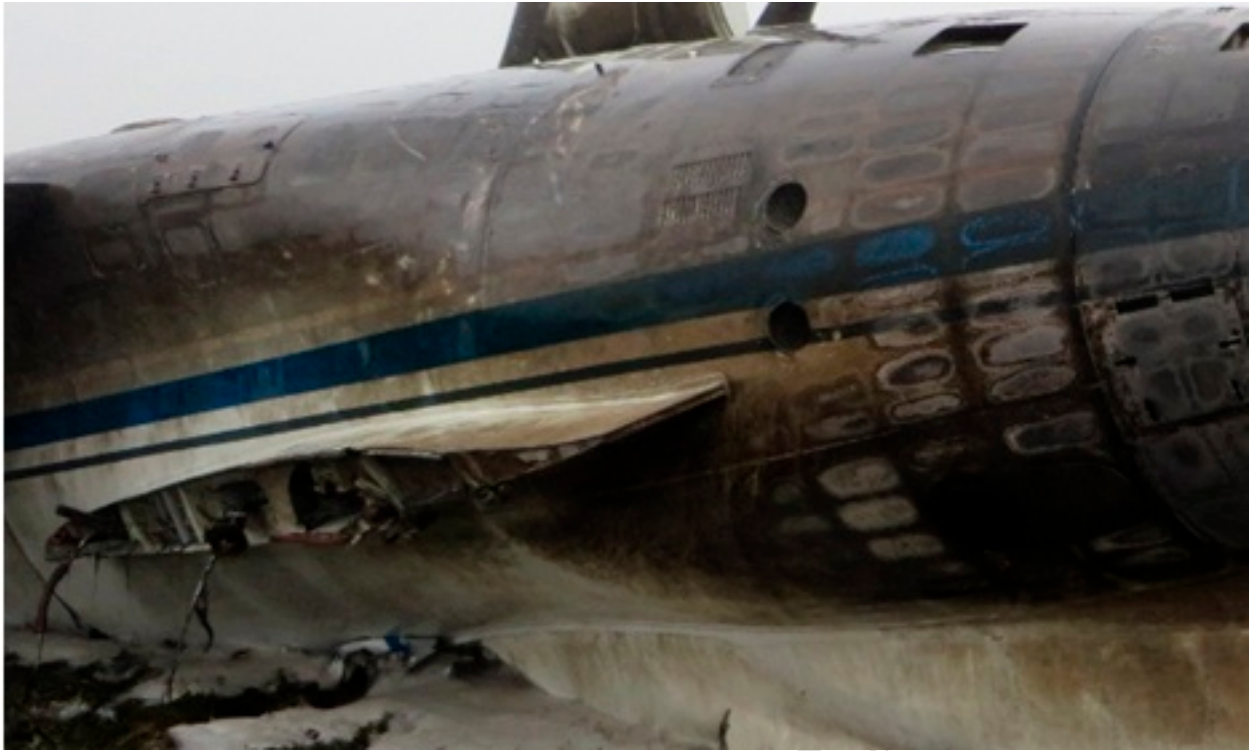
Figure 36. Engine № 3 Fitting

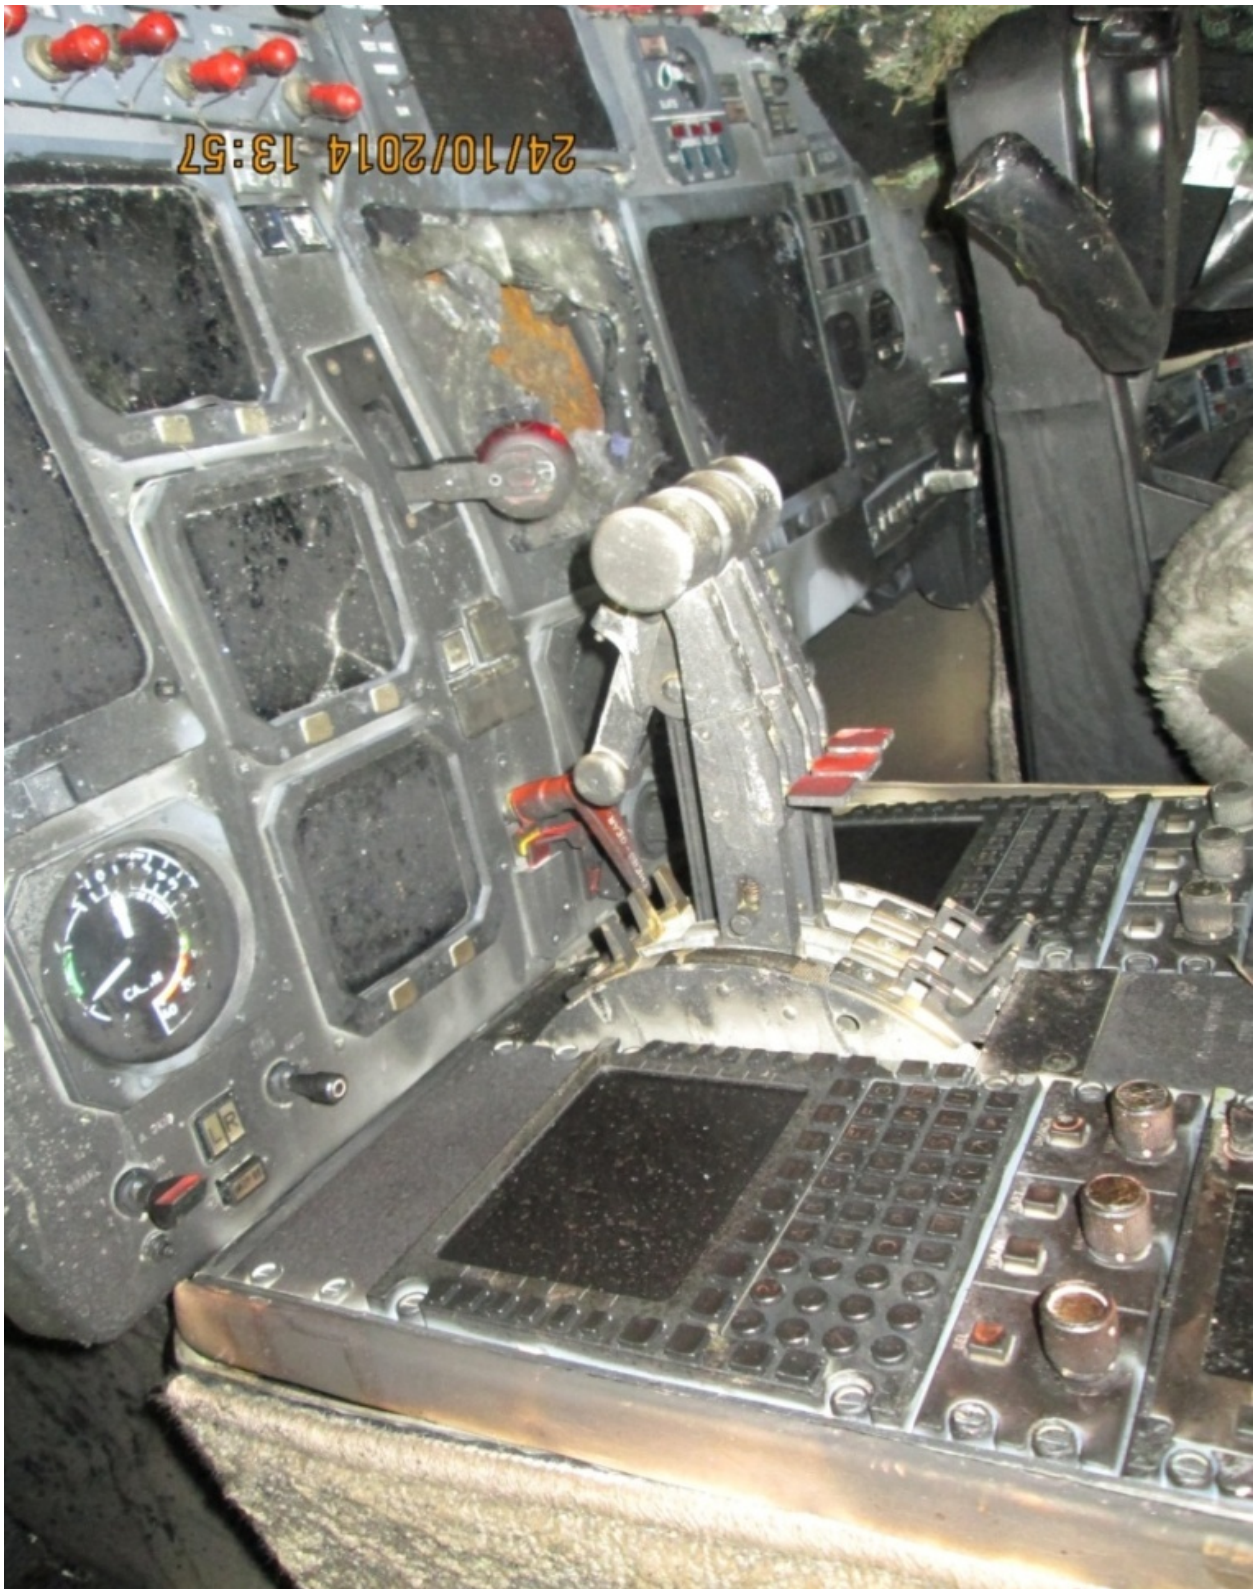
The cockpit was deformed; instrument panel indicators had signs of soot, control wheels synchronically turned to roll left. The throttle levers were set to takeoff position, thrust reverse lever of Engine № .2 retracted, flap/slat control handle set to S+FLAPS 20°, landing gear control switch set to LG DOWN (Figure 37).

Figure 37. Cockpit

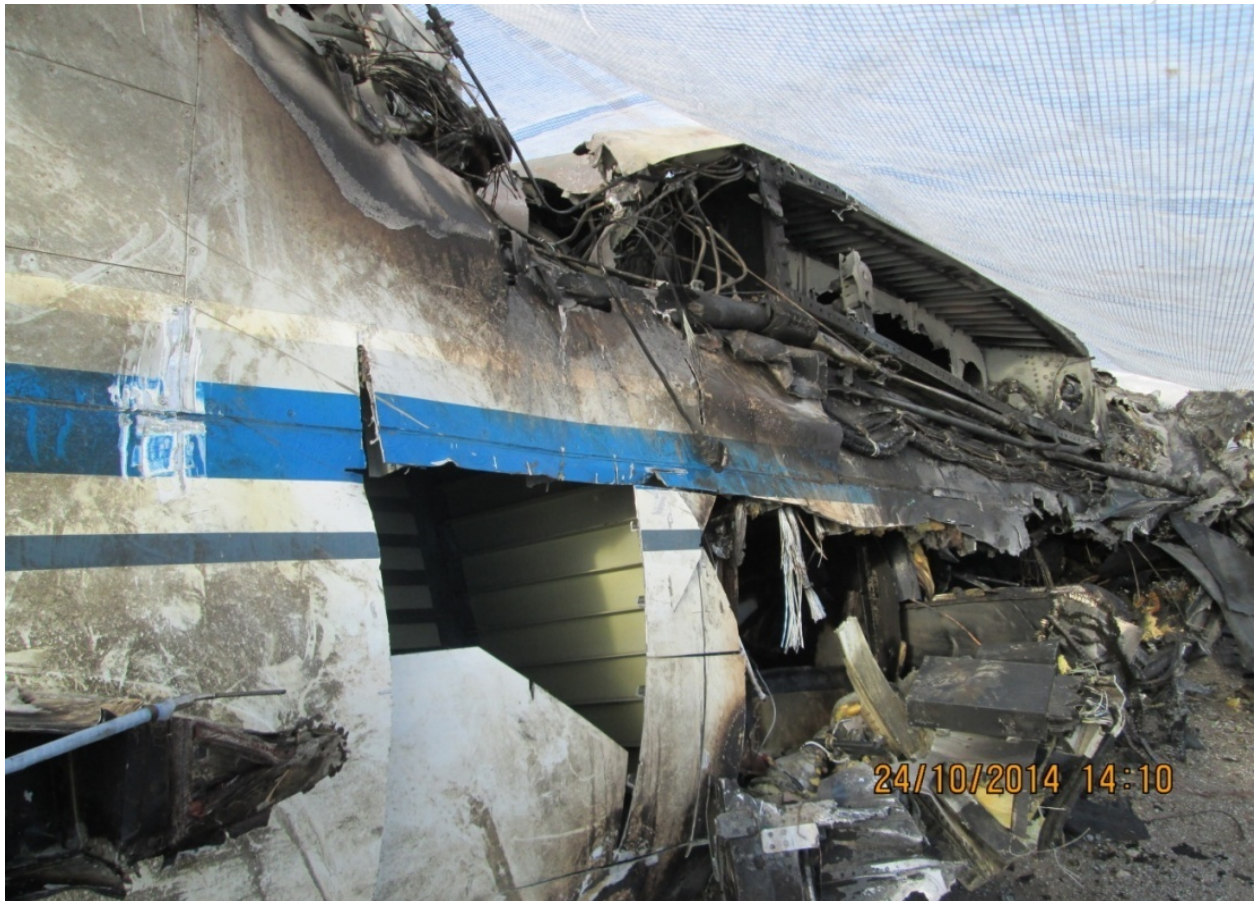
The center wing had traces of fire and deformation, lower panels burnt out (Figure 38). The LH wing to center wing attachment was destroyed along the wing rib, the center wing fuel tank was torn open, fuel missing.

Figure 38. Fuselage and LH wing attachment

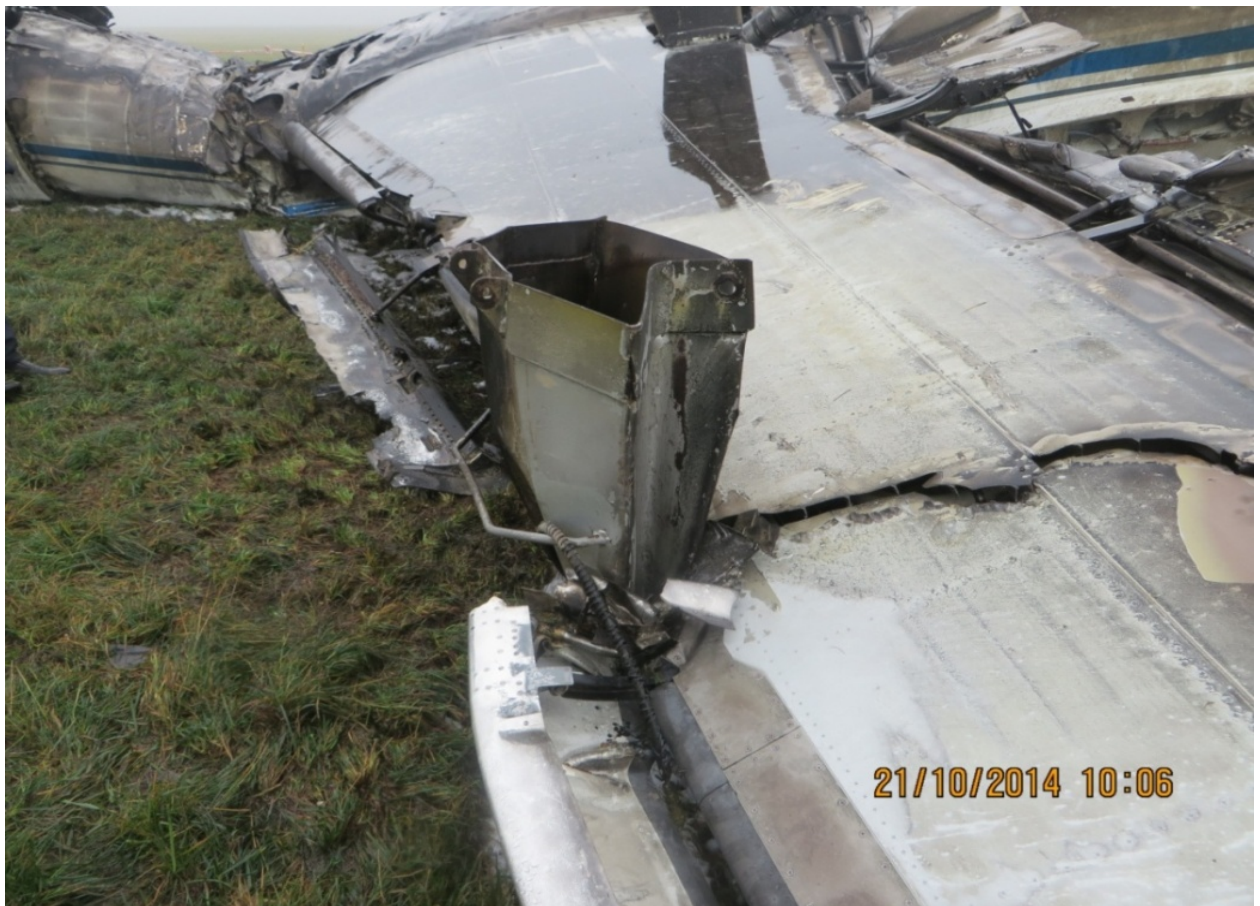
The RH wing showed damage, skin deformation and fire traces. There was a hollow metal foreign fragment in the form of a flattened squared tube (a snowplow fragment) pressed in between the outer and inner slat sections (Figure 39). The metal fragment was wedged perpendicular in the center between the right and left leading edge slat of the right hand wing. The lower part of the RH wing had a through zig-zag crack extending from the forward spar to the aft spar.

Figure 39. RH wing with a snowplow fragment

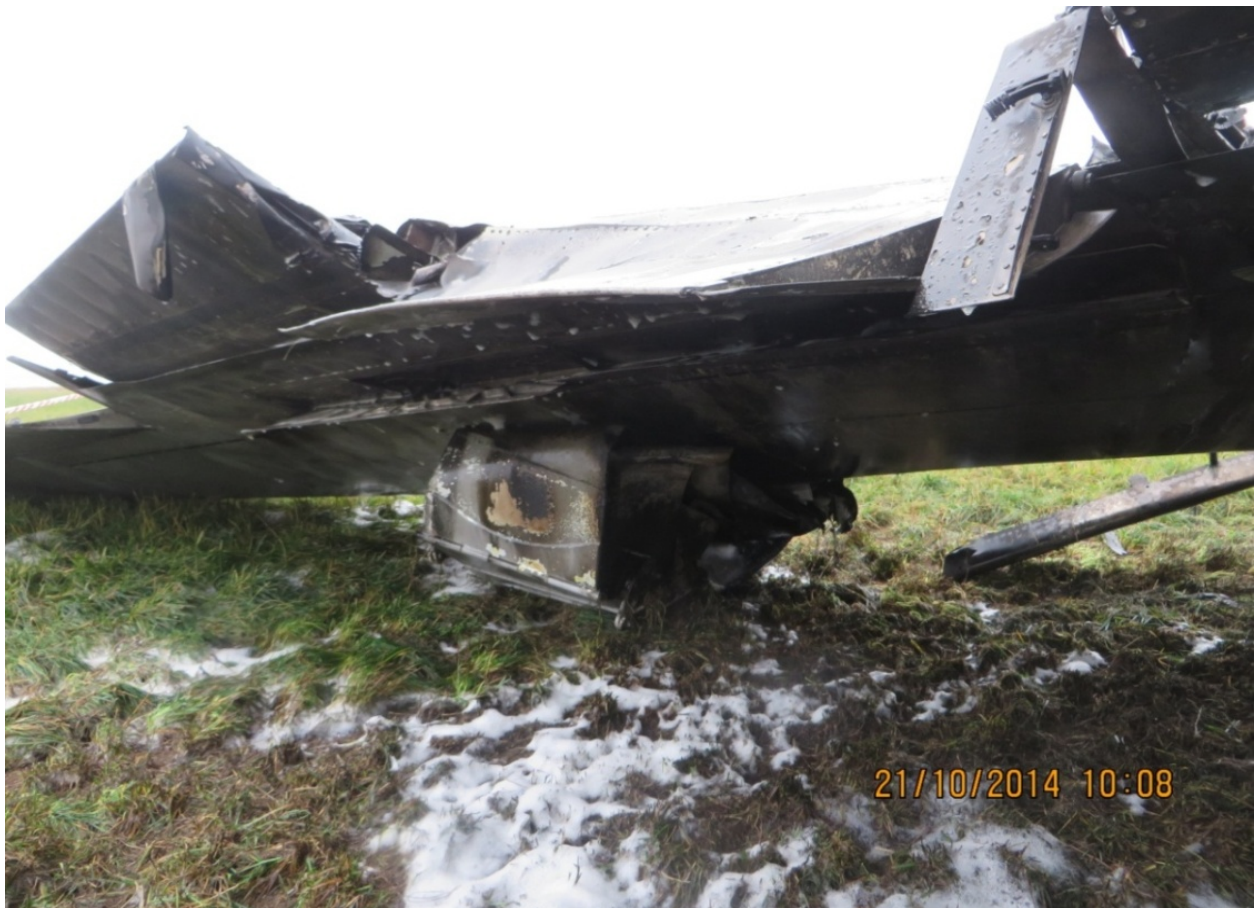
The RH outer flap was split into two parts almost in the middle (Figure 40), its outer part extended (downward), and inner part bent upwards. The RH aileron was deflected to the utmost right roll, and could be moved freely with a hand. The RH wing tip was destroyed, the navigation lights cone broken. The RH slat was torn into two parts by a foreign object, its outer part extended, its inner part destroyed and hanging on the slat cranks.

Figure 40. RH wing

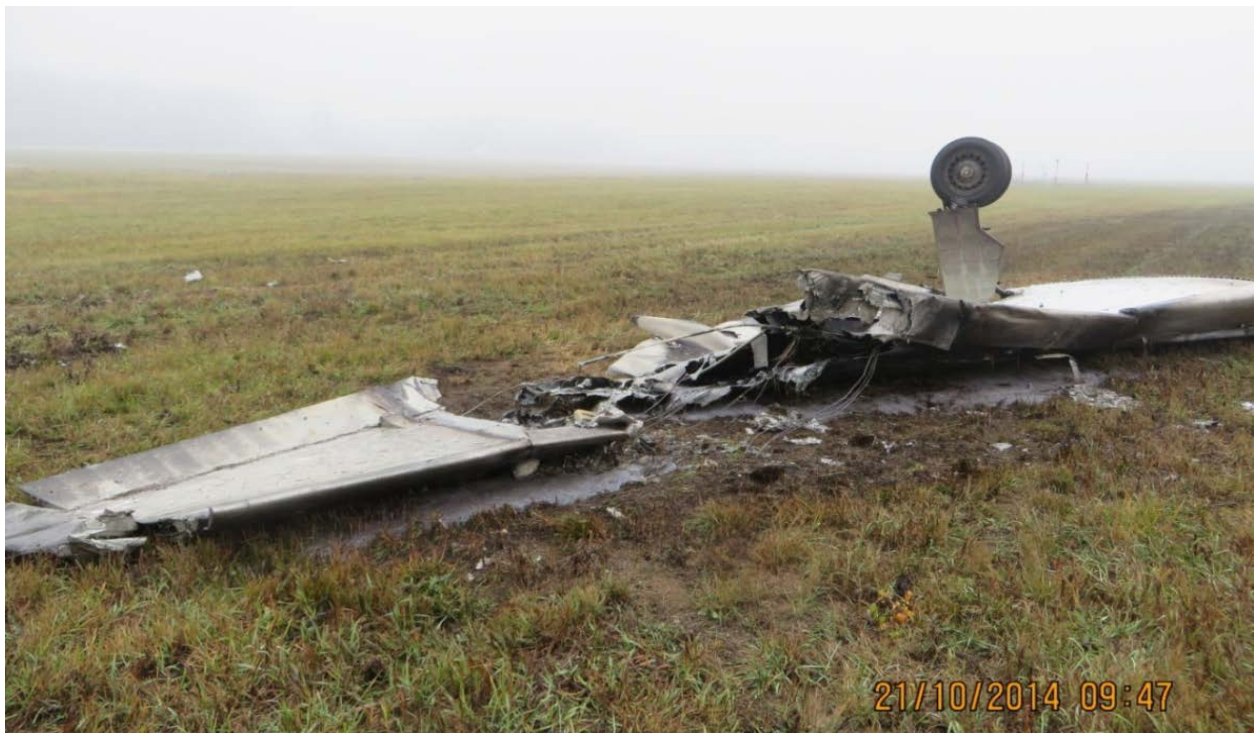
The LH wing with left main landing gear (Figure 41) was detached from the center wing along the wing rib, screw fittings being torn. The root part of the LH wing and the LH aileron tip preserved their design dimensions. The middle part of the LH wing was destroyed by fire after the crash. The LH main landing gear was extended, showing no mechanical damage. The remaining fragments of slat and flaps sections were extended.

Figure 41. LH wing with LH main landing gear

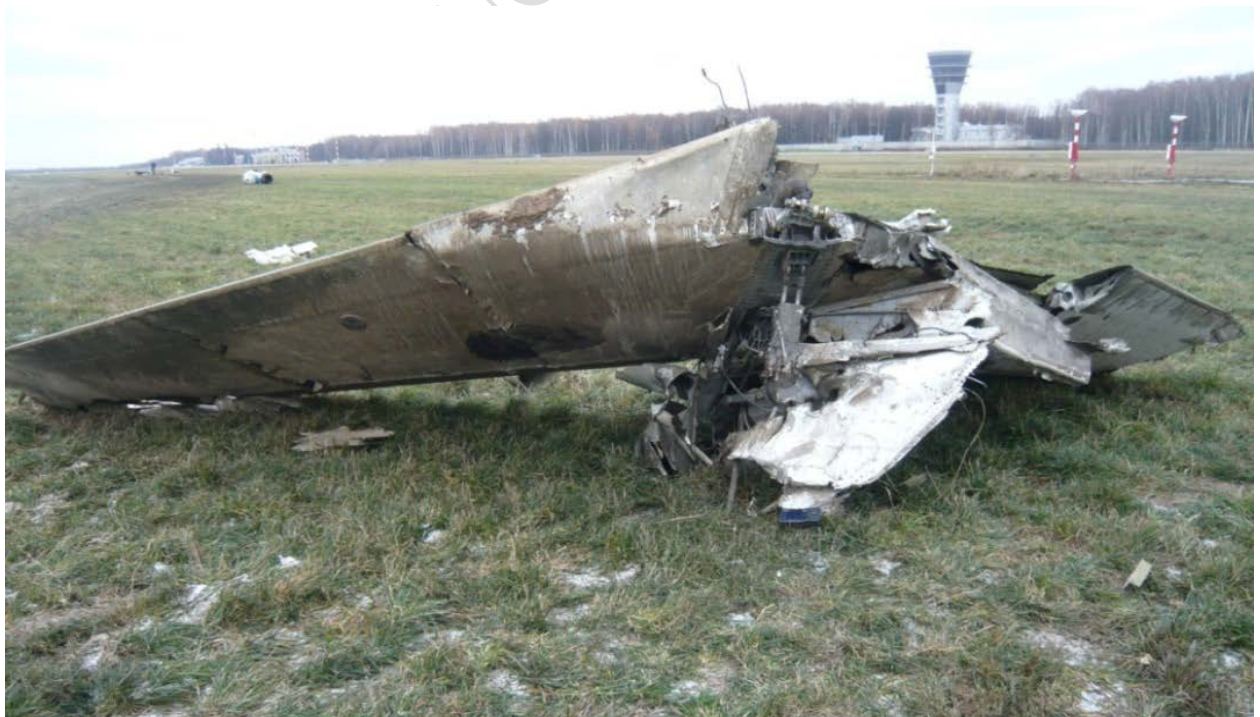
The fragment of fin with horizontal stabilizer (Figure 42) was found perpendicular to the aircraft path after the collision. The attachment of fin to the fuselage sustained tear damage. The upper part of fin was missing; the lower part had substantial damage: the fin fairing and rudder were missing, the fin skin torn.

Figure 42. Fragment of fin with horizontal stabilizer

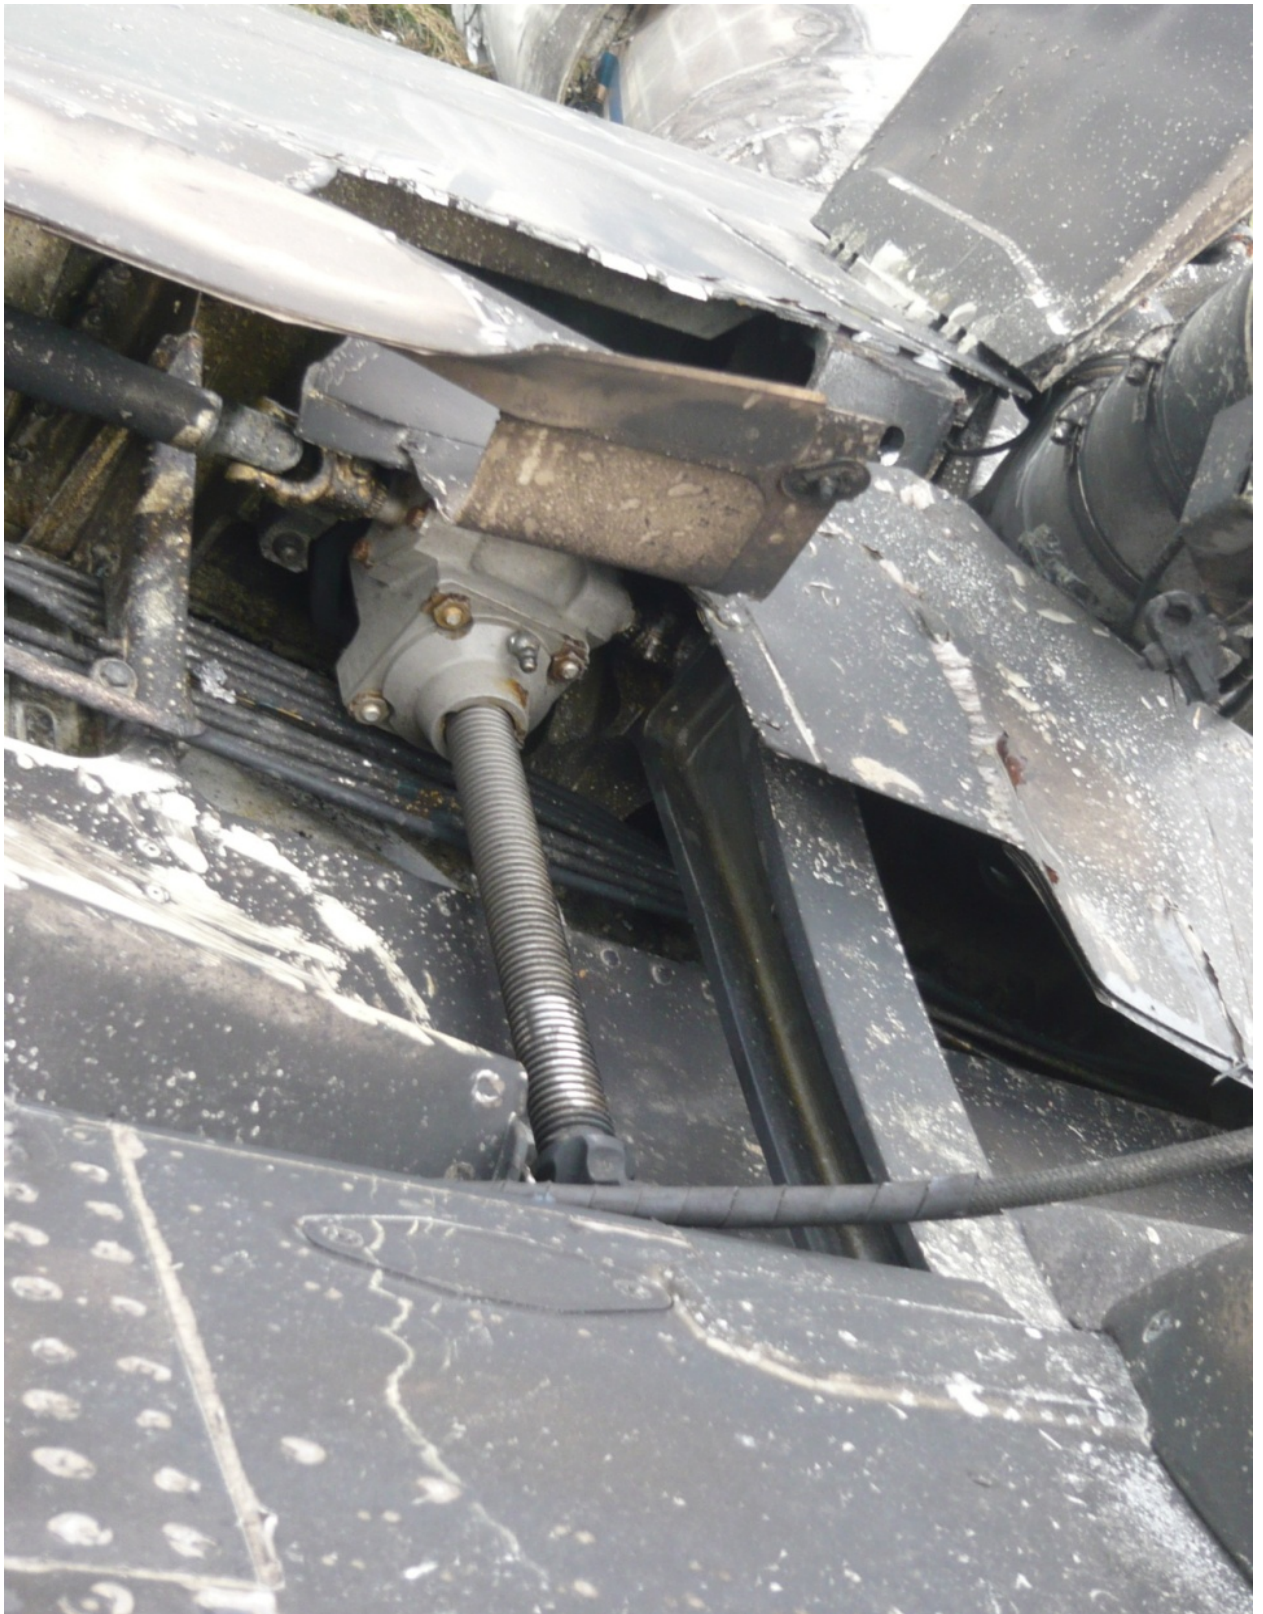
Figure 43. Flaps actuator jack screw

The position of slats and flaps on the remaining part of the wing as well as flap and slat driving rods means the flaps and slats position was compatible with the position of the control handle on the central control panel, set to S+FLAPS 20° (slats and flaps 20 degrees).

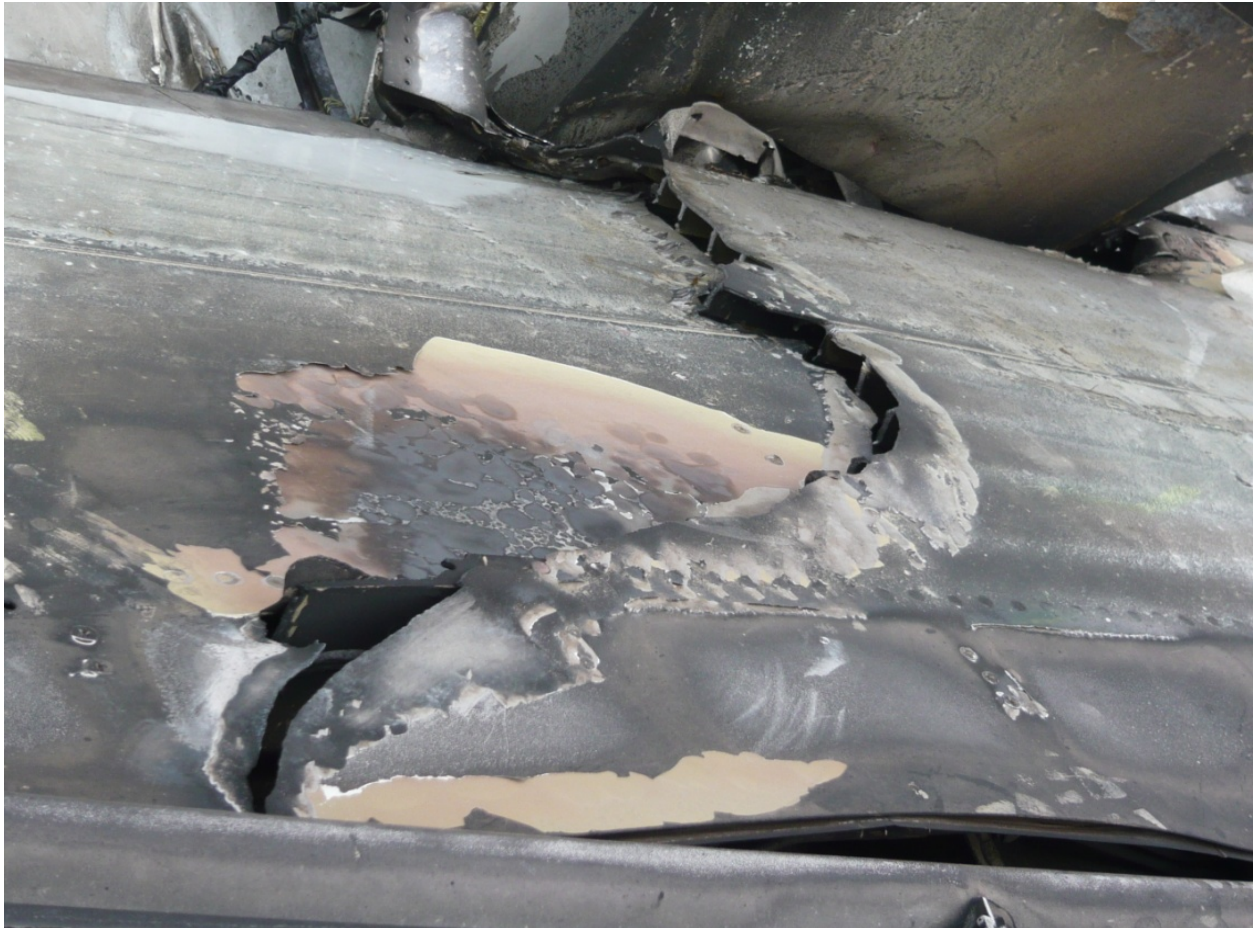
The RH fuel tank was torn open, having a lateral zig-zag crack (Figure 44). The fuel leaked out completely after the wing hit the snowplow.

Figure 44. RH fuel tank

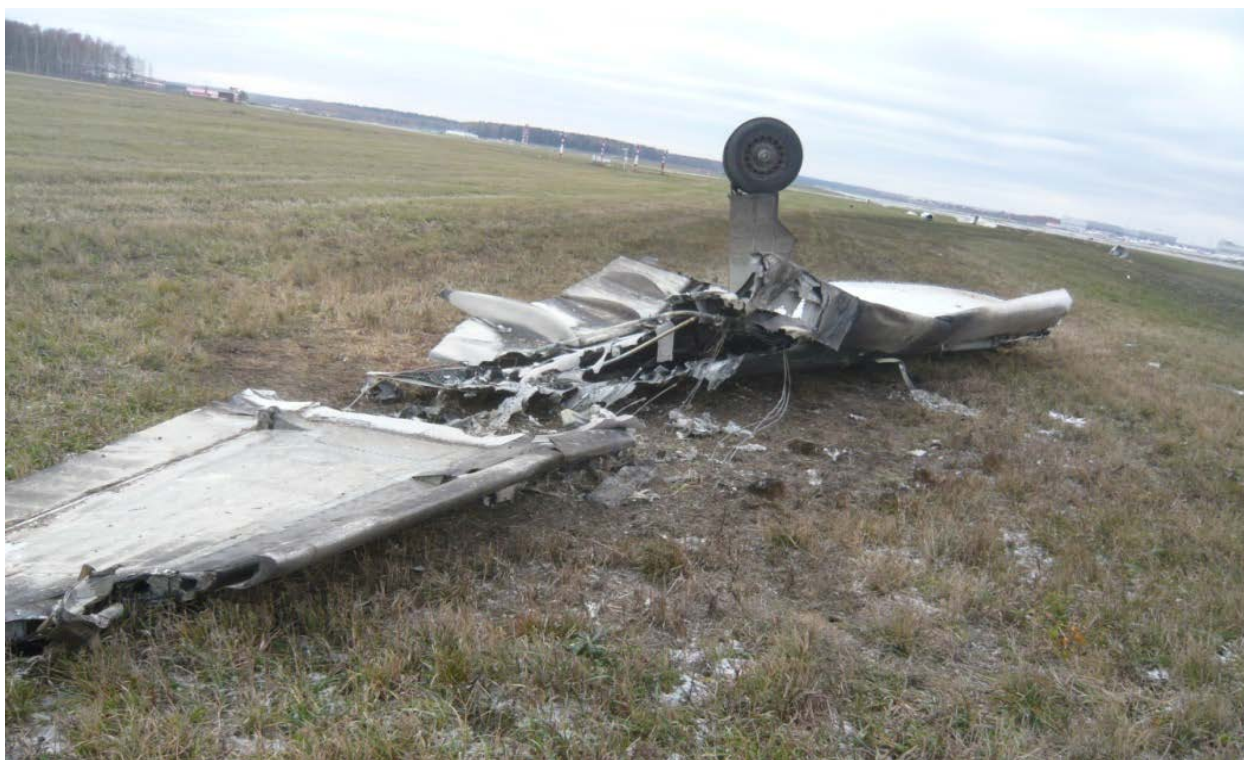
The LH fuel tank was torn open, 50% of the tank structure (from the LH landing gear to the LH aileron) was destroyed by the fire (Figure 45). The fuel leaked out completely after the LH wing was detached from the center wing.

Figure 45. LH fuel tank

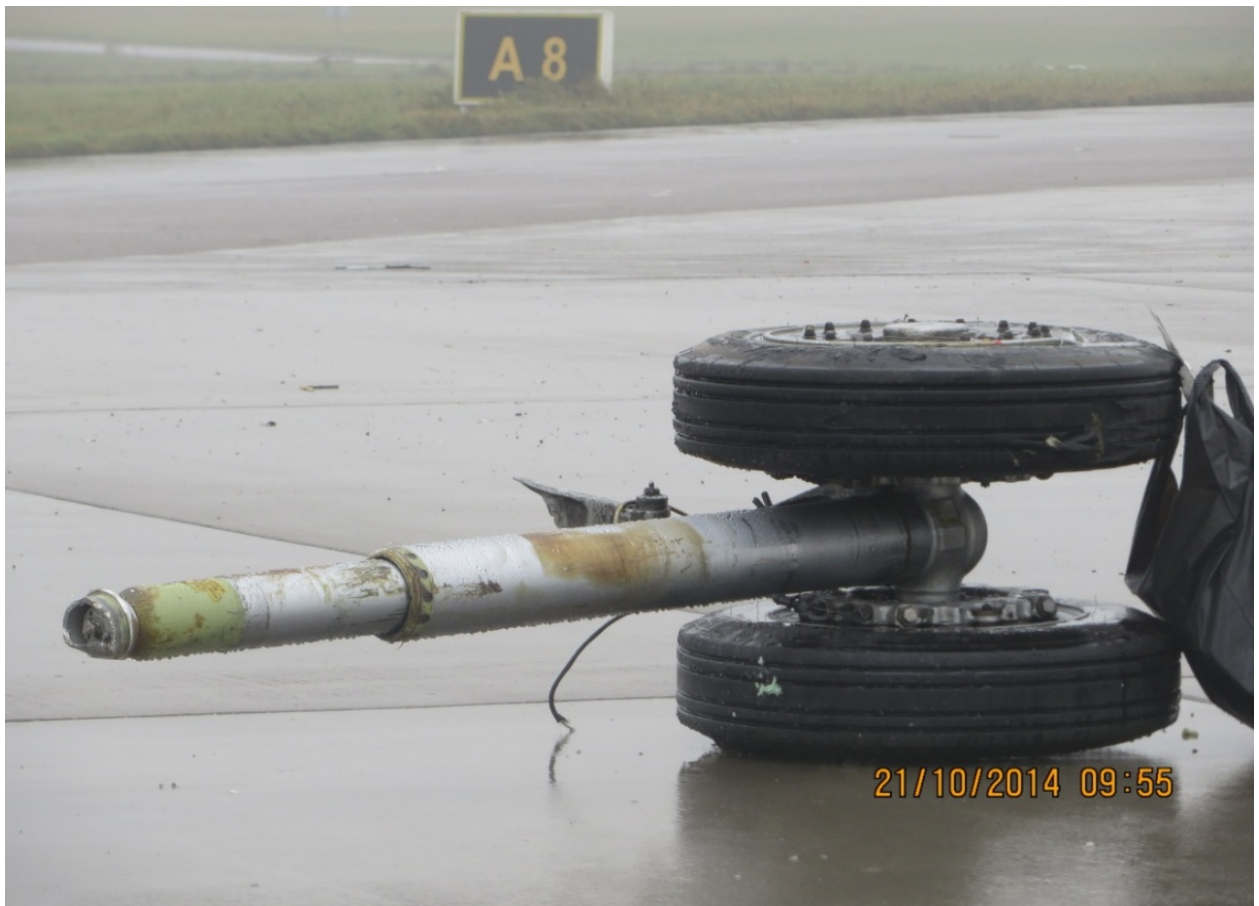
The wheel tire had lateral tear, a crack induced by the hit on the wheel disk rim collar, the upper link of the hinge was destroyed. A fragment of the RH main landing gear with the strut cylinder and cross brace was bent backwards (comparing to the flight direction).

Figure 46. RH main landing gear

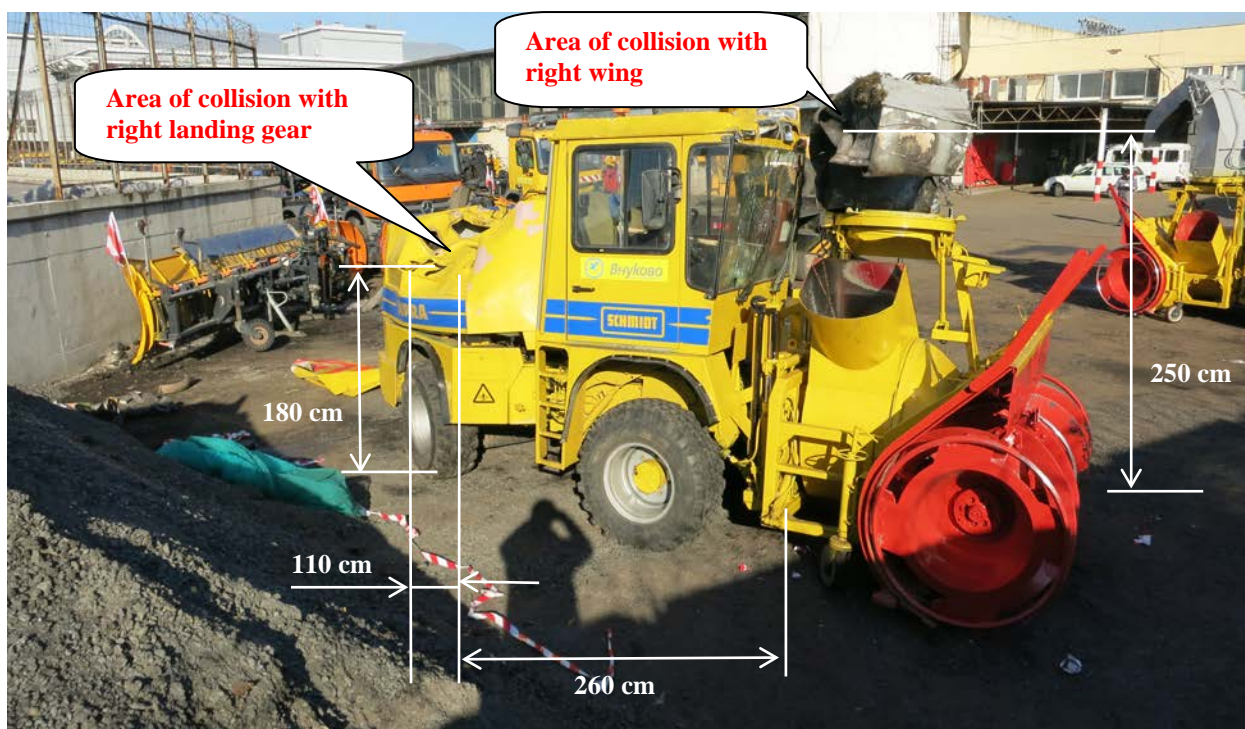
- the roof strobe light glass was missing;
- the engine cowling strobe light was missing;
- the left reverse movement light's casing was damaged;
- the engine cowling contained a dent on the RH side left by the airplane landing gear tire.

Figure 46a. Snowplow after the accident (the damaged snow evacuation nozzle was placed at its location as per design)

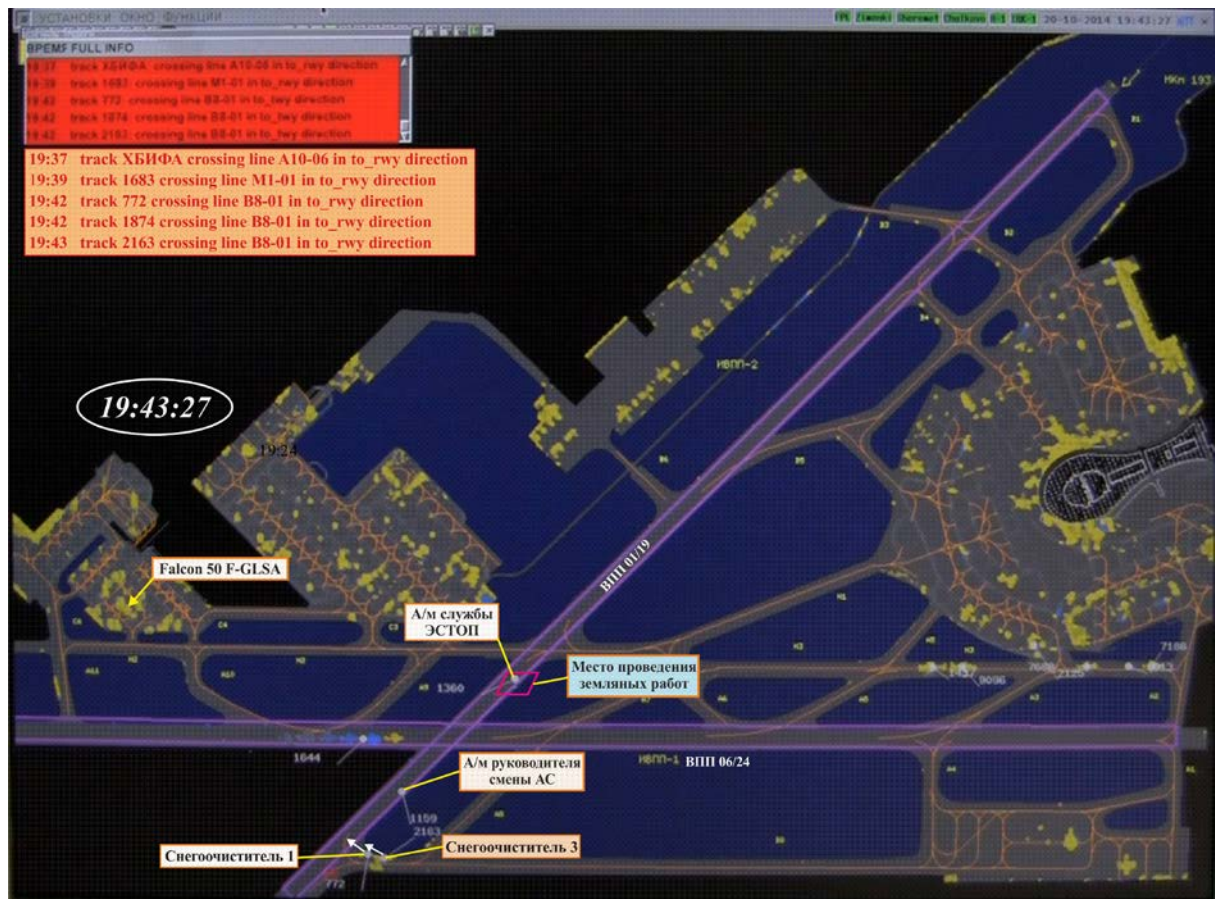
At 19:43 the airdrome service shift supervisor car and snowplows 1 and 3 without notification or clearance of the air traffic service drove from TWY B8 to the inoperative RWY 2 (Figure 57).

Figure 57. Location of objects at airdrome Vnukovo as viewed from the ground controller screen at 19:43:27

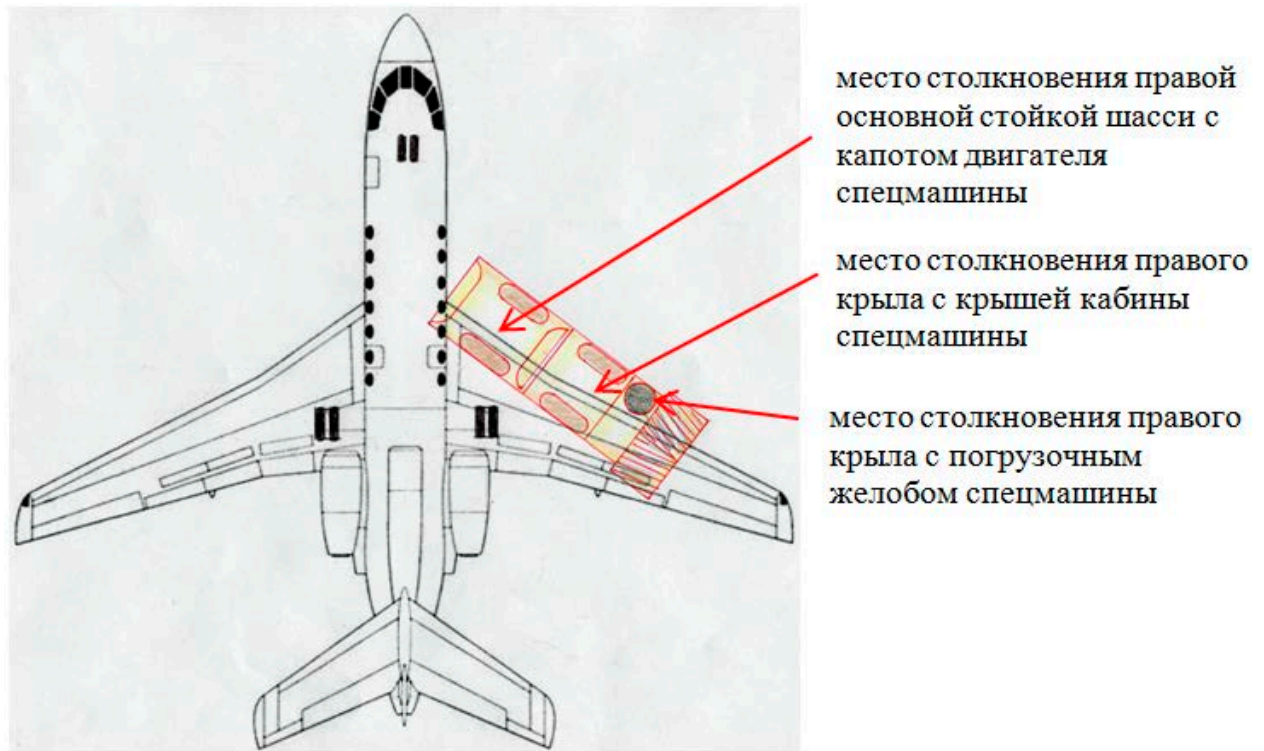
Figure 84. Collision of Falcon 50EX F-GLSA and snowplow 3
