*This document is an English translation of the Final Report on the fatal accident involving the Falcon 50EX aircraft registered F-GLSA that occurred on October 20, 2014 at Vnukovo Airport, Moscow.*

## **INTERSTATE AVIATION COMMITTEE**

### **AIR ACCIDENT INVESTIGATION COMMISSION**

#### **FINAL REPORT**

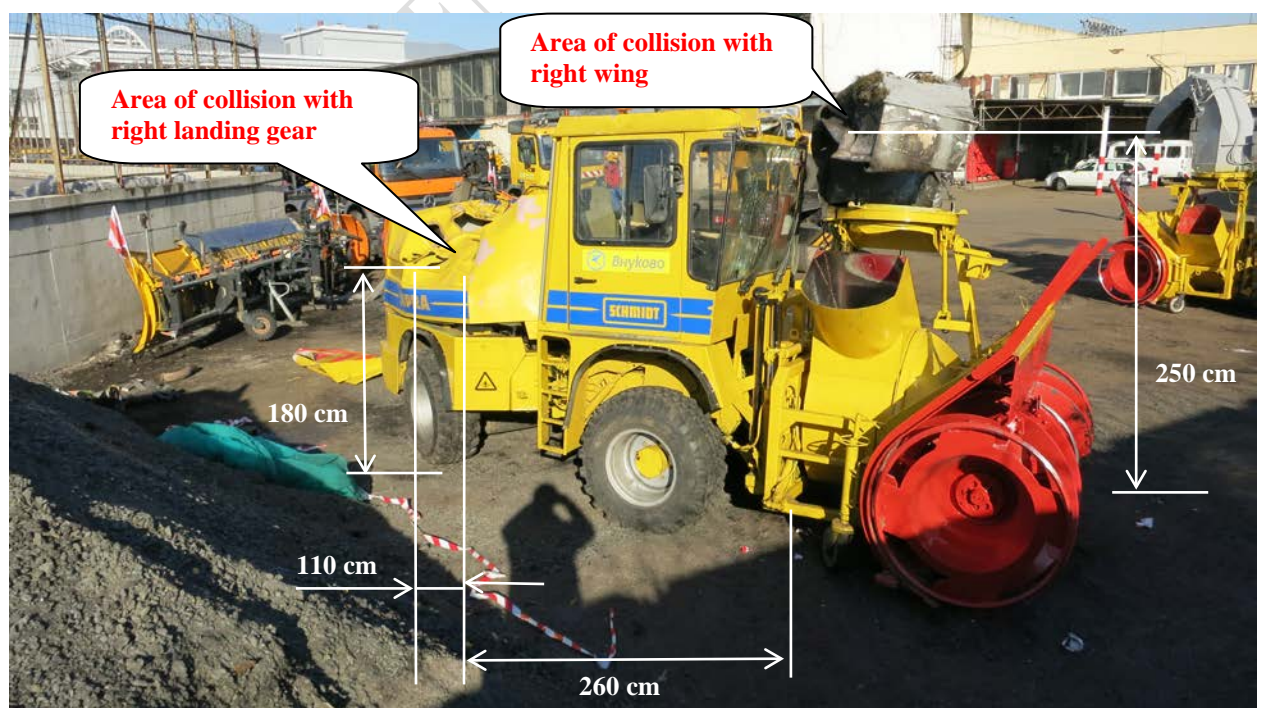
Figure 85. Location of aircraft parts hitting the snowplow
