CIVIL AERONAUTICS BOARD

ACCIDENT INVESTIGATION REPORT

PLYMOUTH OIL COMPANY, INC., LOCKHEED PV-1, N 1505V
NEAR WAYNESBORO, VIRGINIA, NOVEMBER 20, 1954

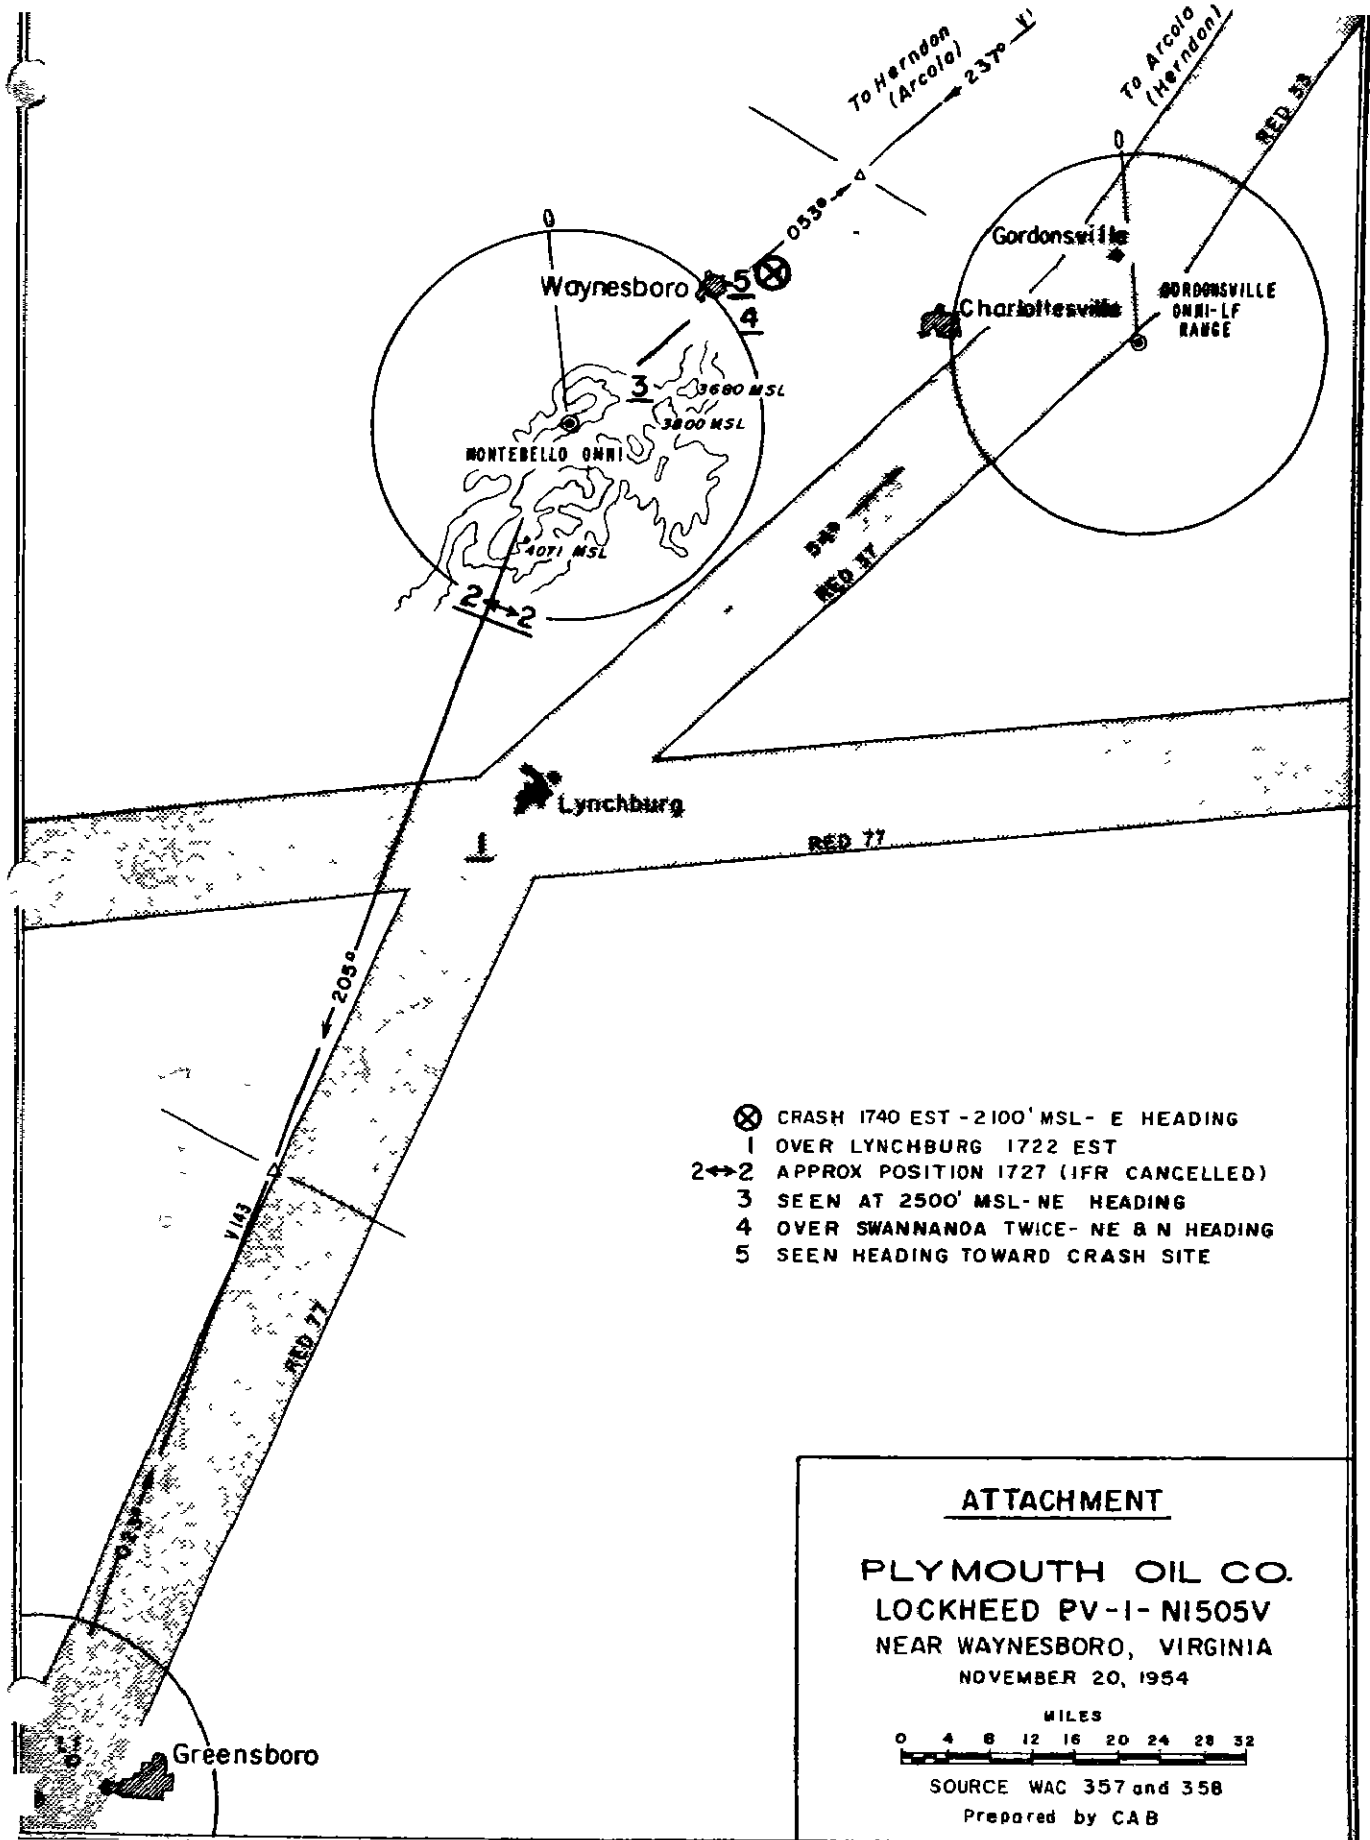
ATTACHMENT

Investigation indicated that the aircraft descended from 11,000 feet at Lynchburg to the northwest of Red 37 airway. This airway's course from Lynchburg to Gordonsville is 54 degrees and is over lower terrain that was free of fog at the time of the accident. The aircraft was first seen flying a north-northeast heading at about 2,500 feet m. s. l. in the Blue Ridge Mountain area, 16 miles south of the accident site. The mountain tops were covered with fog and there was a layer of fog over the valley to the west. Eyewitnesses, near Skyline Drive, testified that they saw the aircraft flying at a very low altitude just below this fog layer.

The heading of Red airway 37 between Lynchburg and Gordonsville is 54 degrees magnetic. This airway passes over low rolling terrain and at the time of the accident the cloud ceilings were 6,000-7,000 feet. Although this airway was specified in the flight's clearance it is apparent that this course was not flown after passing Lynchburg but rather that the aircraft continued to fly on about the same heading which was flown between Greensboro and Lynchburg. A continuation of this heading passes over the accident site.

- ⊗ CRASH 1740 EST - 2100' MSL - E HEADING
- 1 OVER LYNCHBURG 1722 EST
- 2↔2 APPROX POSITION 1727 (IFR CANCELLED)
- 3 SEEN AT 2500' MSL - NE HEADING
- 4 OVER SWANNANOA TWICE - NE & N HEADING
- 5 SEEN HEADING TOWARD CRASH SITE
