CIVIL AERONAUTICS BOARD

ACCIDENT INVESTIGATION REPORT

THE CRANE COMPANY, LOCKHEED PV-1, N 64001,
NEAR JEFFERSONVILLE, INDIANA, MAY 15, 1956

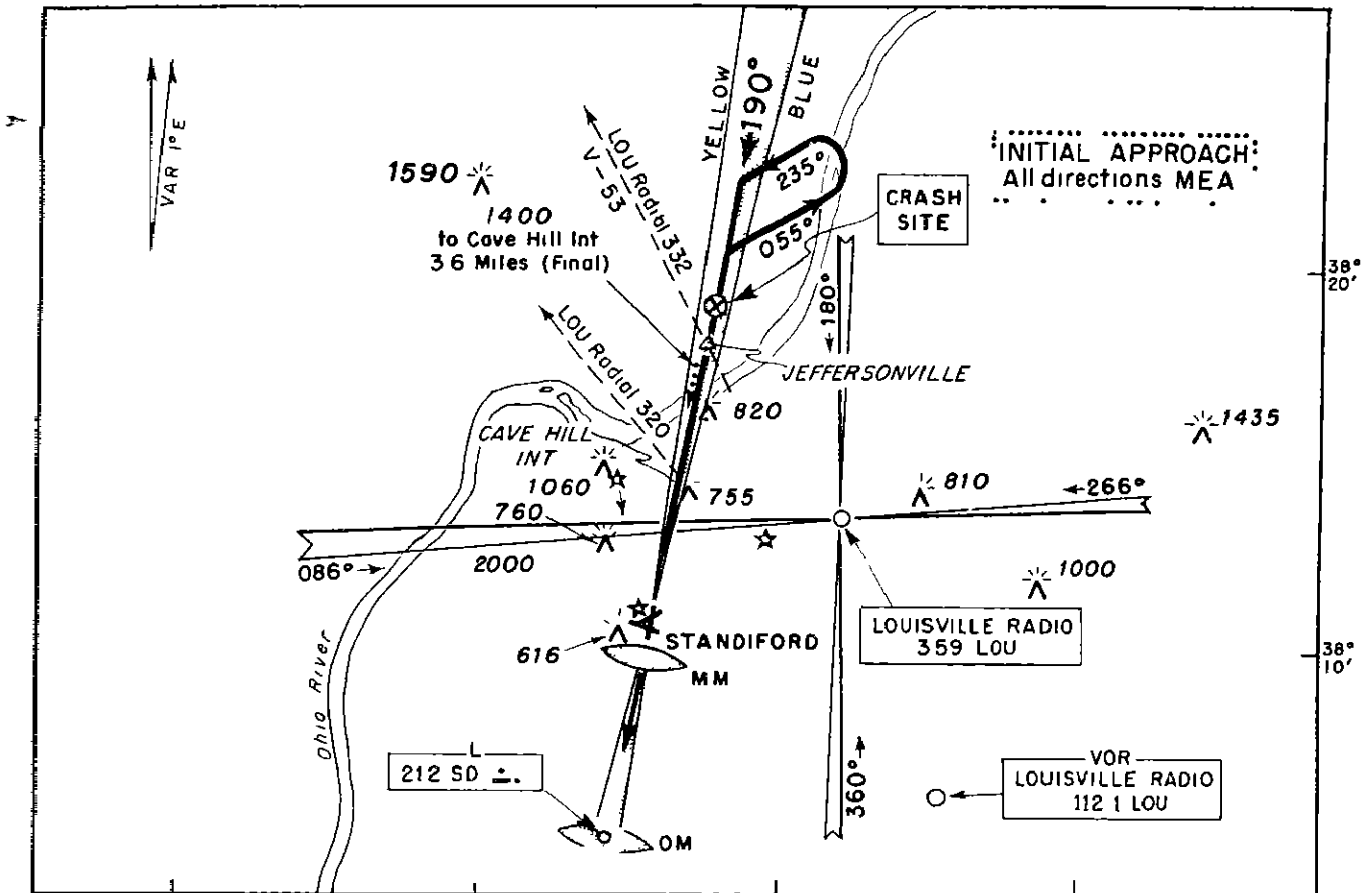
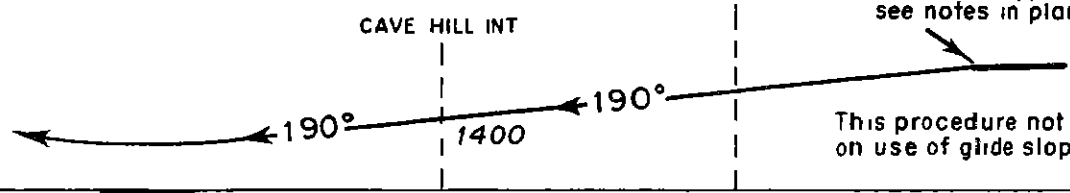
ATTACHMENT A
 PV-1 N 64001
 THE CRANE CO
 NEAR
 JEFFERSONVILLE, IND.
 May 15, 1956

Shortly after takeoff the pilot gave a routine report to Chicago radio of his time off as 0908 and his estimated elapsed flight time as one hour and 20 minutes. He did not request weather information at that time. Other radio contacts followed as the flight progressed, the final one being at 1034 over the Jeffersonville intersection. An approach was then started from that point to the Standiford Airport, 6-9/10 miles distant. During this approach the aircraft struck trees and crashed at a point one-half mile north of the Jeffersonville intersection. (See attachment A, showing standard No. 2 ILS approach for Standiford Airport, with crash site marked.)

It appears that after starting the instrument approach, as shown on attachment A, the left engine lost all but idling power. The left carburetor idle control valve linkage fork must have suddenly become disconnected, without warning, at this time. It would normally be at about this time that power changes (throttle movements) would be made and the aforementioned bolt could then have come out. What may well have happened is that Pilot Mulherin changed throttle settings, experienced a sharp yaw to the left due to windmilling of the left propeller, spent the next several seconds trimming the aircraft to offset the resulting drag, and then attempted to determine the trouble. During this short and critical period, to continue with the premise, and at low altitude, the speed of the aircraft continually decreased until control was lost as it struck trees and then dived into the ground.
