No. 12

Aerovías Nacionales de Colombia, DC-3C, HK-155, crashed on a spur of the "Trujillo Hills" on 9 March 1957, Report released by the Department of Civil Aviation, Colombia.

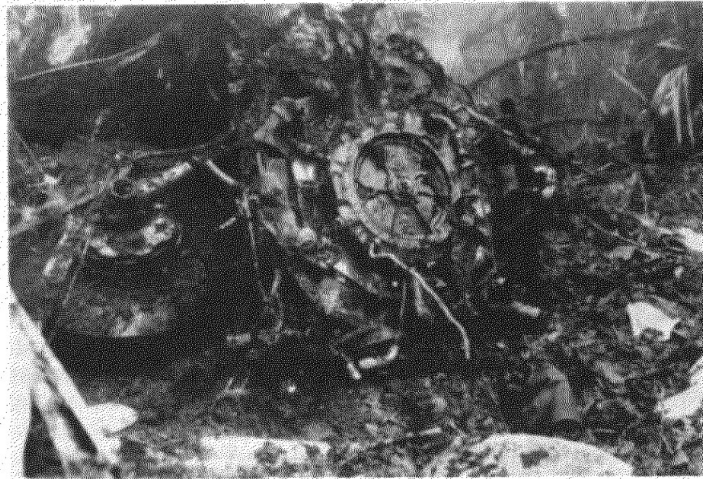
FIGURE 9

DC-3C, HK-155, which crashed on a spur of the "Trujillo Hills", Colombia on 9 March 1957.
