No. 50

Karl Herfurtner Air Transport Company, DC-4, D-ALAF, crashed at Dusseldorf on 3 November 1957. Report released by the Directorate of Civil Aviation, Federal Republic of Germany.

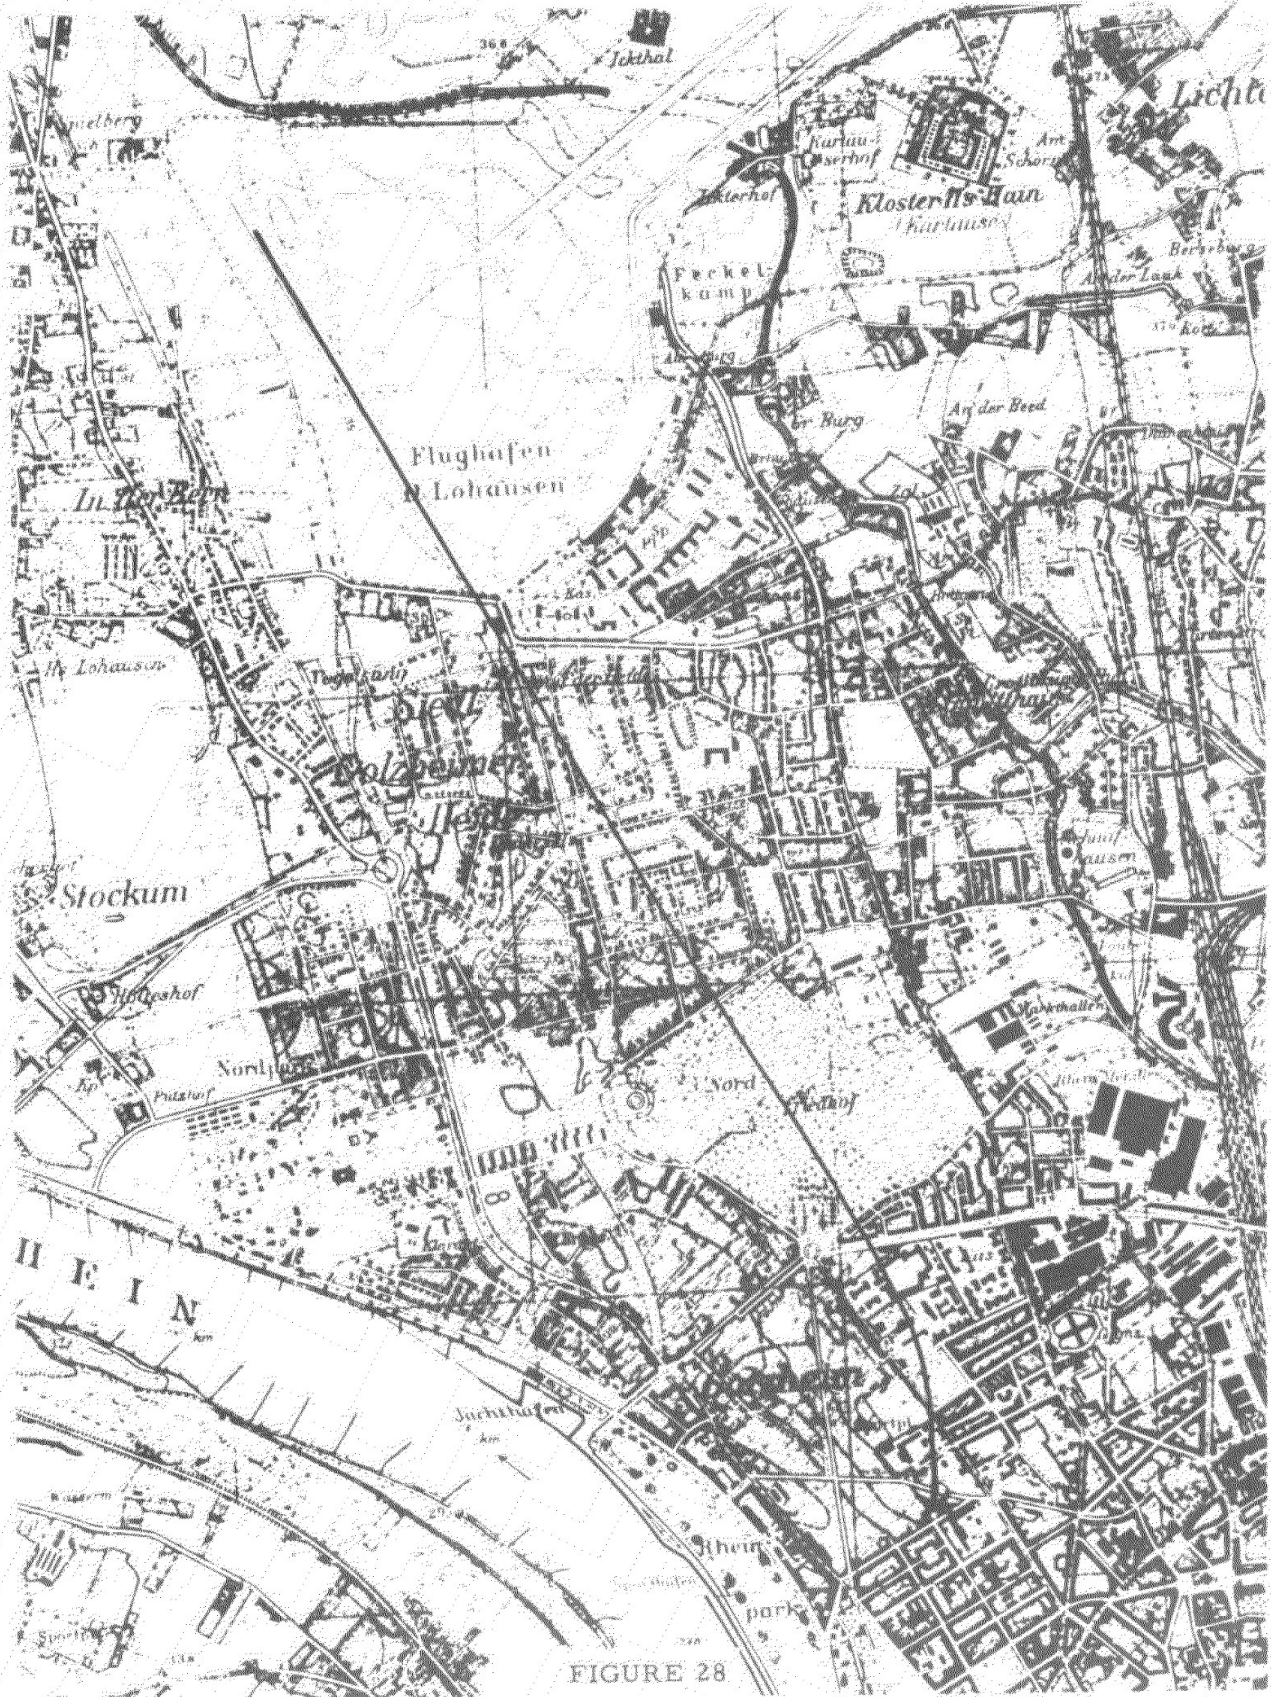
FIGURE 28

Flight path of D-ALAF prior to its crashing at Dusseldorf

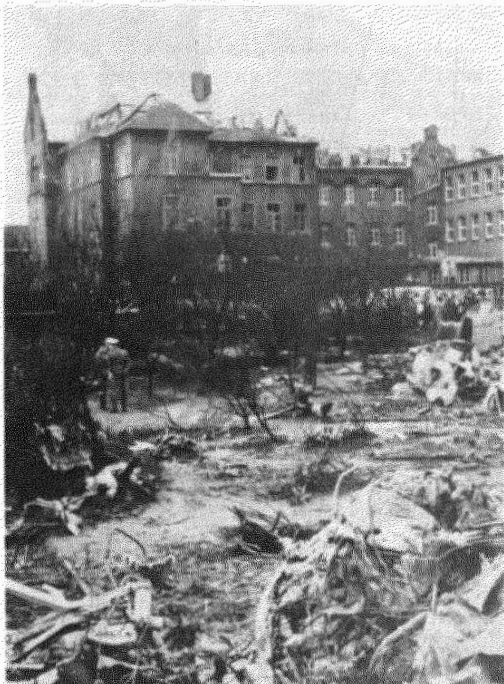
FIGURE 29

View toward approach
with burnt out house.

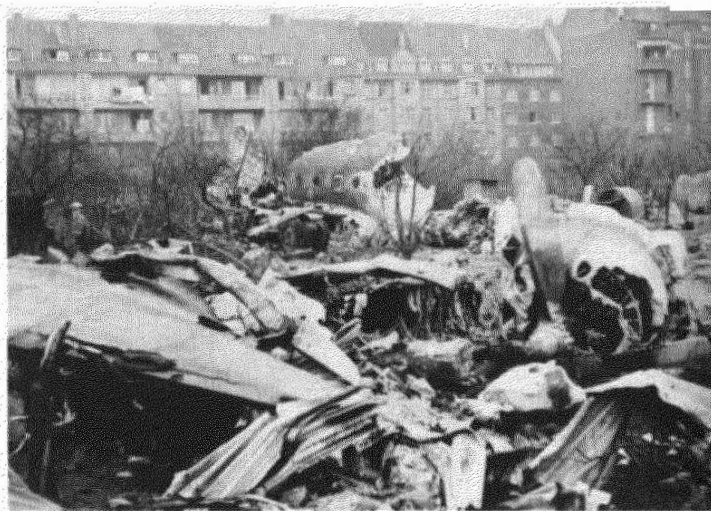
FIGURE 30

In the foreground demolished
right wing and engine No. 3.

In the background mid-section
of fuselage.

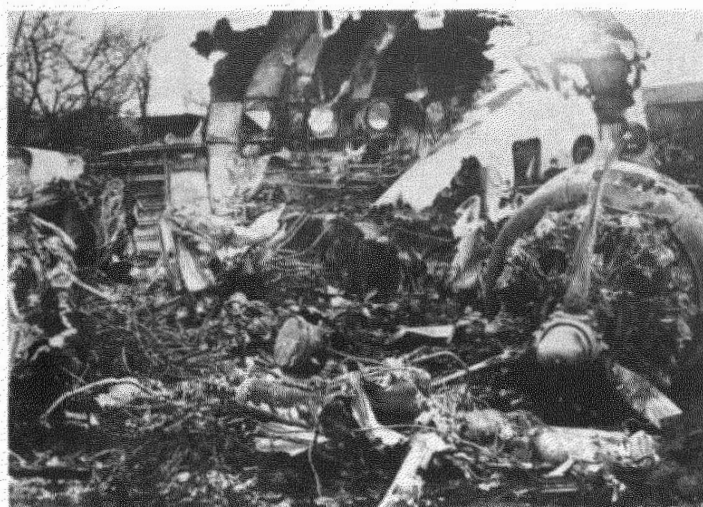
FIGURE 31

The condition of No. 2 propeller revealed that at the time of impact the propeller blades were fully or almost fully feathered. It is impossible to ascertain from the condition of the pitch control mechanism whether the blades were already feathered or whether they were in the process of change to or from the feathered position.

Engine No. 2 with mid-section
of fuselage.
