No. 11

Aviación y Comercio, de Havilland D.H. 114, Heron 2D, EC-ANZ,
crashed into a mountain near Puigpufent, Majorca, on 15 November 1957.
Report released by the Directorate General of Civil Aviation, Spain.

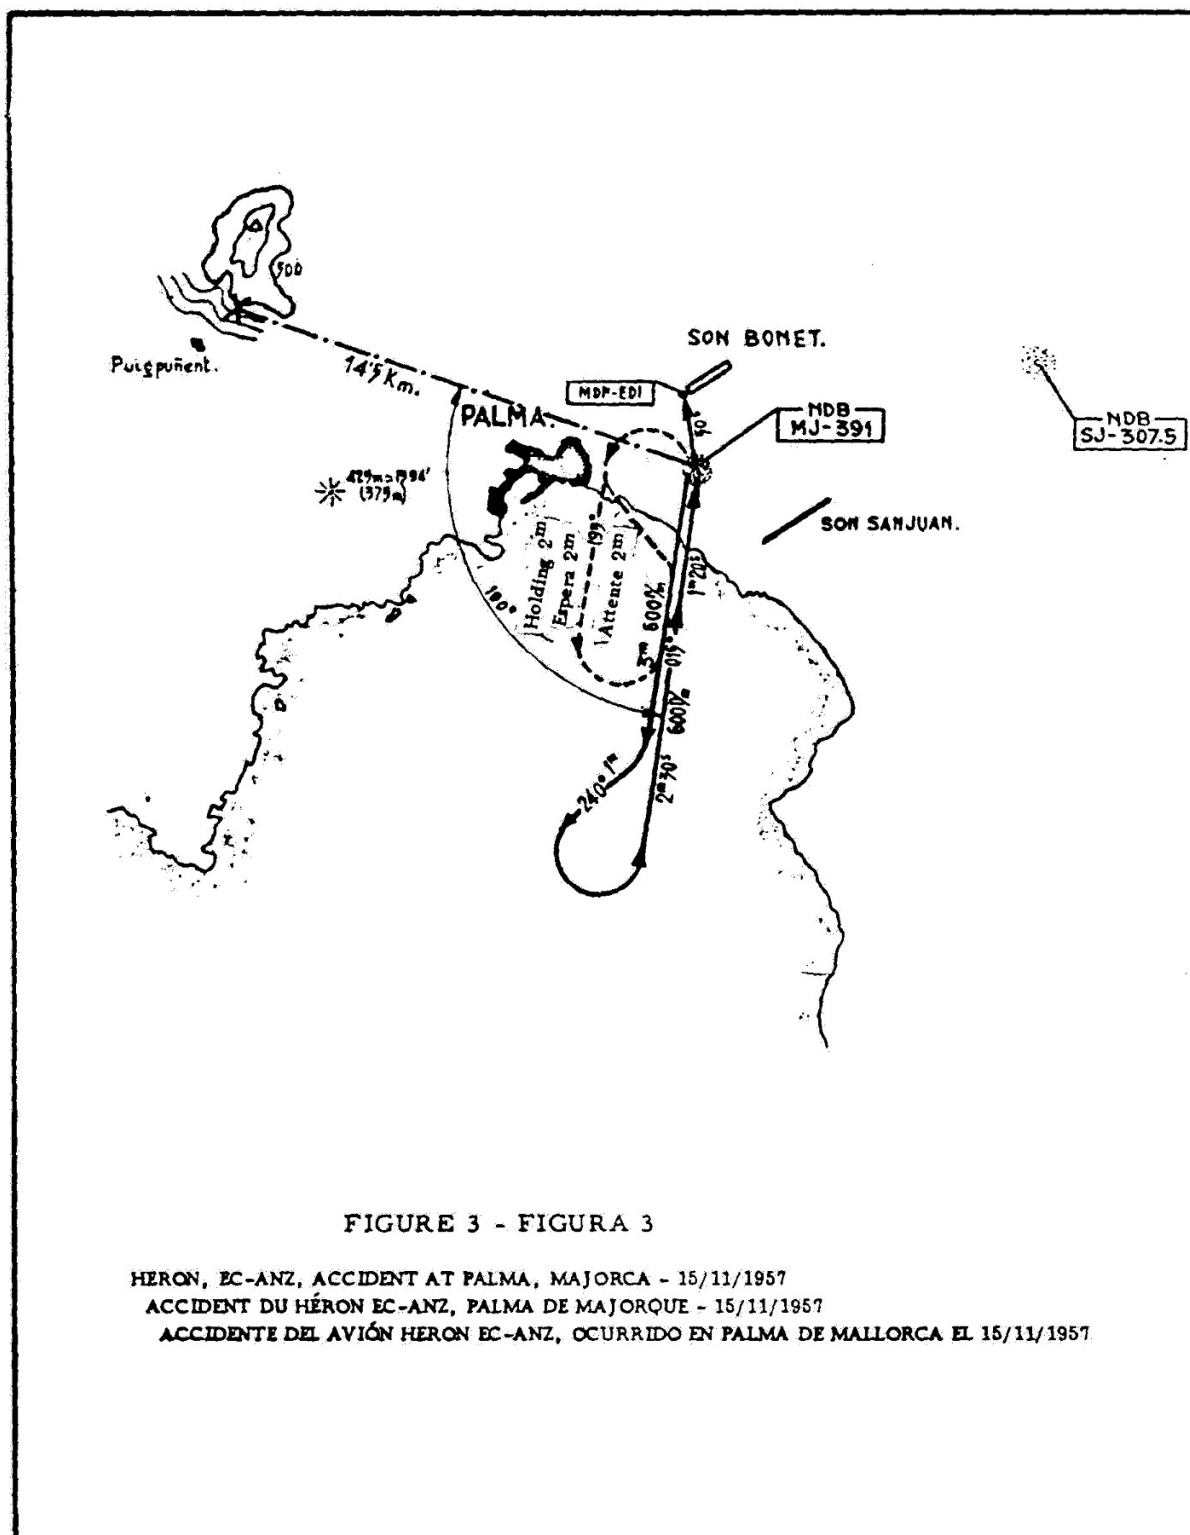
FIGURE 3 - FIGURA 3

Now if a line is drawn from the radio beacon MJ to the site of the accident, it will be seen that the direction of the line is 295°, i.e., that it forms an angle of 100° with the let-down heading (195°); it is possible, therefore, that in setting the directional gyro the pilot mistakenly added 100 degrees. The distance of 14.5 kilometres corresponds approximately to the distance from the beacon of a procedure turn.

HERON, EC-ANZ, ACCIDENT AT PALMA, MAJORCA - 15/11/1957
 ACCIDENT DU HÉRON EC-ANZ, PALMA DE MAJORQUE - 15/11/1957
 ACCIDENTE DEL AVIÓN HERON EC-ANZ, OCURRIDO EN PALMA DE MALLORCA EL 15/11/1957
