No. 57

Aerolíneas Argentinas, DC-4, LV-AHZ, crashed in the vicinity of Bolívar (Province of Buenos Aires), Argentina, on 8 December 1957. Investigation Report No. 918 released by the Ministry of Aeronautics, Argentine Republic.

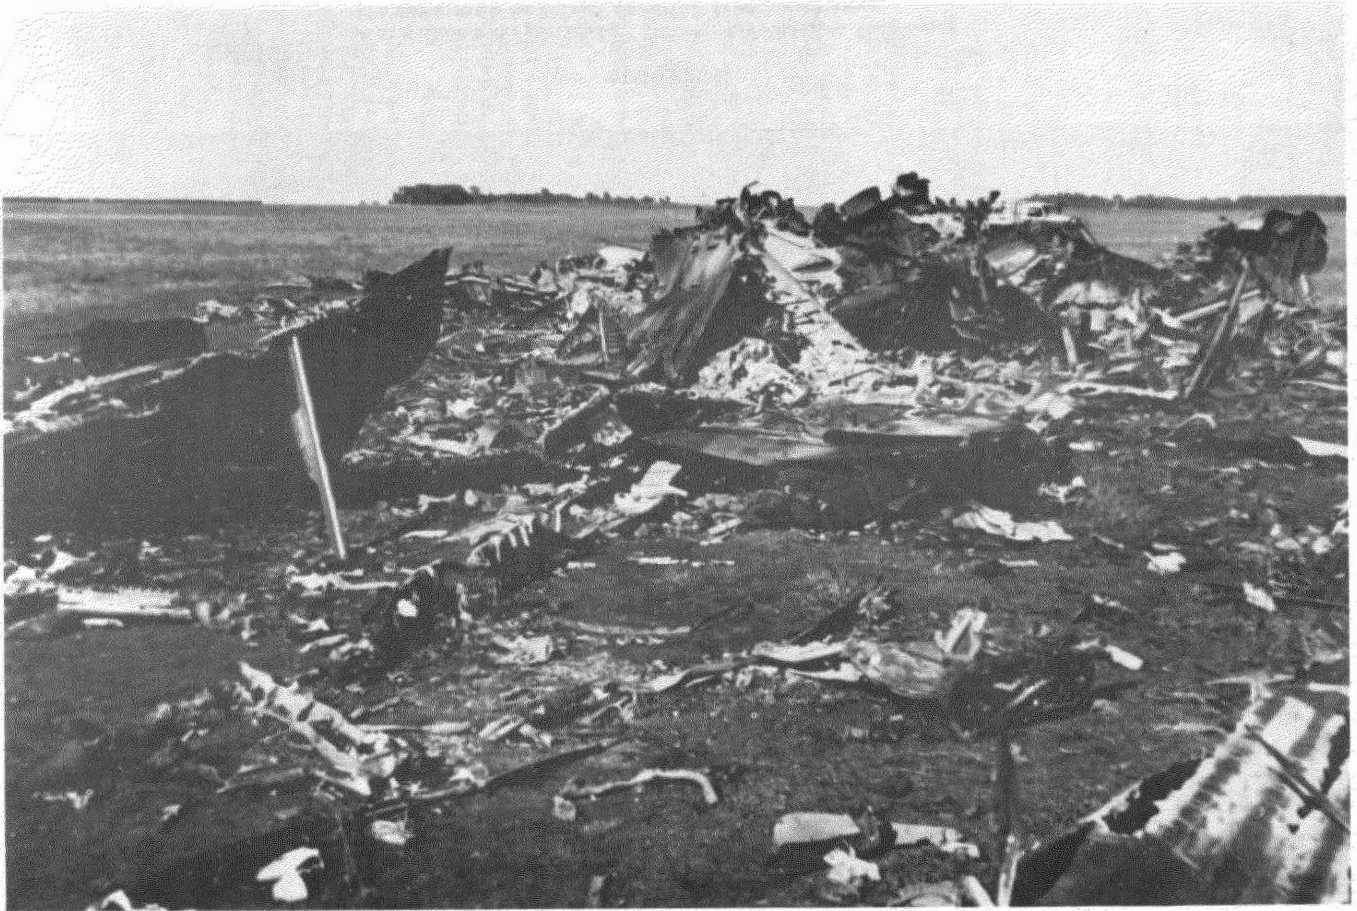
FIGURE 40

The wreckage followed the same direction as the heading of the falling aircraft, with a length up to 125 metres and a width of 25 metres. Its engines were buried in the soil down to a depth of 1.5 metres.

The central section of the wing, most of which had melted, showed a fracture of the joint of the left wing, at 50 centimetres from the bolted end, and all the extremity of the left wing was missing. The right wing had fallen off on impact. The landing gear and the nose-wing were in the retracted position, including their jacks; the flaps appeared in the retracted position and all the flight controls had been destroyed on impact or through fire. As regards the aircraft instruments, only the tachometer of the No. 2 engine was found jammed at 2 550 rpm; all the other instruments were destroyed. The panel and switches of the electric system were also destroyed with the exception of one of the sets of switches of the radio equipment which was found switched on for the VHF equipment and switched off as regards radio compasses.

LV-AHZ - Wreckage of the aircraft destroyed
by impact and subsequent fire.

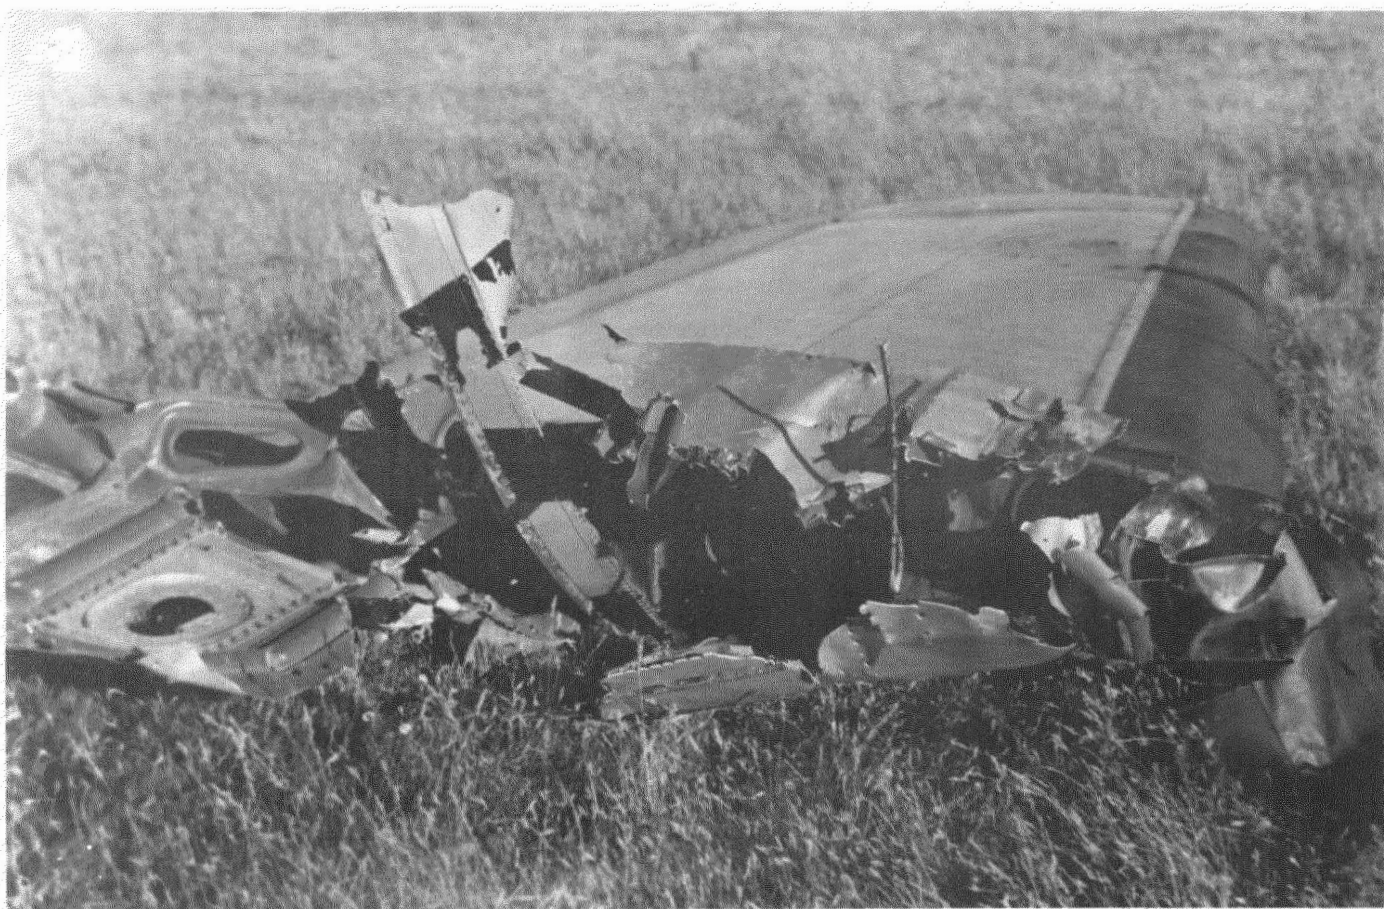
FIGURE 41

Examination of the wing tip indicated that it reached the ground sideways, in other words, that the tip of the wing slid onto the ground first and was followed by its lower surface; the scorings and small damage confirmed this conclusion. Consequently, the leading edge, the aileron, upper surface of the wing, trailing edge and the fracture zone were intact, and thus permitted observing the scorings left in the leading edge by the impact and the friction marks on the fin and the right stabilizer, where the leading edge de-icers left pieces of rubber sticking to the skin of the tail, which caused dents and scratches on the side of the leading edge of the detached wing.

The fracture on this side of the wing was about 1 metre long and the stressed skin was torn off. The flange and web of the wing spar were obviously broken with upward and downward distortions following a similar fracture of the wing through simultaneous torsional deflection.

The bottom flange plate of the spar showed a combined torsion and flexion

fracture running in a perpendicular line to its axis.

It was concluded that fracture was due to combined stress above the design stress of the parts concerned.

Aerolíneas Argentinas, DC-4, LV-AHZ - left wing tip torn free in flight showing fractured area.
