National Transportation Safety Board Aviation Accident Final Report

Location:	Iliamna, AK	Accident Number:	ANC15FA071
Date & Time:	09/15/2015, 0606 AKD	Registration:	N928RK
Aircraft:	DEHAVILLAND DHC 3T	Aircraft Damage:	Substantial
Defining Event:	Loss of control in flight	Injuries:	3 Fatal, 5 Serious, 2 Minor
Flight Conducted Under:	Part 91: General Aviation - Other Work Use

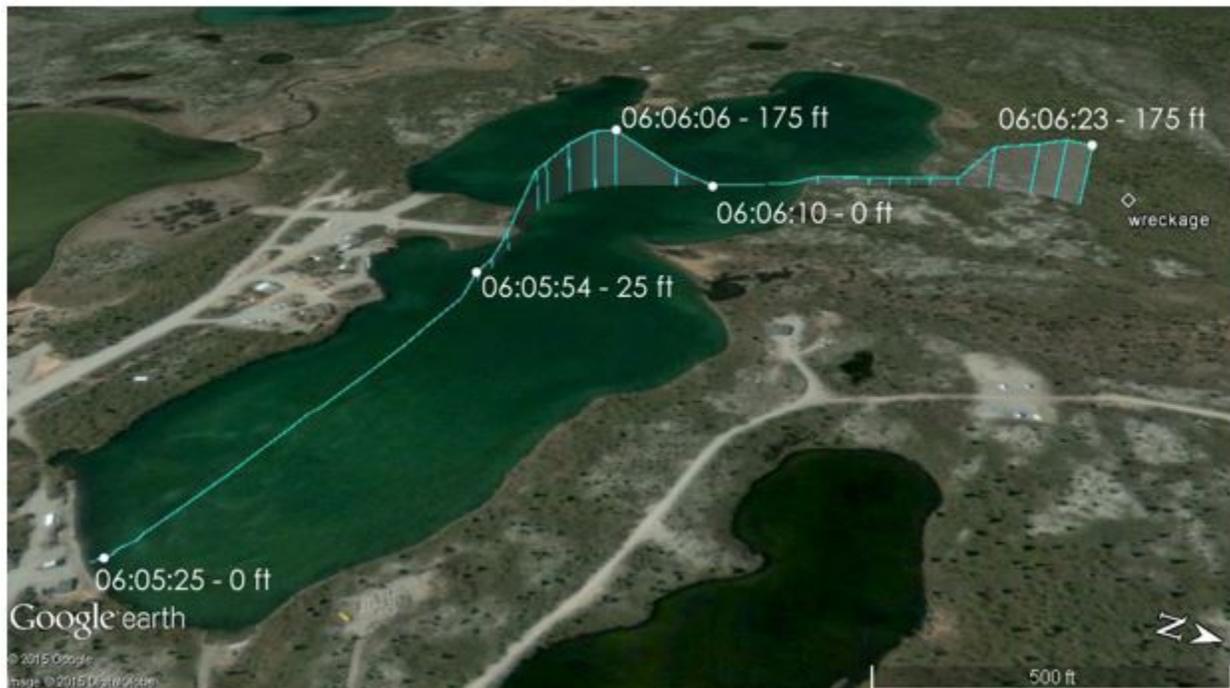
Figure 1. Airplane's flightpath from ADS-B data.

Data from the accident airplane's ADS-B, as shown in figure 1, show the airplane's flightpath. Airspeeds were calculated using the ADS-B position data and the reported wind information. Airplane orientation was calculated from these data and a basic aerodynamic model of the airplane. Calculations made from ADS-B and weather data are subject to uncertainty; therefore, airspeeds and attitude values should not be considered exact.

During the initial climb, the airplane remained below the recommended airspeed per the Texas Turbine Conversions, Inc., AFM. The data show the airplane initially gaining altitude at 0605:54 and reaching 56 mph, as recommended in the AFM. After the initial climb with a 10° bank angle, the airplane made a descending right turn at 57 mph and lost 175 ft of altitude, which placed the airplane at or near the water's surface. Subsequently, the airplane began regaining altitude with a 30° bank angle, and then it made another right turn at less than 57

mph. The airplane's stall speed is 57 mph at a 0° bank angle, 59 mph at a 20° bank angle, and 65 mph at a 40° bank angle.
