No. 42

Panair do Brasil S. A., DC-7, PP-PDO, accident at Recife Airport,  
Pernambuco, Brazil on 1 November 1961. Report released by  
the Brazilian Air Ministry (SIPAer).

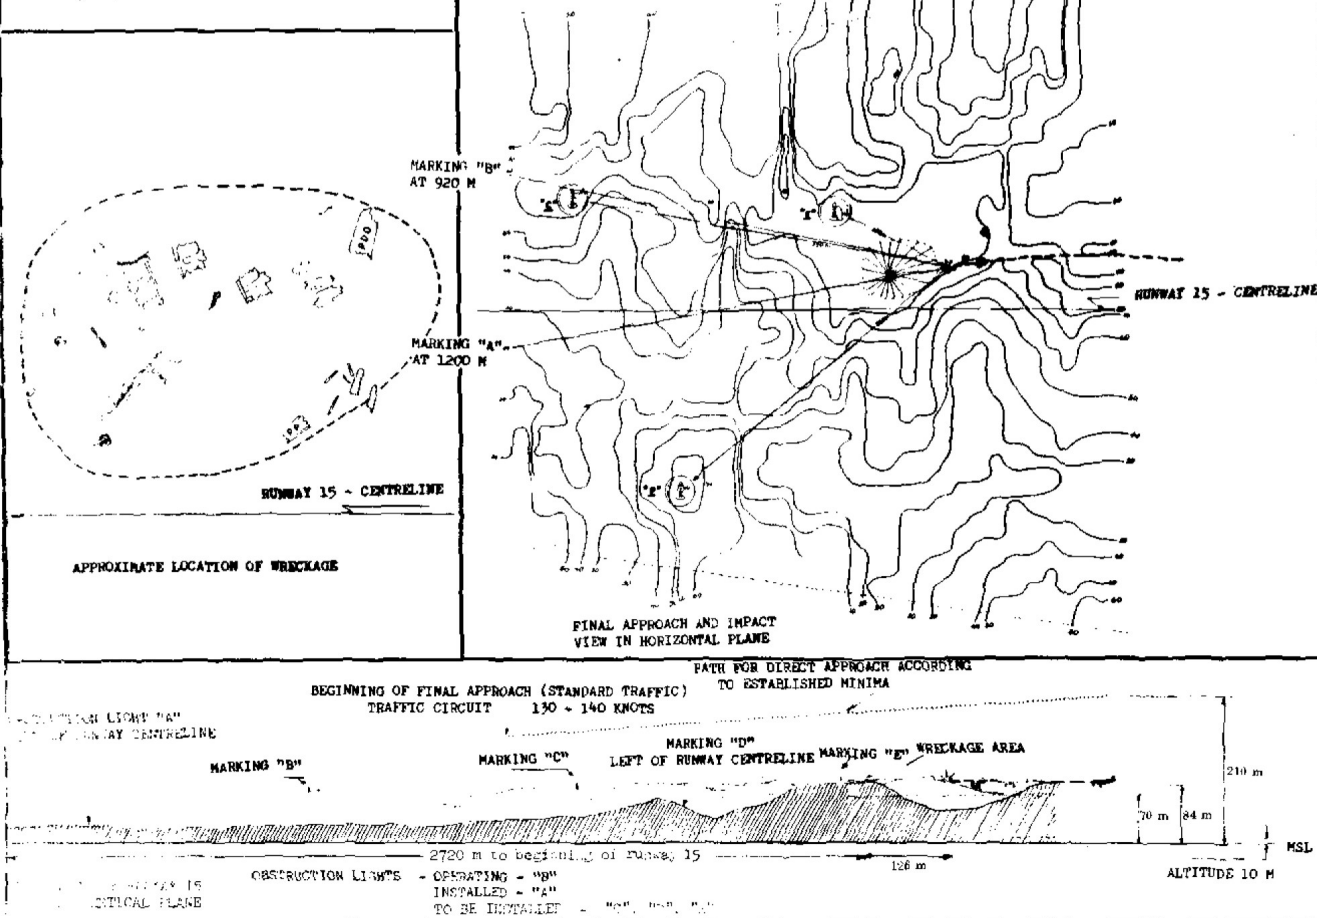
FIGURE 20

Referring to the elevations of the approach area to Runway 15, as shown in Figure 20, it is noted that there are five points above that area (A, B, C, D, E), which measure 16.10 m, 24.40 m, 22.90 m, 26.00 m and 29.80 m, respectively. In accordance with Annex 14, Part IV, paragraph 3.1.1, these five points should be marked. However, only two points (A and B) have obstruction lights installed, and on the night of the accident only the light in B was operating.

It is observed that at the impact point, if the aircraft had performed an IFR approach, it should have been at an altitude of 210 m as it had practically reached the critical point in the pattern. Performing a visual approach, it should have begun the long final approach and should have been at the minimum altitude of 160 m.

A contributing cause was the improper night marking of obstructions along the approach path towards runway 15.
