No. 11British European Airways, Vanguard, G-APEE, accident at London (Heathrow) on
27 October 1965. Report, undated, released by the Board of Trade,
United Kingdom, C.A.P. 2701.- Investigation1.1 History of the flight

ACCIDENT TO VANGUARD, G-APEE, OF BRITISH EUROPEAN AIRWAYS, AT LONDON
(HEATHROW) ENGLAND, ON 27 OCTOBER 1965

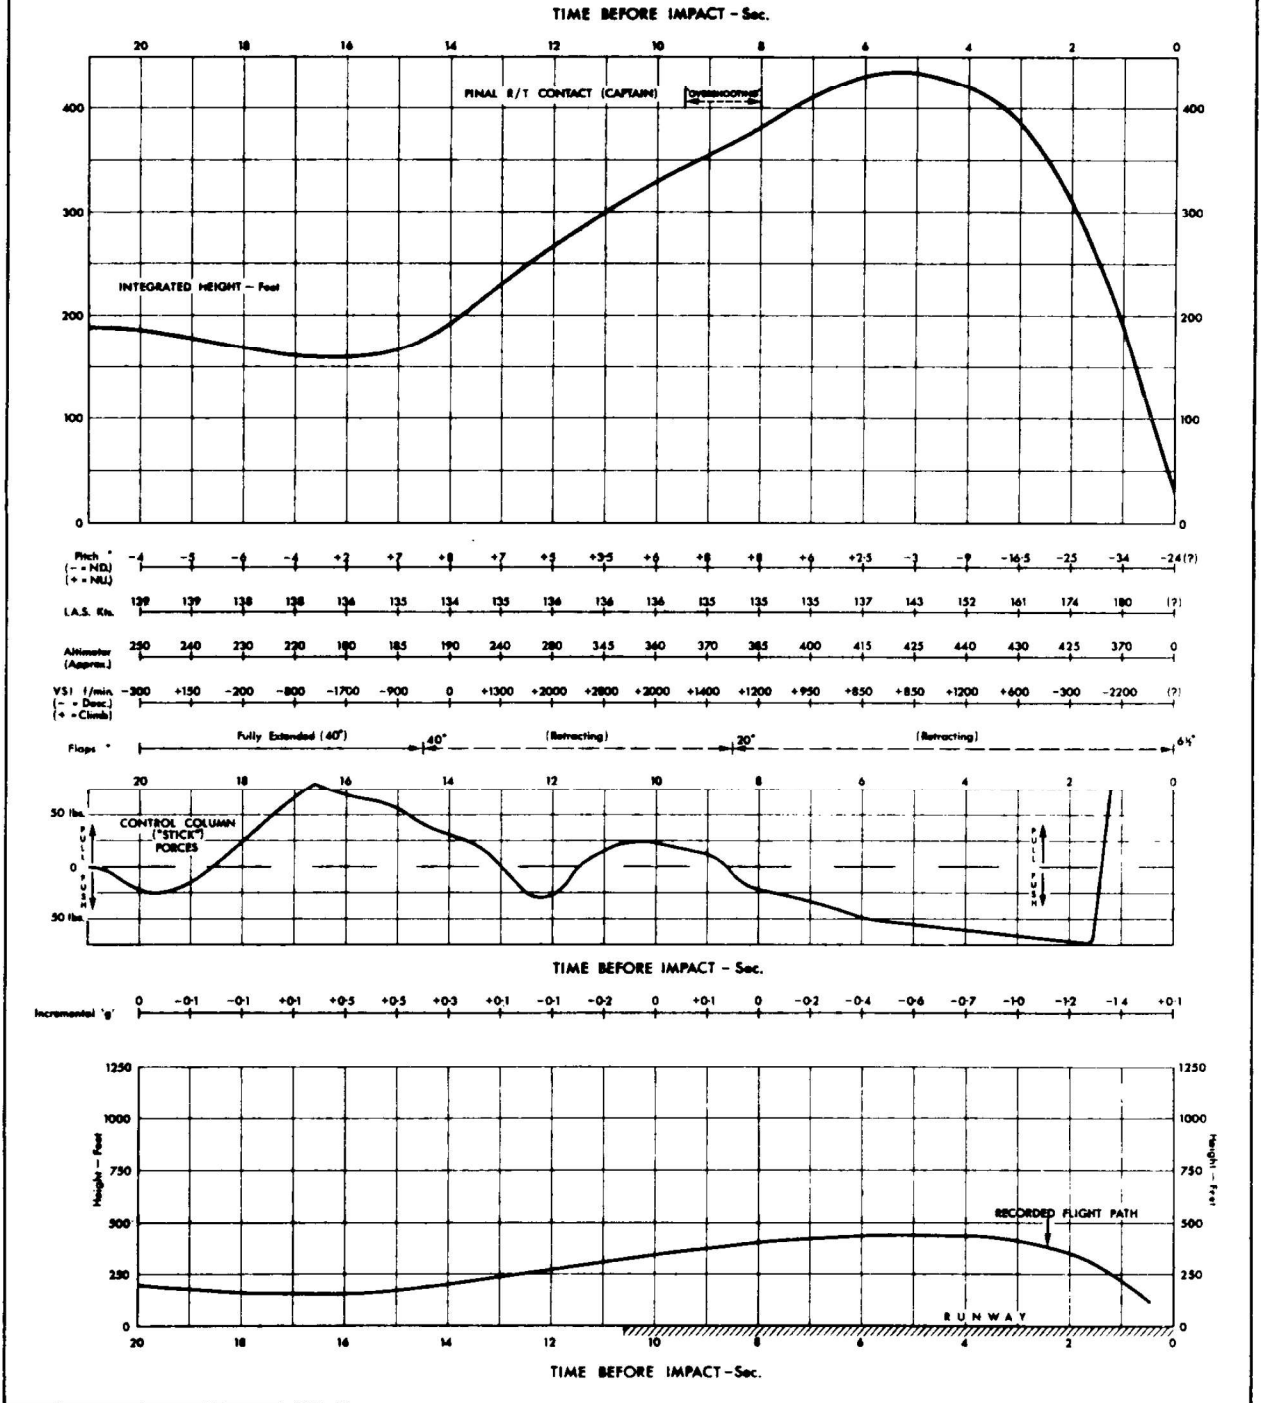
Fig. 11-1

The composite picture presented by the direct recordings of the FDR and the further calculations made from them is illustrated by Figure 11-1.

From this it will be seen that at -20 seconds the aircraft was about 50 ft lower than the height recorded, and the co-pilot's altimeter probably indicated about 250 ft. The true height was about 190 ft.

At -18 seconds the aircraft was coarsely rotated upwards. The pitch-attitude was changed from 6° nose down to about 8° nose-up. This was the initiation of the overshoot.

At -15 seconds there was a partial change of attitude towards the horizontal, followed by a further significant upward movement of the elevators at -12 seconds.

At -10 seconds there was a relaxation of the backward pull on the elevators followed by a progressive downward movement of the elevator control.

A slow build-up of speed then took place, so that at -4 seconds the indicated air speed was 152 kt.

But the altimeter was still at that stage showing an increase in height, reaching its maximum (at -4 seconds) of 440 ft and the vertical speed indicator at that point was still showing a 1 200 ft/min climb.

At -3 seconds the vertical speed indicator was still showing a climb of 600 ft/min, although the aircraft had been descending for 2 $\frac{1}{2}$ seconds and the control column had been forward of neutral for 4 seconds.

At -1 $\frac{1}{2}$ seconds a violent pull-up was initiated.

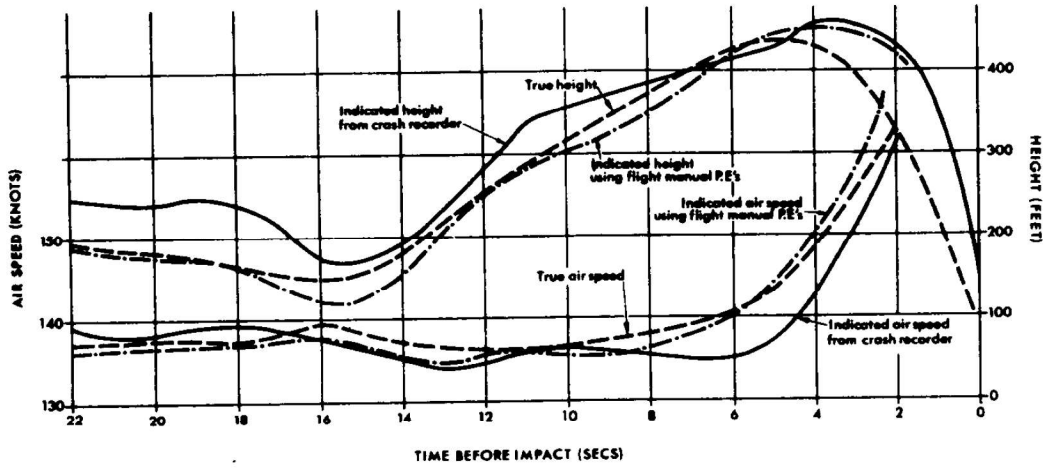
Fig. 11-2

These traces did, however, also show that on Echo Delta at least there was some difference between the flight recorder readings and those of the pilots' instruments. If anything, the pilots' altimeter readings were even further from the true height (as calculated from normal acceleration) than the flight recorder. (See Fig. 11-2).

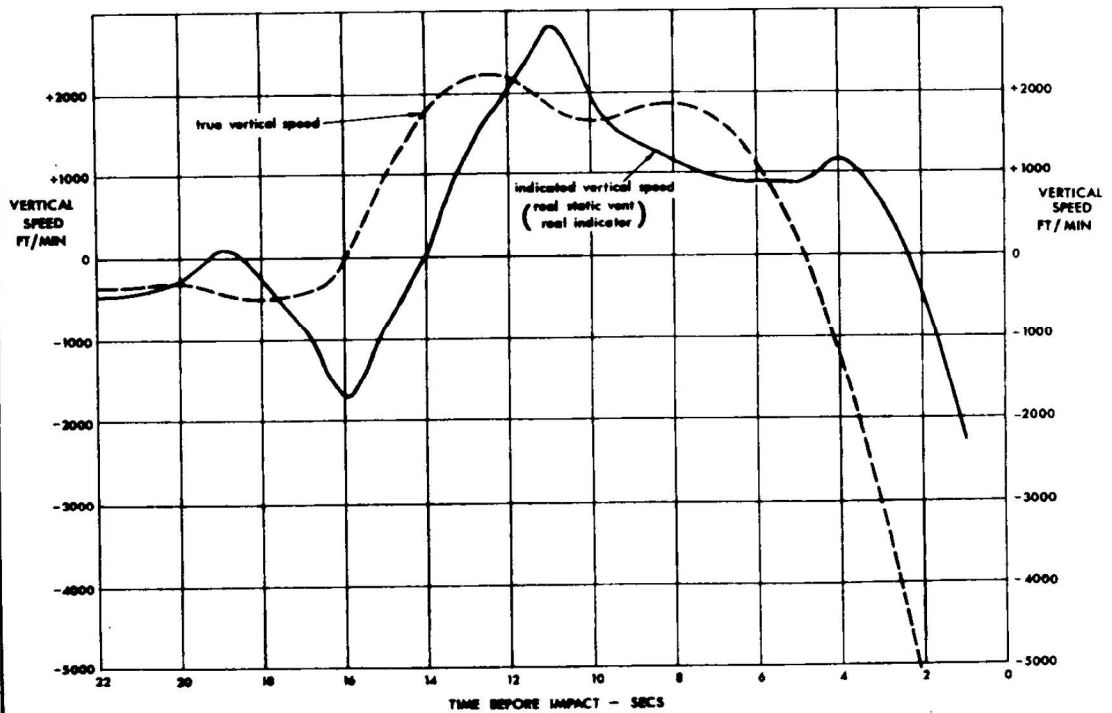
Fig. 11-3

The standard vertical speed indicator appeared to give a fairly good representation of the true vertical velocity variations but with an approximately constant lag of about 2 seconds and lower peak values. Whilst this pattern of errors did not entirely confirm the deductions made in respect of Double Echo, it did show that the time-lag calculations were approximately correct. (See Fig. 11-3).
