No. 9

Trans World Airlines, Inc., Boeing 707, N-742TW, accident at the Greater Cincinnati Airport, Erlanger, Kentucky, U.S.A., on 6 November 1967. Report File No. 1-0029, dated 11 September 1968, released by the National Transportation Safety Board, U.S.A.

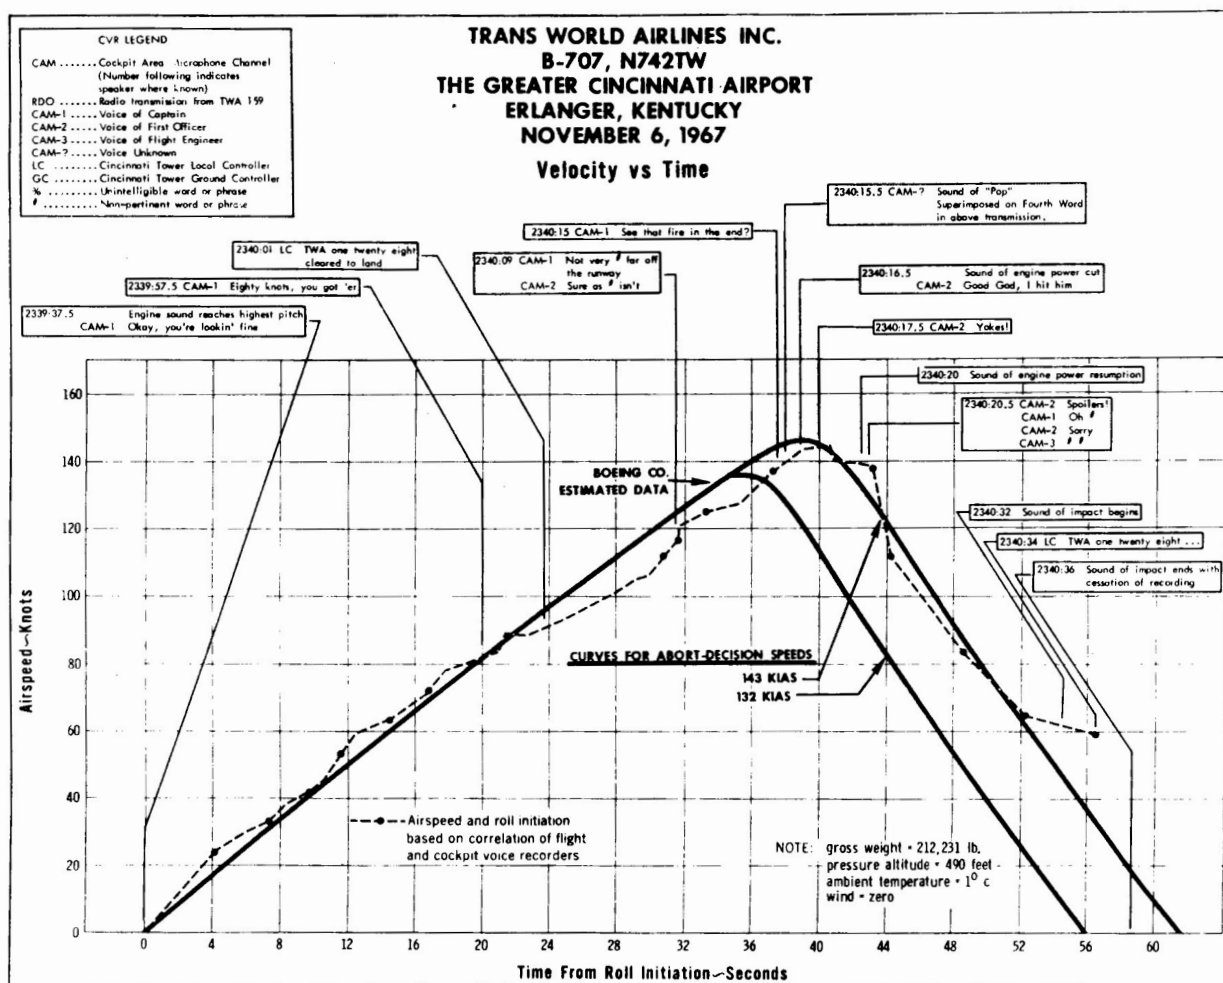
Figure 9-1

The Cockpit Voice Recorder-Flight Data Recorder airspeed curve was then compared with a predicted performance curve provided by Boeing (See Figs. 9-1 and 9-2). This comparison, utilizing the take-off clearance as a time reference, revealed an apparent disparity between the predicted and recorded performance of the aircraft in both the acceleration and deceleration phases of the take-off. Further study of the evidence prompted selection of the engine noise reaching its highest peak as the time reference for the take-off roll initiation point. This resulted in closer comparison of the two airspeed traces at the higher, more accurately recorded values, and still provided exceptional correlation with the physical evidence. In addition to the time base reference point, there were three other factors affecting the compatibility of the predicted and recorded performance. First, the airspeed values during deceleration were apparently depressed due to static position error induced by disturbed airflow while reverse thrust was utilized. Second, the airspeed values depicted by the flight recorder in the lower regimes, below 80 kt, tended to be less accurate than at the higher values. Third, the flight recorder tape drive system was malfunctioning. While this had no effect on the airspeed values recorded, it did result in irregular tape advance prior to the accident, and may have caused some minor distortion of the time scale during the take-off.

The significance of the crew's slow implementation of the abort procedure was apparent from the Boeing performance data (see Figs. 1 and 2), which showed that the total accelerate-stop distance of the aircraft was approximately 6 560 ft for an abort-decision speed of 132 kt and approximately 7 850 ft for an abort-decision speed of 143 kt. Although this data indicates that the overrun was inevitable, it was noted that had the abort been executed properly the aircraft would have stopped either prior to the brow of the hill (225 ft from the runway end) or at least would have arrived there at a sufficiently reduced airspeed so that it would not have become airborne again as it did and damage to the aircraft would have been greatly reduced.
