SUMMARIES OF AIRCRAFT ACCIDENT REPORTS AS PREPARED BY ICAOTAKE-OFF PHASENo. 1

British United Airways, BAC 1-11, G-ASJJ, accident at S. Donato Milanese, Italy, on 14 January 1969. Report, not dated, released by the Directorate General of Civil Aviation, Italy. Translation of the report, issued by the Italian Commission of Inquiry, was published by the United Kingdom Board of Trade as C.A.P. 347

B.A.C. ONE-ELEVEN G-ASJJ AT LINATE AIRPORT - 14th JANUARY 1969

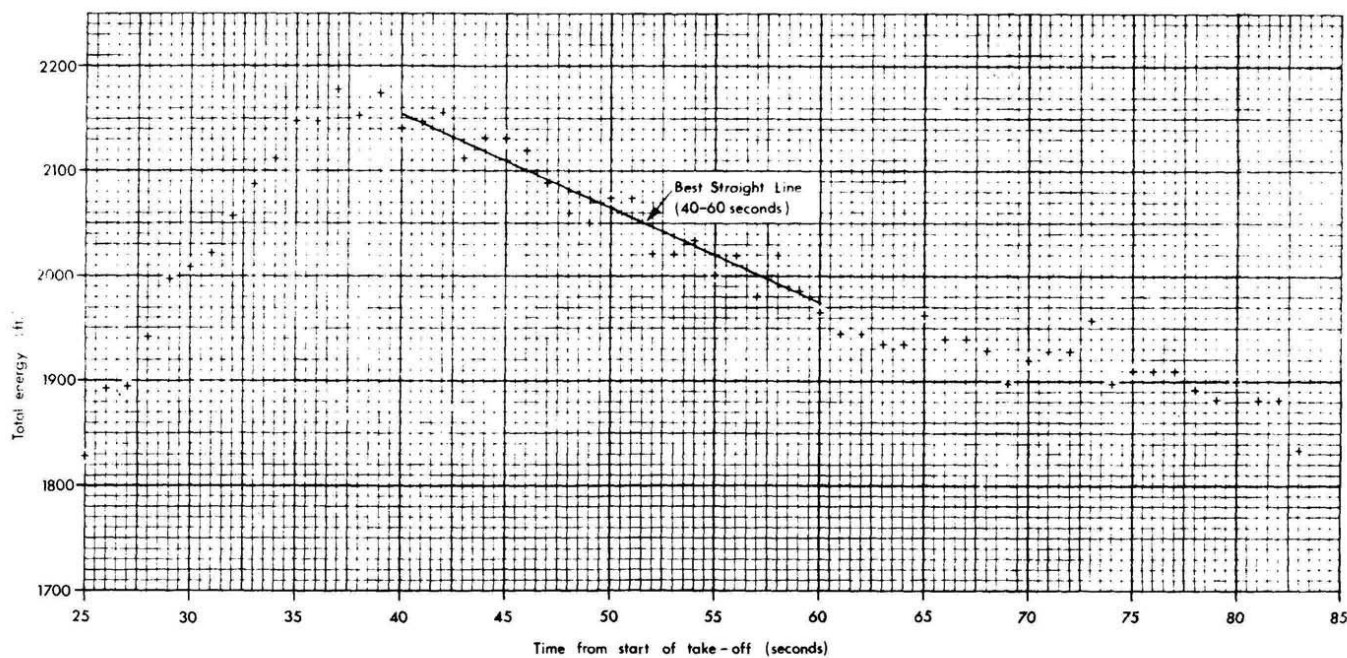
The data for the first 60 seconds were consistent with an acceleration up to rotation speed with both engines at maximum thrust and a normal take-off, followed immediately by a rapid reduction of about 30 per cent in the total thrust. Then, at about 37 seconds from release of brakes, there was another reduction in thrust, compatible with the throttling back of No. 1 engine, and the undercarriage was retracted, after which the aircraft lost height and/or speed so that the total energy decreased during the remainder of that period of time.

Figure 1-2.- Variation of Total Energy with Time, from Unstick to the End of Flight

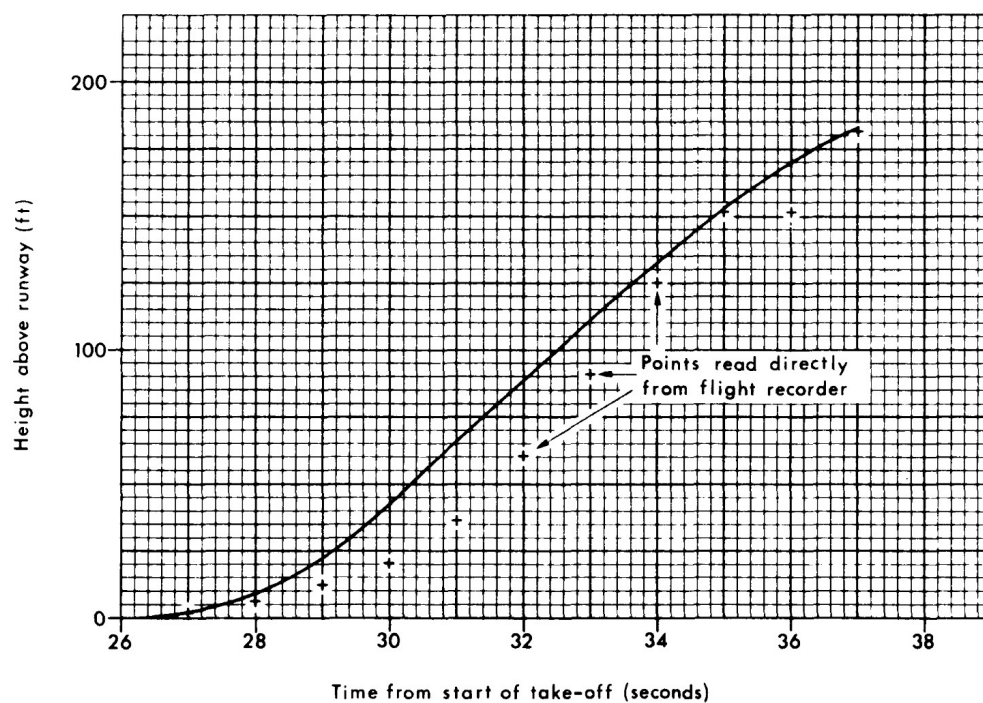
Figure 1-3.- Comparison of Height Trace Obtained by Integrating the Acceleration Information with that Obtained directly from the Recorder
