National Transportation Safety Board

Aviation Accident Final Report

Location:	Amarillo, TX	Accident Number:	CEN17FA168
Date & Time:	04/28/2017, 2348 CDT	Registration:	N933DC
Aircraft:	PILATUS AIRCRAFT LTD PC 12	Aircraft Damage:	Destroyed
Defining Event:	Loss of control in flight	Injuries:	3 Fatal
Flight Conducted Under:	Part 135: Air Taxi & Commuter - Non-scheduled - Air Medical (Medical Emergency)

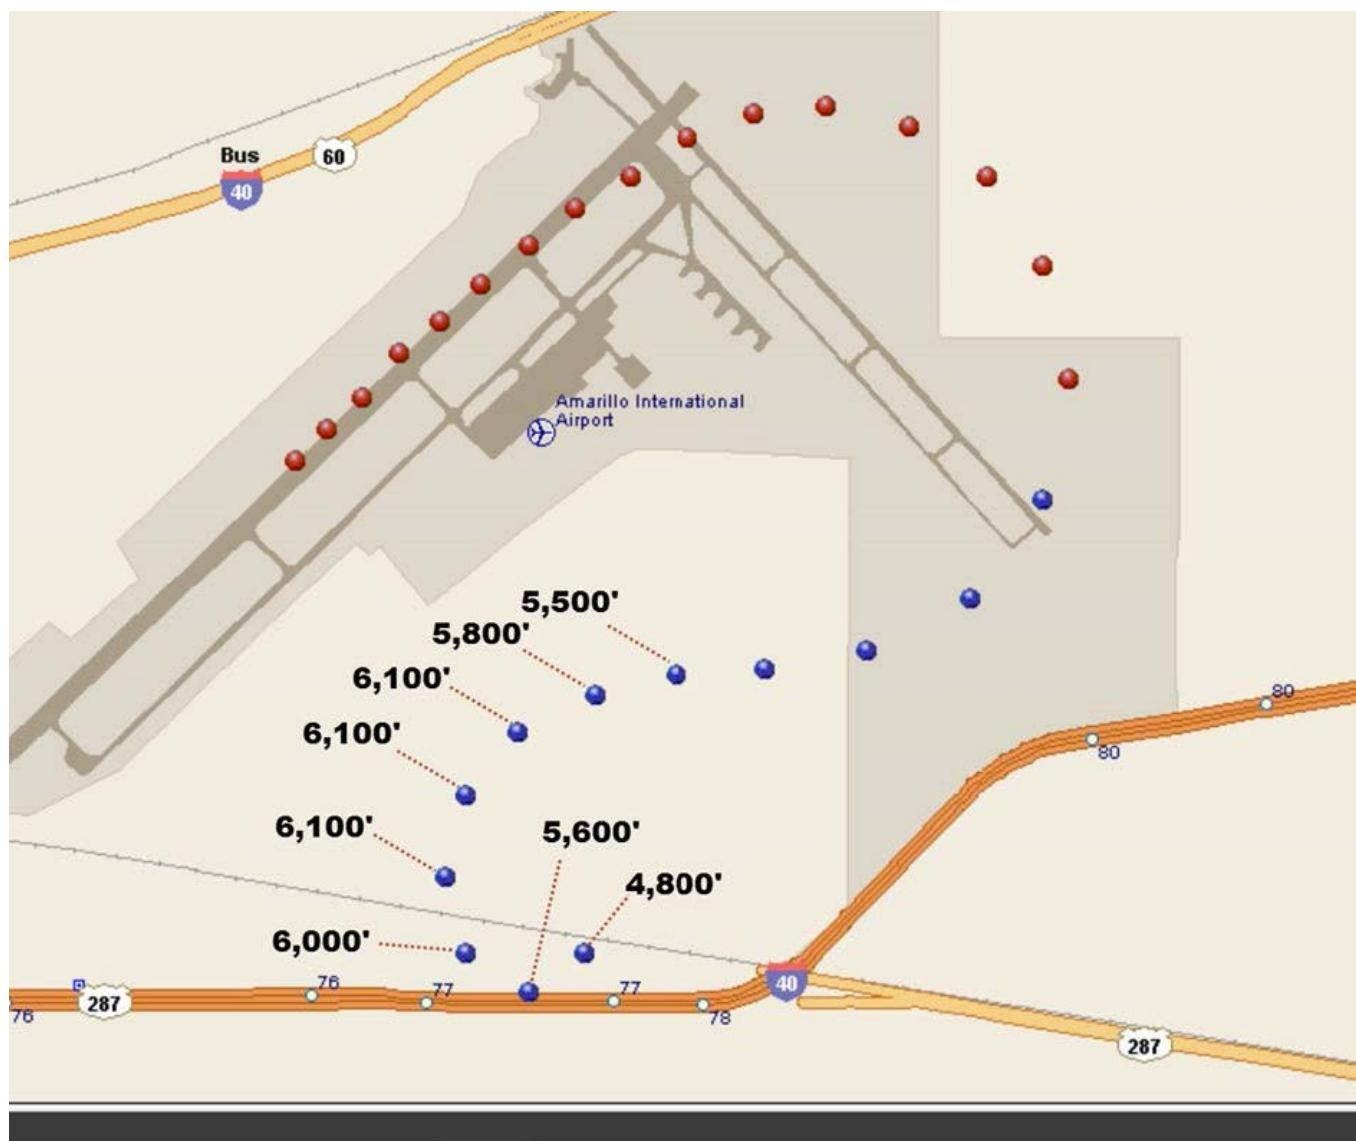
Figure 1 – Plotted radar data illustrating the accident flight path

After departing runway 4, the local controller observed a primary target with an associated transponder code of 4254, which was the code that had been assigned to the airplane on its previous flight. The local controller observed the 4254 target climb through 4,400 ft msl and instructed the pilot to reset the transponder to 4261. The pilot reset the transponder code to 4261. The local controller observed the beacon code change from 4254 to 4261, then advised the pilot "I've got you now," and instructed him to contact AMA departure control.

Figure 1 shows the plotted AMA radar data illustrating the accident flight path. The red targets are from transponder code 4254, and the blue targets are from transponder code 4261. The last eight recorded targets are labeled with their mode C reported altitudes.

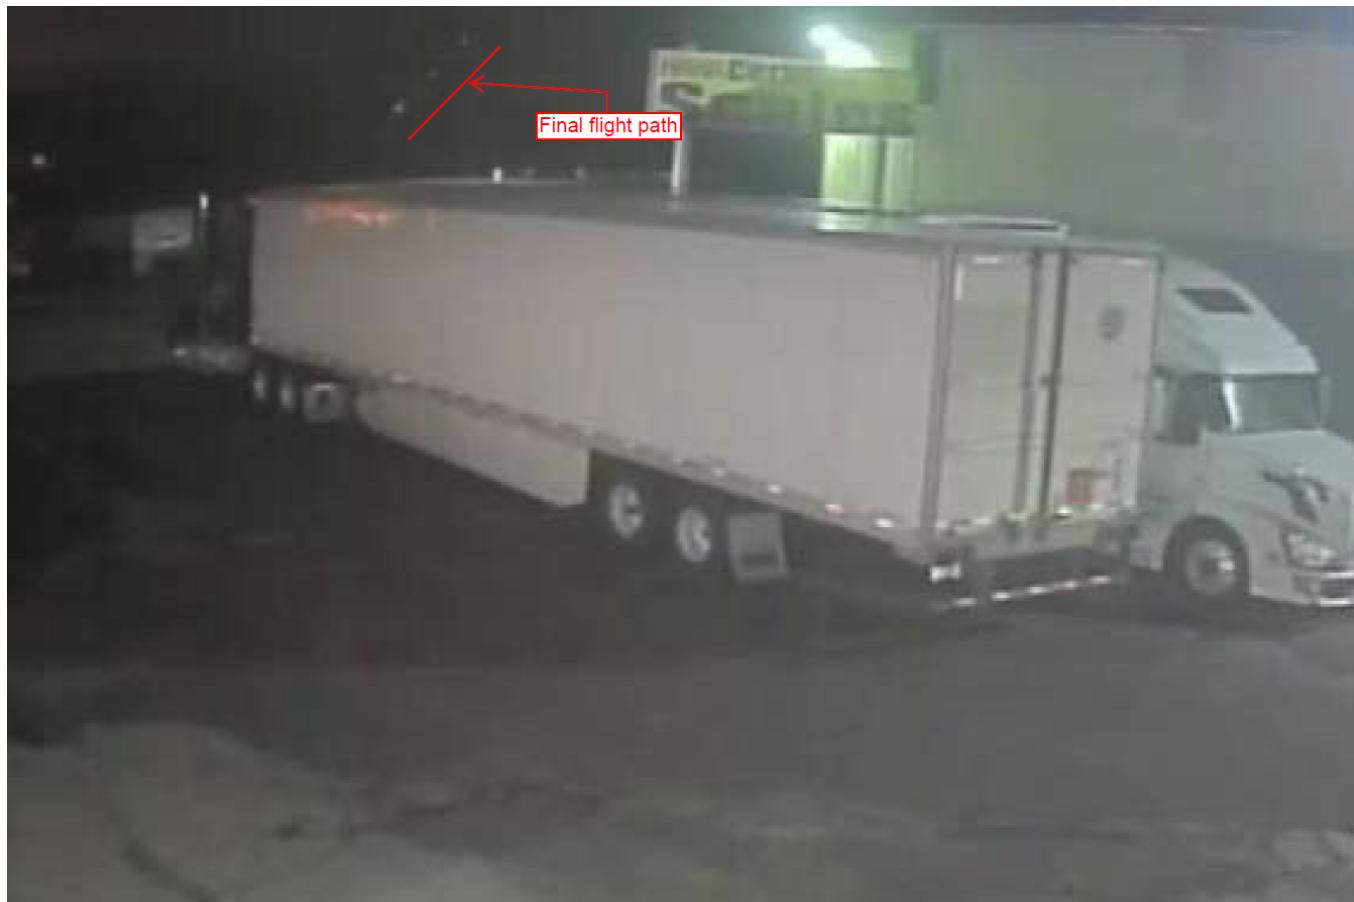
Figure 2 – Accident airplane's final flight path

site, recorded lights from the airplane followed by an explosion. Still images were taken from the video and layered to produce figure 2, which depicts the airplane's final flight path. The images show the airplane descending about a 45°angle to ground impact.

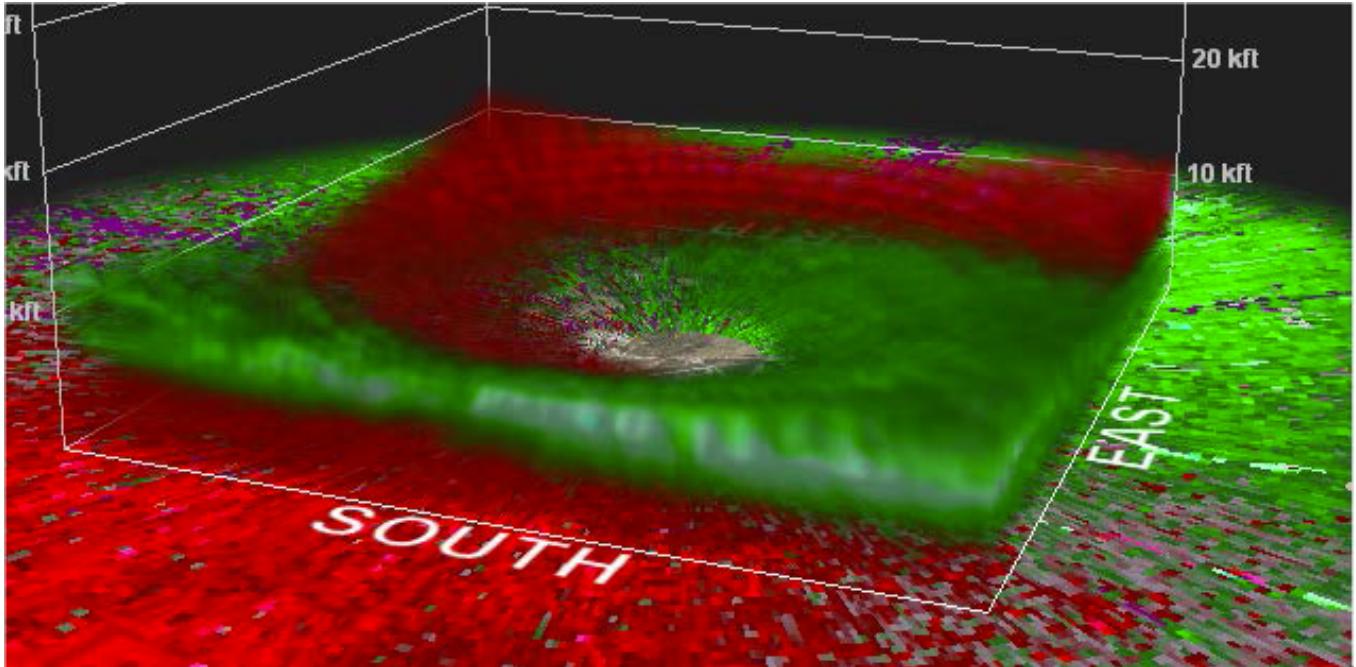
Figure 3 – Wind profile, 3D view

The warning coordination meteorologist for the National Weather Service (NWS) Weather Forecast Office (WFO) in Amarillo, Texas, provided a 3D image (figure 3, which shows AMA at the center of the 3D box) that showed a wind shear zone between 2,500 and 3,500 ft msl as seen from the AMA weather radar about 2355. The red area indicates wind away from the radar, and the green area indicates wind toward the radar. The image shows a northerly wind near the surface and a 40 to 60 knot southerly wind above 4,000 ft msl.

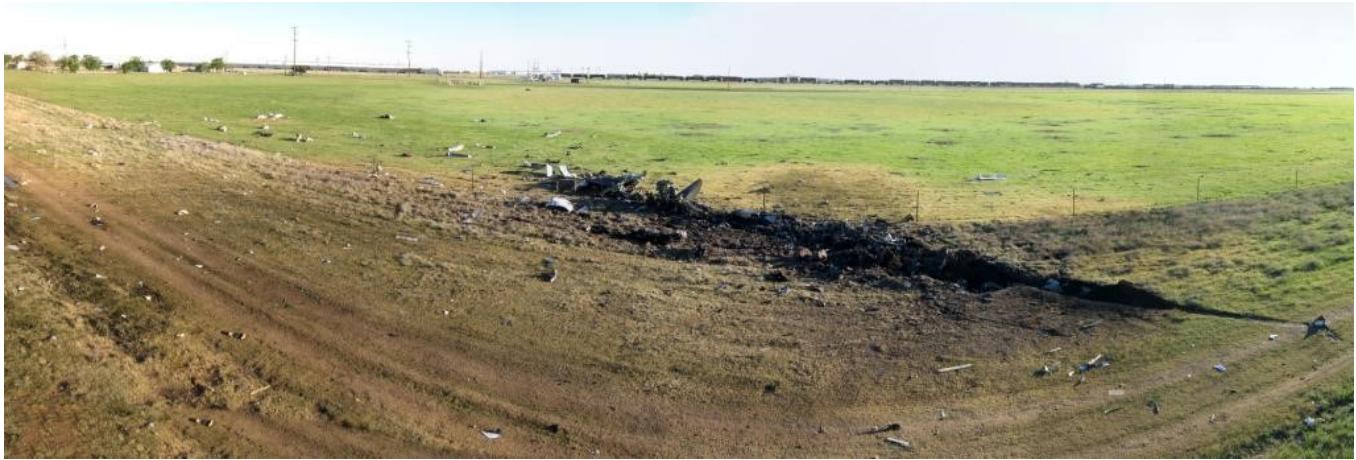
Figure 4 – Accident site viewed from the south

The airplane impacted a pasture (figure 4) adjacent to several stationary train cars about 1.5 nautical miles south of AMA, and a postimpact fire ensued. The wreckage debris path was generally oriented along a northeast-southwest line, and the airplane impacted the ground facing southwest. All major structural components of the airplane were located within the debris field.

Ground scars at the accident site and damage to the airplane were consistent with the airplane impacting in a steep, nose-low and wings-level attitude. The top soil was dark and relatively soft extending 3 to 4 ft deep, and the subsoil was a relatively hard clay. The impact crater was about 5 ft deep. A section of the left winglet, the left pitot tube, and the angle of attack sensor from the left wing were found embedded in the ground; the winglet is noticeable on the far right side of figure 4. The vertical stabilizer remained attached to the fuselage and sustained relatively minor damage compared to the rest of the airplane structure. The horizontal stabilizer separated near mid-span, and both sides were identified. The left side was severely crushed from the leading edge aft; a corresponding impact mark was observed in the ground near the center and in front of the impact crater.

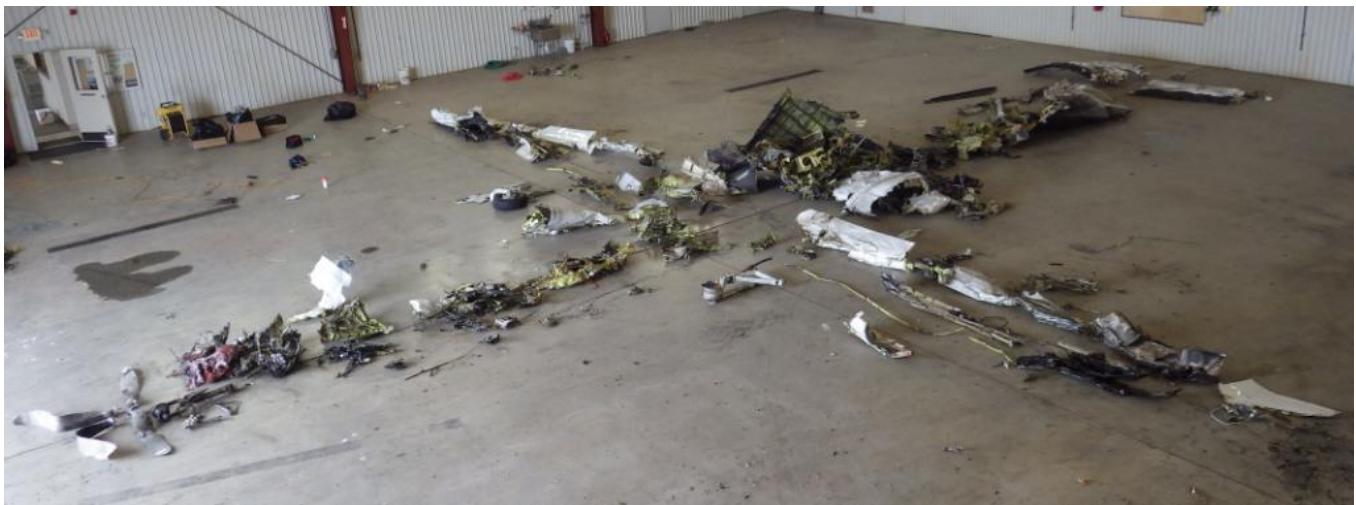
Figure 5 – Wreckage organized in hangar

The wreckage was documented at the accident site and then relocated to a secure hangar at AMA for a full layout and detailed examination. The airplane was heavily fragmented (figure 5).

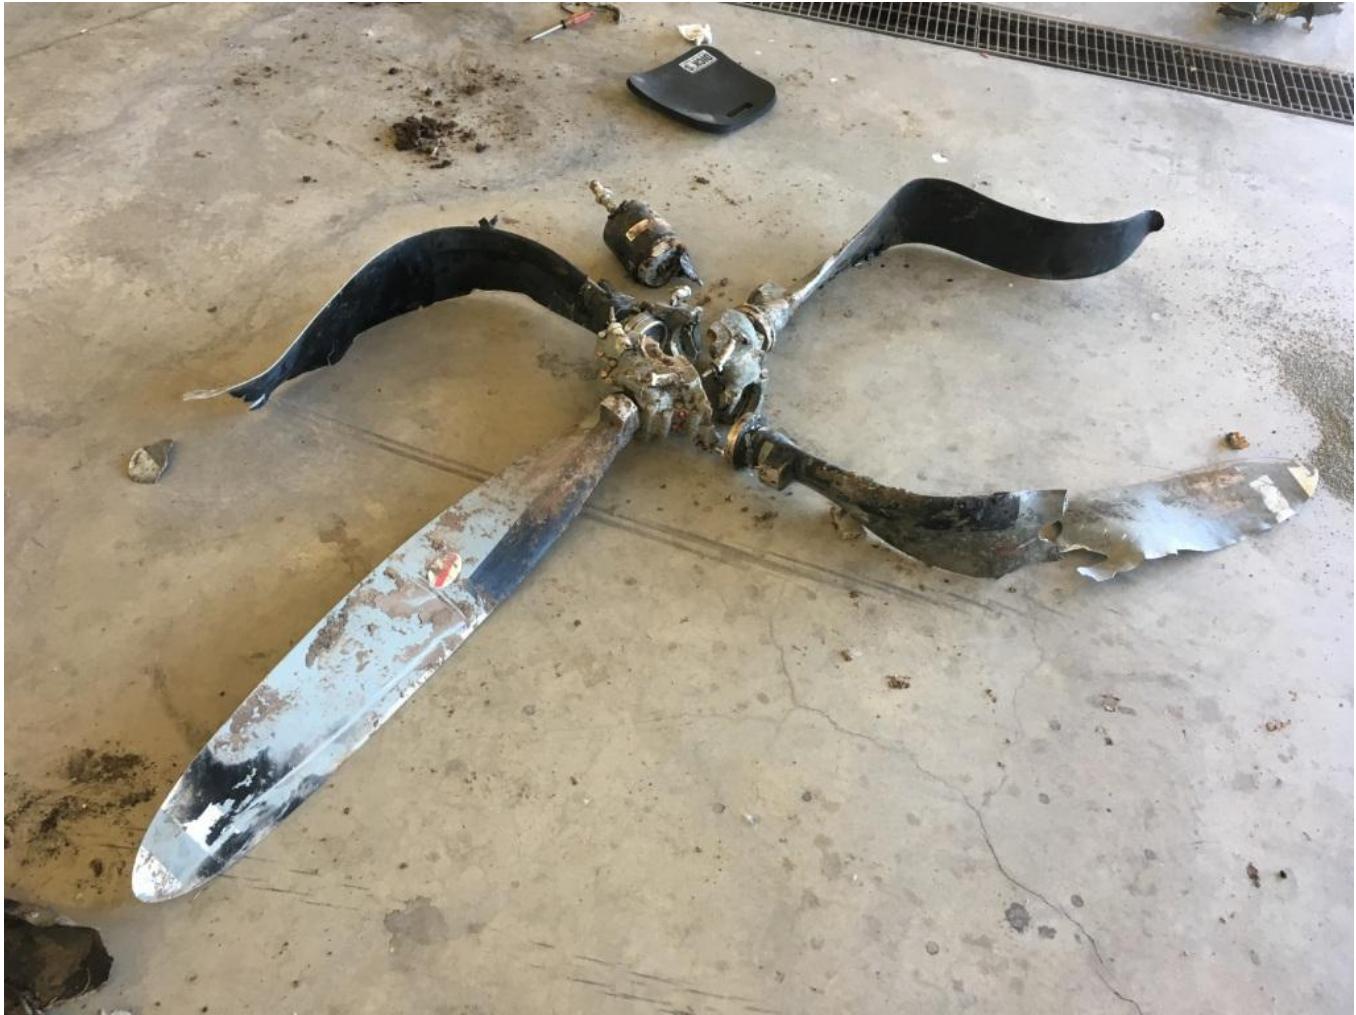
Figure 6 – Propeller

The propeller blades (figure 6) exhibited damage consistent with engine operation during impact.

There were no preimpact anomalies found that would have prevented or degraded normal propeller operation.

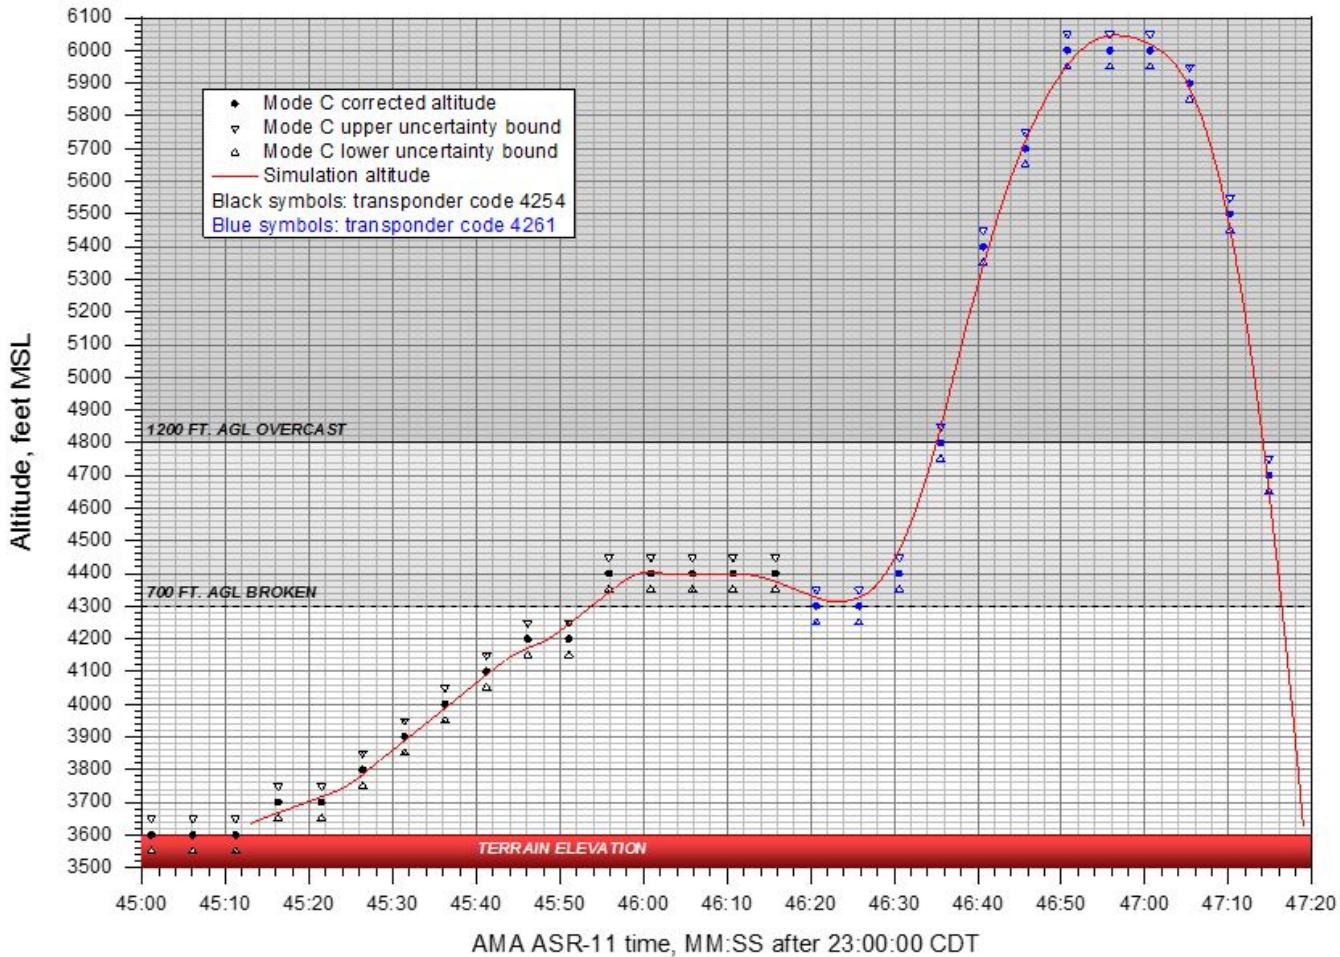
Figure 7 – Simulation of accident flight, altitude vs time graph

The simulation indicated that, after lifting off from AMA runway 4, the airplane accelerated to about 193 knots calibrated airspeed (KCAS) while climbing between 600 and 1,200 ft per minute (fpm) to an altitude of about 4,400 ft msl, or about 800 ft agl (figure 7). The airplane leveled about 4,300 to 4,400 ft msl for about 30 seconds; at 23:46:30, it resumed climbing, reaching 6,000 ft msl (2,400 ft agl) at 23:46:52. During this climb, the airplane decelerated

from 193 KCAS to 122 KCAS. At 23:47:02, the airplane started an increasingly rapid descent from 6,000 ft msl to the ground (elevation 3,600 ft msl). Based on the simulation, the estimated rate of descent and airspeed at impact were about 17,000 fpm and 220 KCAS, respectively. The estimated time of impact was 23:47:19.

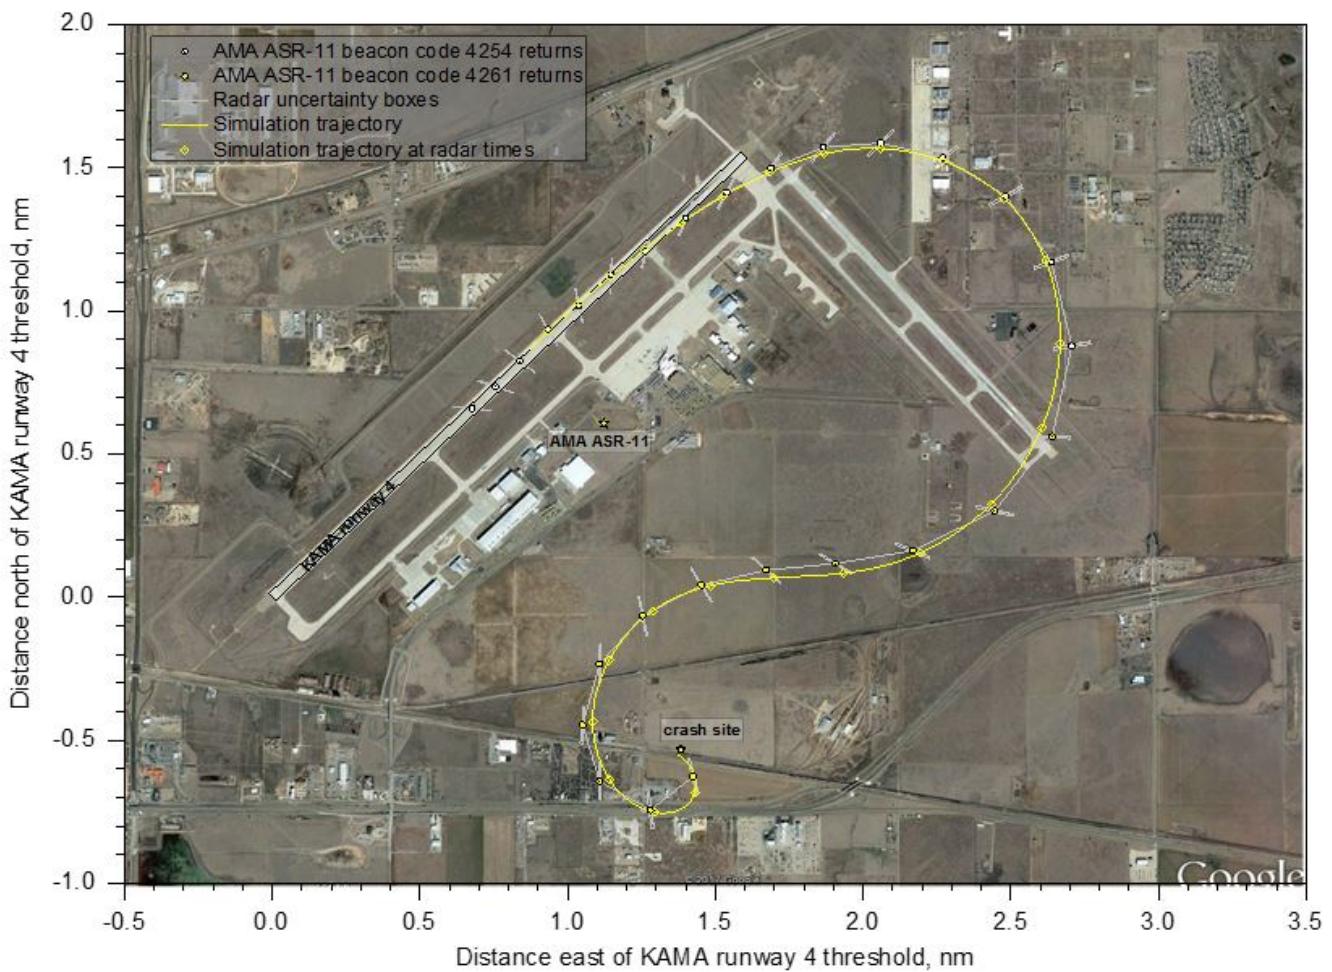
Figure 8 – Google Earth view of radar data and simulation trajectory

At 23:45:42, while climbing through 4,100 ft msl (500 ft agl), the airplane started a slow right roll (figure 8), reaching a roll angle of about 42° at 23:46:10. At 23:46:24, the roll angle had decreased to 36° , and the pitch angle started to increase steadily, which was consistent with the climb to 6,000 ft msl. At 23:46:32, when the roll angle was 30° , the airplane started rolling more quickly to the left, rolling through wings level at 23:46:40, then on a ground track of 267° true.

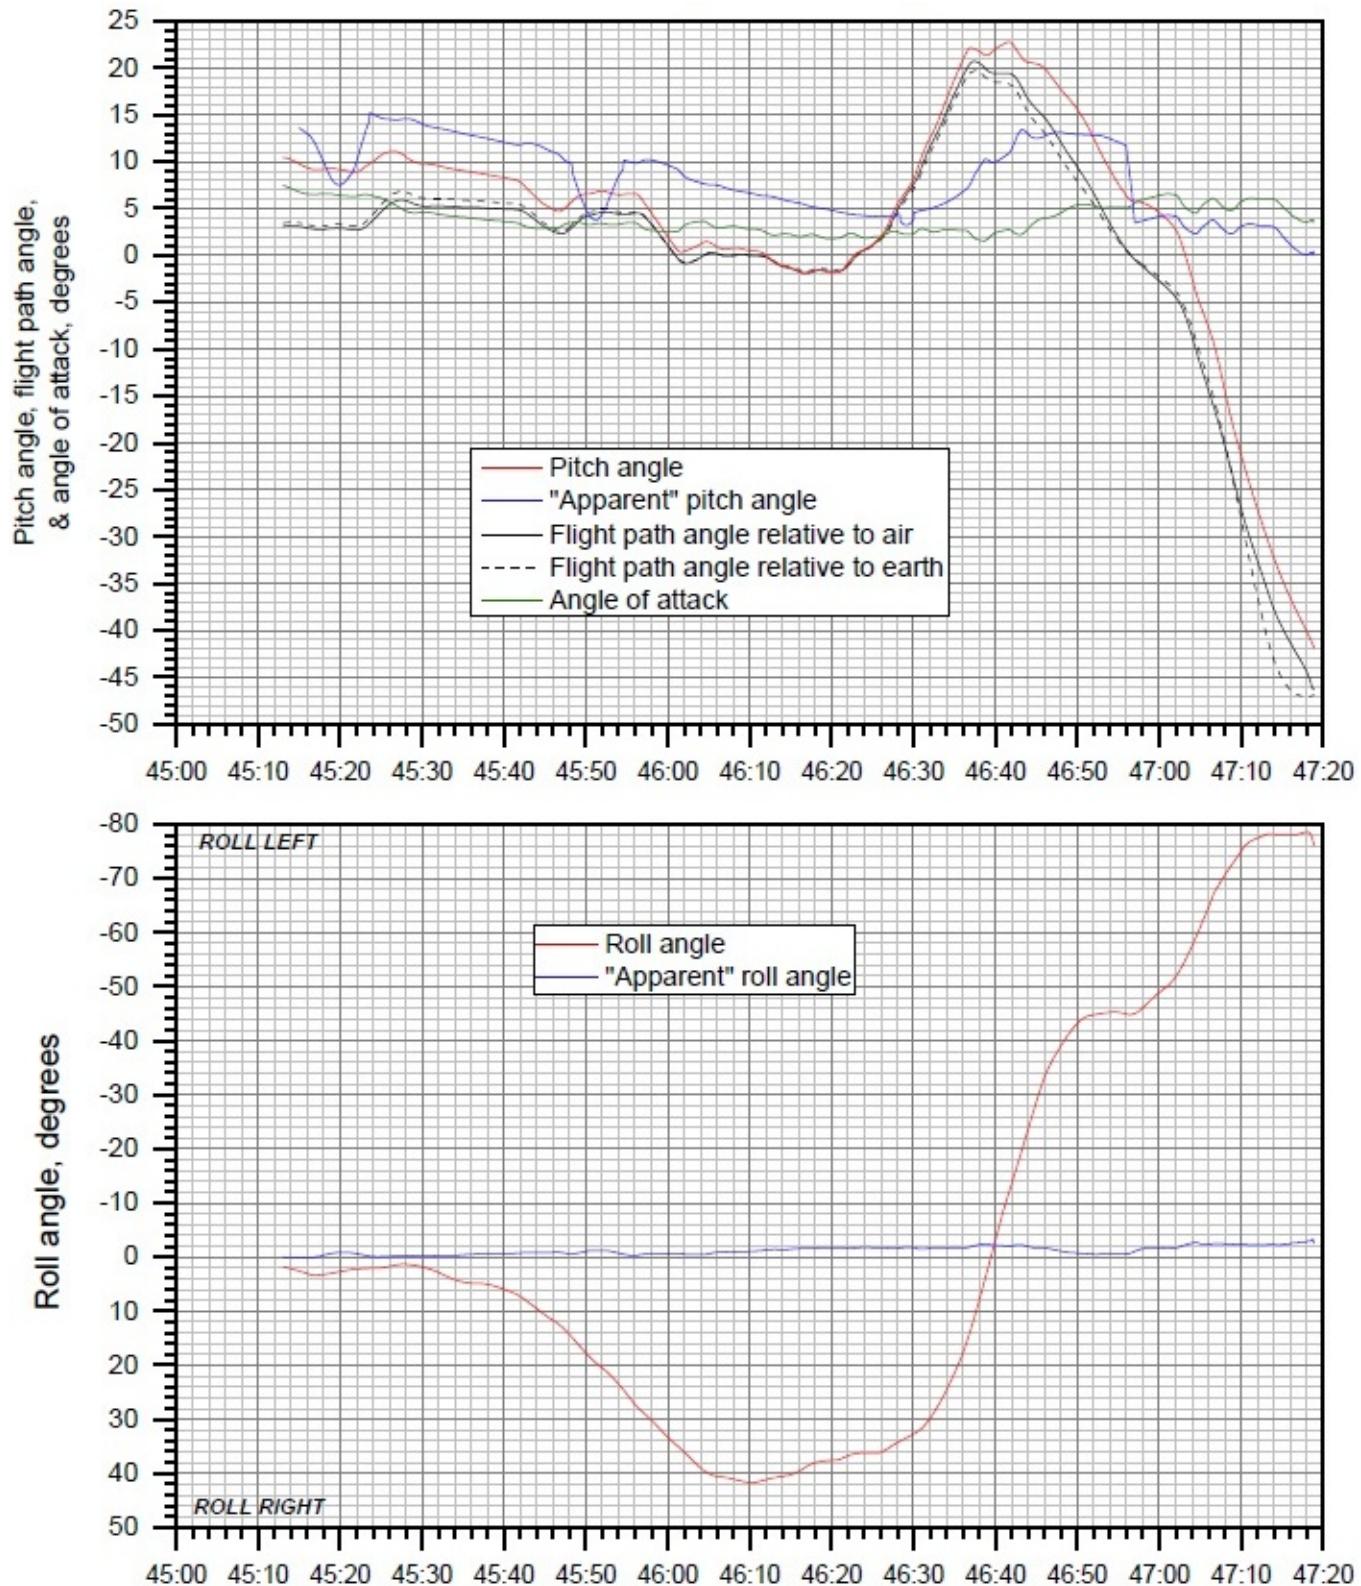
AMA ASR-11 time, MM:SS after 23:00:00 CDT
 Figure 9 – Simulation apparent pitch and roll angles

An estimate of the "apparent" pitch and roll angles, which represent the attitude a pilot would "feel" the airplane to be in based on his vestibular/kinesthetic perception of the components of the load factor vector in his own body coordinate system, was made based on the simulation load factors. The "apparent" pitch angle ranged between 0° and 15° , and the "apparent" roll angle ranged between 0° and -4° (figure 9).
