1. Report No. NTSB-AAR-78-7		2. Government Accession No.		3. Recipient's Catalog No.	
4. Title and Subtitle Japan Air Lines Co., Ltd. McDonnell-Douglas DC-8-62F, JA 8054, Anchorage, Alaska, January 13, 1977		5. Report Date January 16, 1979		6. Performing Organization Code

AIRCRAFT ACCIDENT REPORT

JAPAN AIR LINES CO., LTD.  
MCDONNELL-DOUGLAS DC-8-62F, JA 8054  
ANCHORAGE, ALASKA  
JANUARY 13, 1977

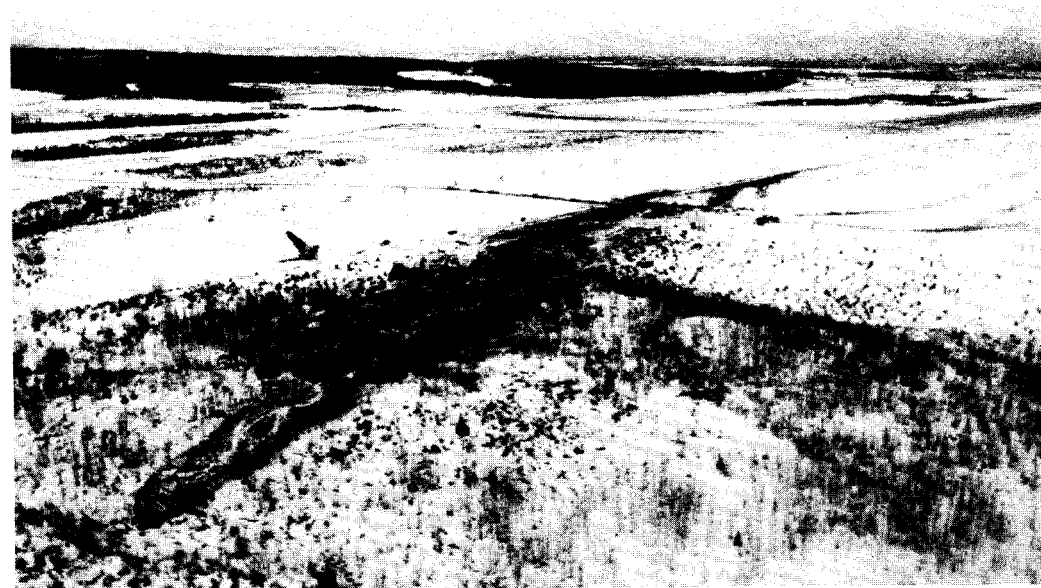
VIEW OF WRECKAGE SITE

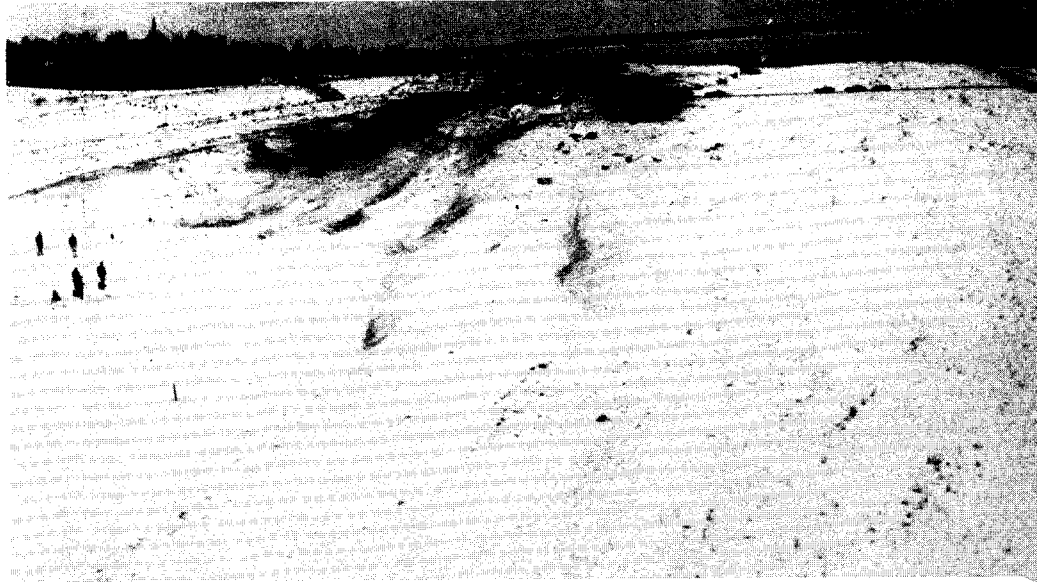
VIEW OF INITIAL IMPACT
