AIRCRAFT ACCIDENT REPORT

**PACIFIC SOUTHWEST AIRLINES, INC.,
B-727, N533PS AND**

**GIBBS FLITE CENTER, INC.,
CESSNA 172, N7711G**

**SAN DIEGO, CALIFORNIA
SEPTEMBER 25, 1978**

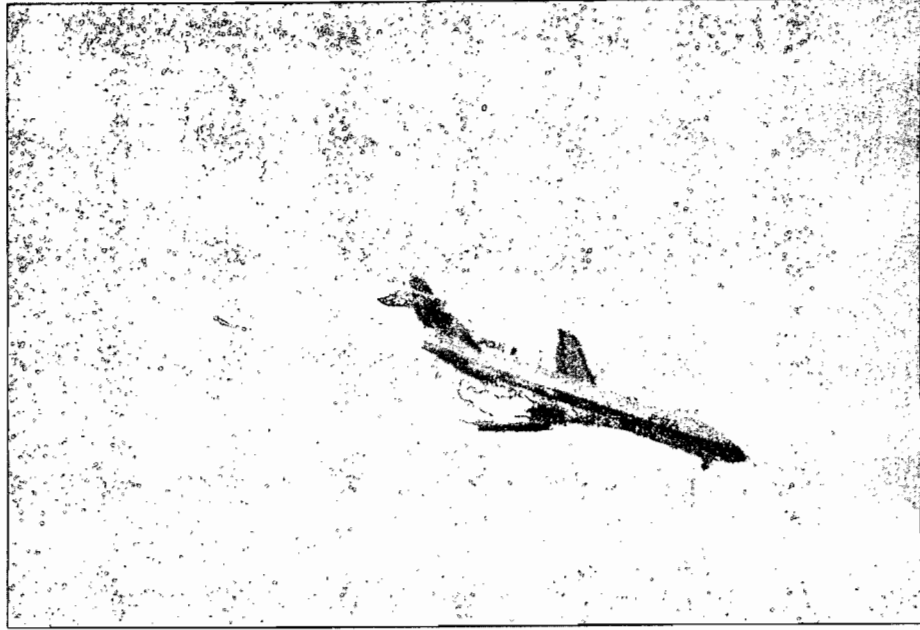
Enlargements of two postcollision photographs were used to try to determine the Boeing 727's flight control displacements and the condition of its fuel and hydraulic systems during the latter portions of the flight. (See Figures 1 and 2.)

Except for the upper and lower rudders, which were centered in the first photograph and positioned 10° left in the second, the deflections of the other control surfaces in both pictures were the same. The left wing flight spoilers were full up; the left wing ailerons were full up; the right wing outboard aileron was down; the elevators were almost full up; the trailing edge flaps were extended to 15°; and the leading edge devices were extended fully.

Figure 1. Flight 182 after colliding with the Cessna.

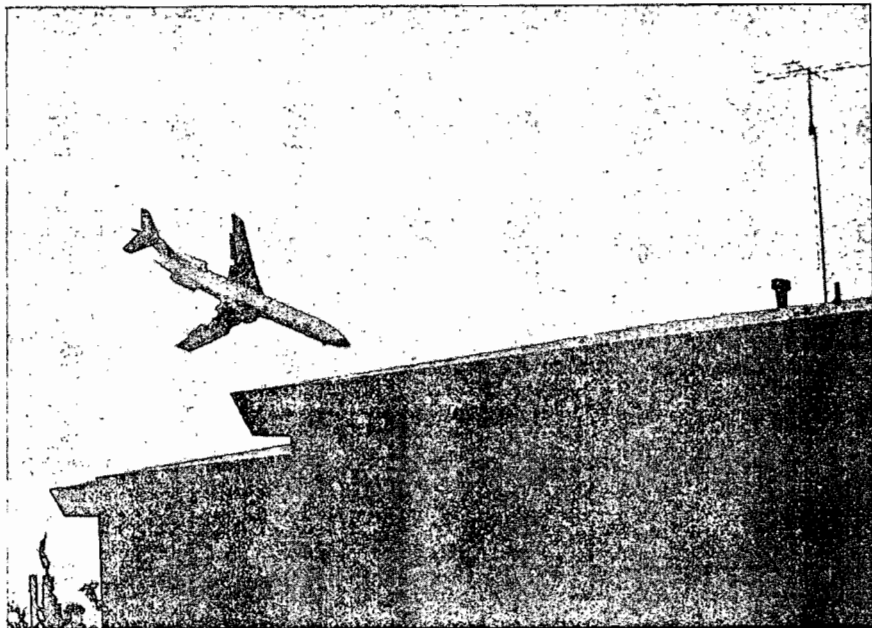
The right wing, as shown in Figure 2, was studied. The examination revealed that the Nos. 5 and 6 leading edge flaps were missing, a portion of the No. 5 leading edge slat was missing, and a large portion of the wing's leading edge back to about the front spar was peeled off the aircraft.

Hydraulic tubing from both the System A and the standby hydraulic systems was routed to the leading edge devices forward of the front spar. It was not possible to determine from the photographs if the tubes were broken or flattened. The B hydraulic system's tubing was located just aft of the rear spar of the wing. Because the extent of damage that could have existed in that area could not be determined, the status of the tubing could not be determined.

Figure 2. Flight 182 descending. (Photo taken after Figure 1)

The study of the two photographs showed that the structural damage to the Boeing 727's right wing leading edge extended from the No. 4 inboard leading edge flap outboard to, and including, the No. 3 leading edge slat--a distance of 30 feet or more. The chordwise penetration of this damage appeared to extend rearward to the front spar of the wing. The calculated positions of the flight controls in Figure 2 show almost full deflection in the proper direction to arrest the abnormal attitude and to restore controlled flight. The deflected position of the flight controls and the left wing flight spoiler surfaces indicated that at least partial hydraulic pressure was available from system A and system B.

The Safety Board was not able to assess precisely what effect the structural damage, the impingement of Cessna parts on the structure, and the existing fire had upon Flight 182 aerodynamic capabilities and control effectiveness. Considering the extent and magnitude of the collision damage, the Safety Board concludes that the aircraft was probably uncontrollable.

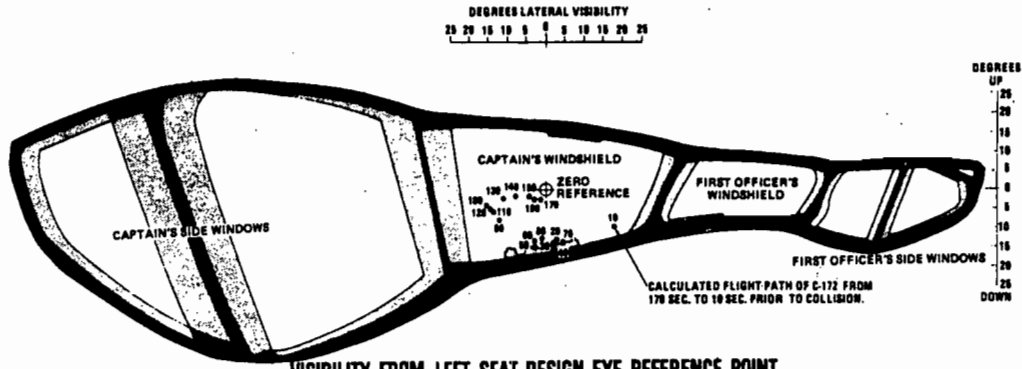
VISIBILITY FROM LEFT SEAT DESIGN EYE REFERENCE POINT

3. The Cessna pilot failed to maintain the assigned heading contained in his ATC instruction.
4. The cockpit visibility study shows that if the eyes of the Boeing 727 pilot were located at the aircraft's design eye reference point, the Cessna's target would have been visible.
