**Havarikommisjonen**

# **PRELIMINARY REPORT**

**Cessna 560 XLS+**

**D-CAWM**

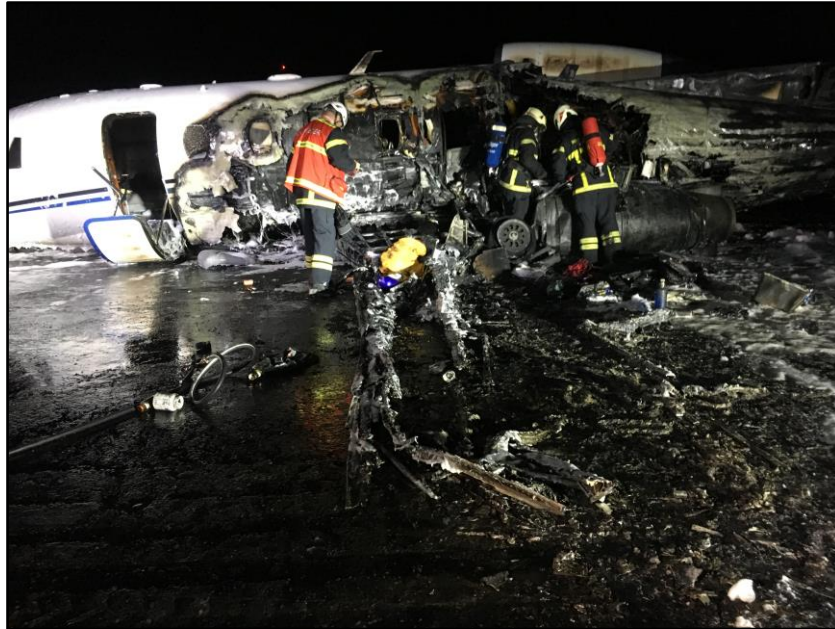
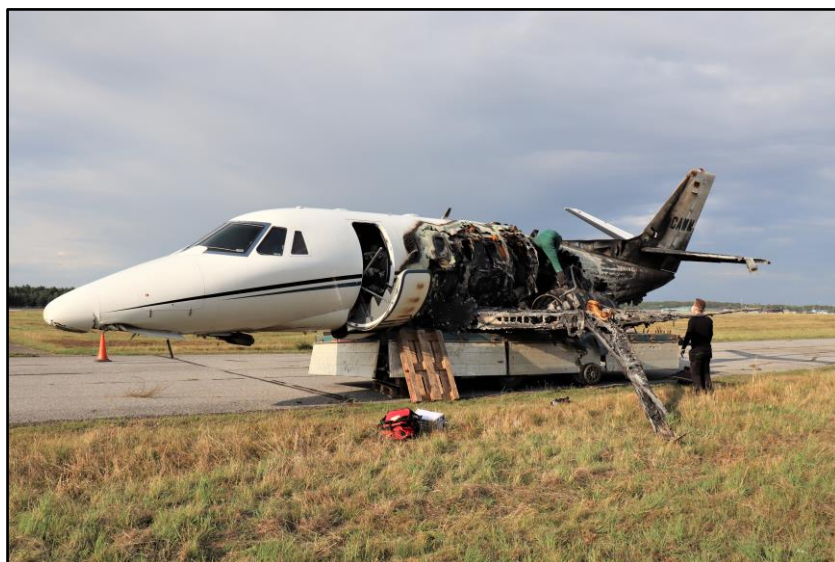
## Damage to aircraft

The aircraft was destroyed.

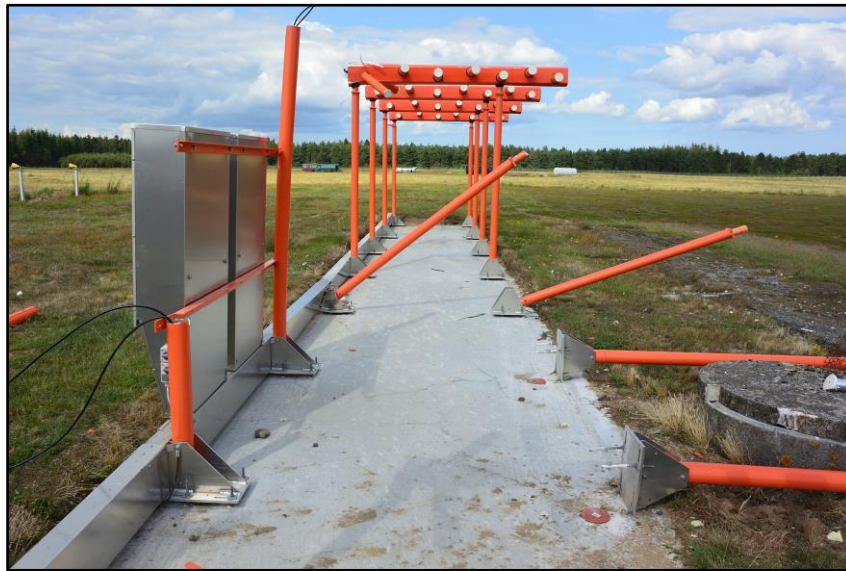
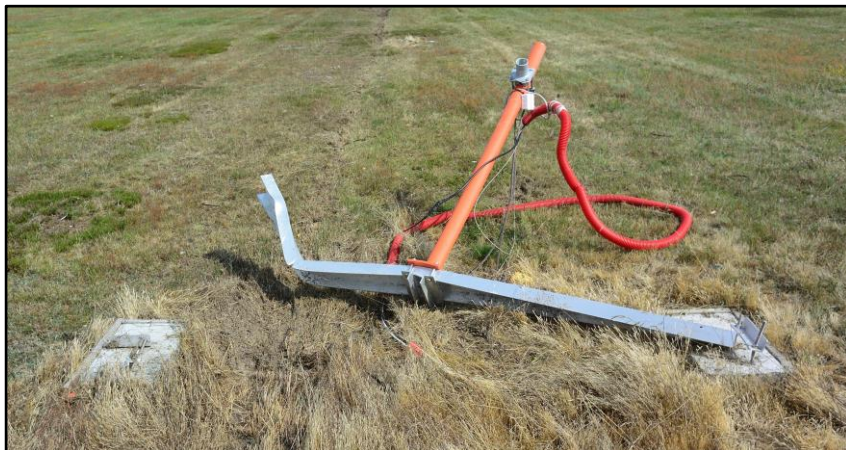
## Other damage

There were damages to:

- the antenna mast system of the localizer for runway 28L located in front of runway 10R
- a near field antenna (localizer for runway 28L) located on the extended centreline between the localizer antenna mast system and runway 10R
- the runway surface on runway 10R.

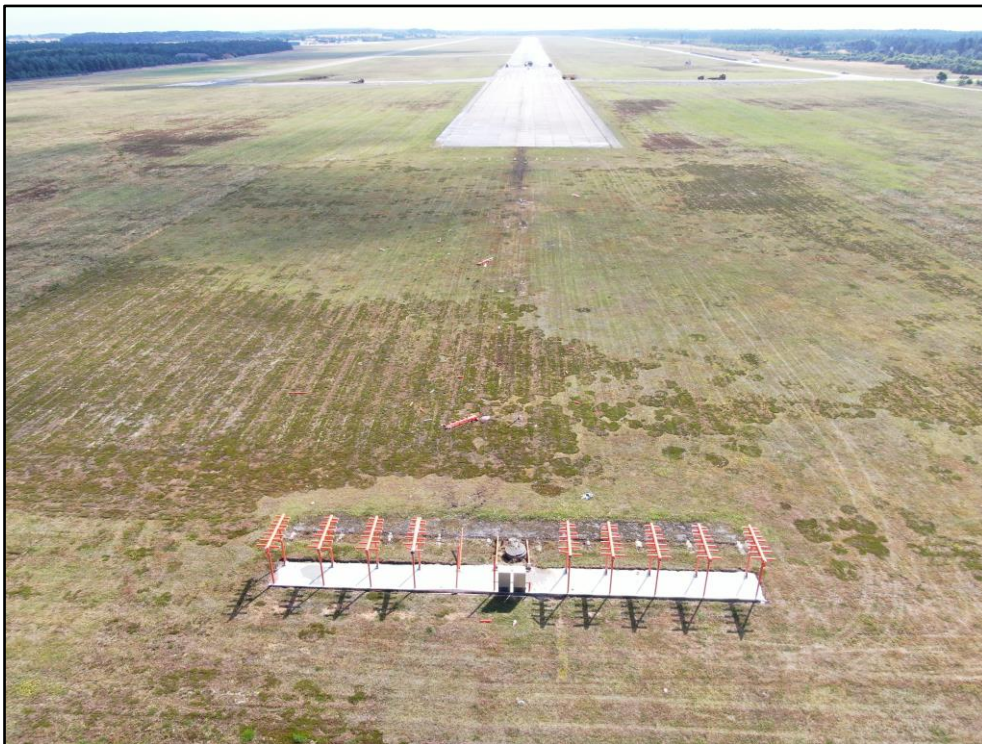
Approximately 450 m before the beginning of runway 10R (measured from the green threshold lights), the aircraft collided with the antenna mast system of the localizer for runway 28L.

At collision with the antenna mast system, the left wing fuel tank ruptured resulting in a fuel leakage.

Approximately 390 m before the beginning of runway 10R (measured from the green threshold lights), the aircraft touched down in the RESA for runway 28L (grass area).

After a landing roll of approximately 60 meters, the nose landing gear collided with the near field antenna of the localizer for runway 28L and collapsed.

While rolling on the main wheels and skidding on the nose section, the aircraft entered the stopway for runway 28L

The aircraft came to a full stop approximately 230 m after the beginning of runway 10R (measured from the green threshold lights).
