ACCIDENT

Aircraft Type and Registration:	Piper PA-31, N250AC	
No & Type of Engines:	2 Lycoming TIO-540-A2C piston engines	
Year of Manufacture:	1976 (Serial no: 31-7612040)	
Date & Time (UTC):	6 September 2017 at 1723 hrs	
Location:	Caernarfon Airport, Gwynedd	
Type of Flight:	Private	
Persons on Board:	Crew - 1	Passengers - None
Injuries:	Crew - 1 (Fatal)	Passengers - N/A
Nature of Damage:	Aircraft destroyed	
Commander's Licence:	Commercial Pilot's Licence	
Commander's Age:	62 years	
Commander's Flying Experience¹:	Over 4,000 hours (with experience on type) Last 90 days - unknown Last 28 days - unknown	
Information Source:	AAIB Field Investigation

Synopsis

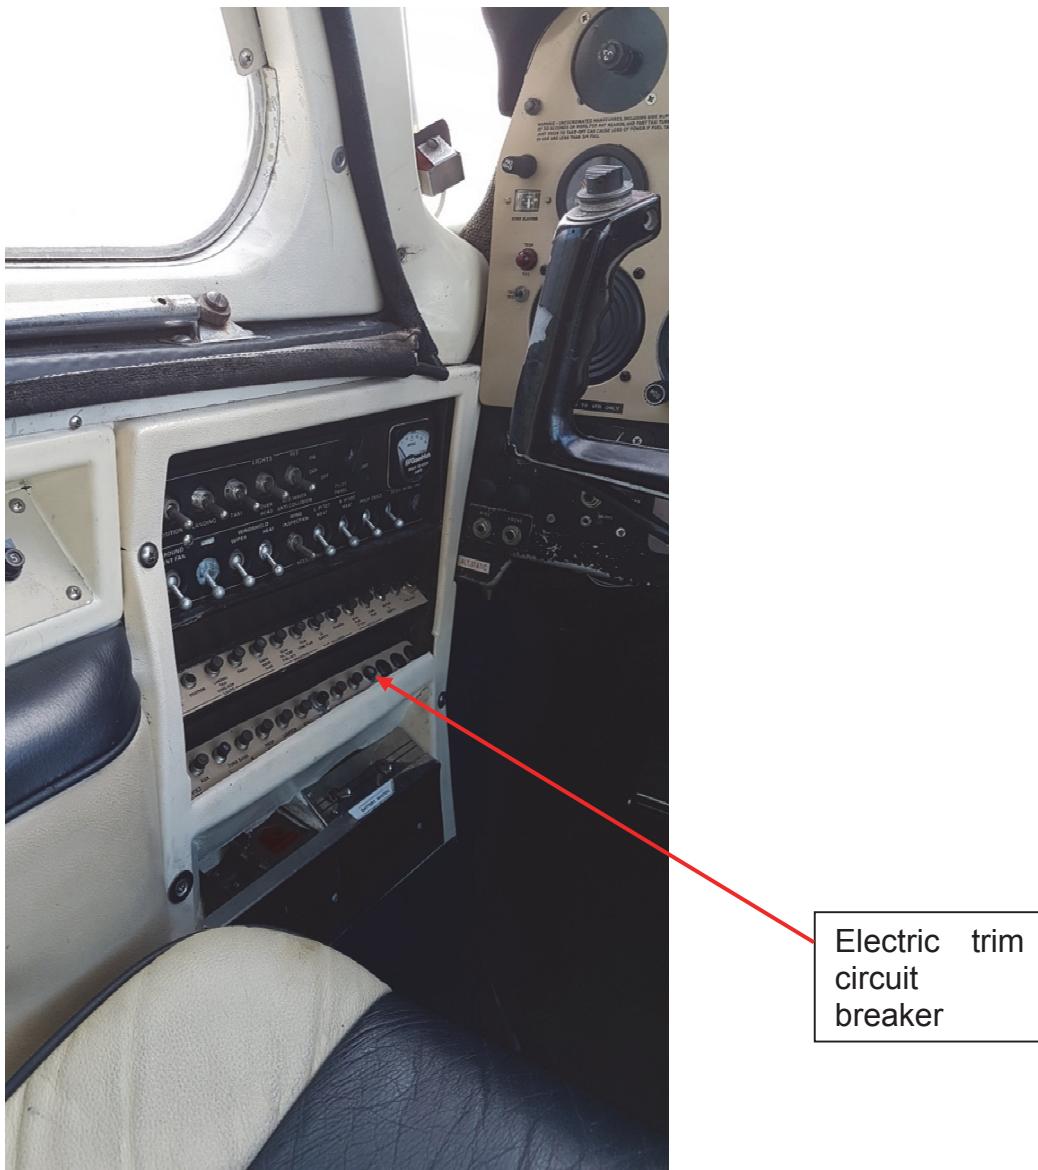
Figure 4
Circuit breaker panel in a representative PA-31

Similar to that described in the N996JR accident report, the procedure for responding to a malfunction of the electric trim system was to pull the electric trim circuit breaker. In N250AC this was located in the lower portion of the circuit breaker panel, which was beside the pilot's left knee. Fire damage to the panel meant that it could not be determined whether any circuit breakers had been opened. The flight trial and other previous events have indicated that the forces associated with a trim runaway can be such that a single-pilot, in particular, could have difficulty flying the aircraft whilst attempting to locate and pull a circuit breaker.

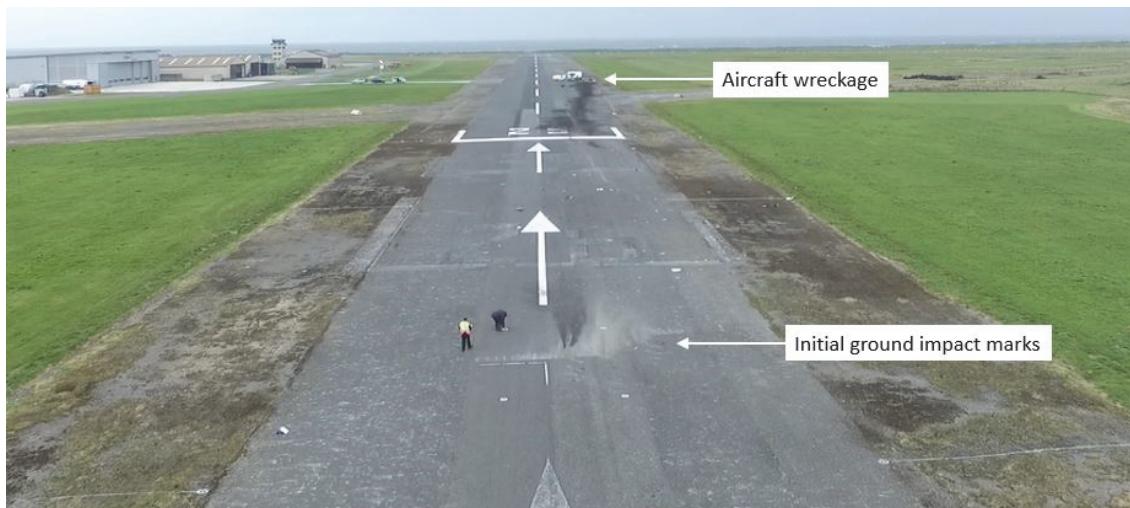
The aircraft had struck the paved surface of Runway 25, 3 m to the right of the runway centreline and 101 m before the displaced threshold (Figure 5). The main wreckage of the aircraft, consisting of the fuselage, empennage, right wing and engine and most of the left wing apart from the left engine had come to rest on the runway surface 293 m beyond the initial impact point. A severe post-impact fire had consumed the majority of the aircraft with only the nose section ahead of the cockpit remaining free from fire damage. Examination of the wreckage confirmed that the aircraft had been structurally complete at the point of impact. The landing gear was retracted and the flaps were fully up, confirmed by the position of the flap jackscrew actuators.

Assessment of the initial ground impact marks indicated that the aircraft had struck the ground in a nose-down attitude with a slight left bank. The distance between the first and second propeller ground impact marks was 72 cm for both the left and right engines, indicating that both engines were operating at the same speed at impact and the aircraft's groundspeed at impact was approximately 180 kt. The absence of ground marks from the aircraft's flaps and landing gear further confirmed that both were retracted at impact.

Figure 5
Accident site (image courtesy of North Wales Police)

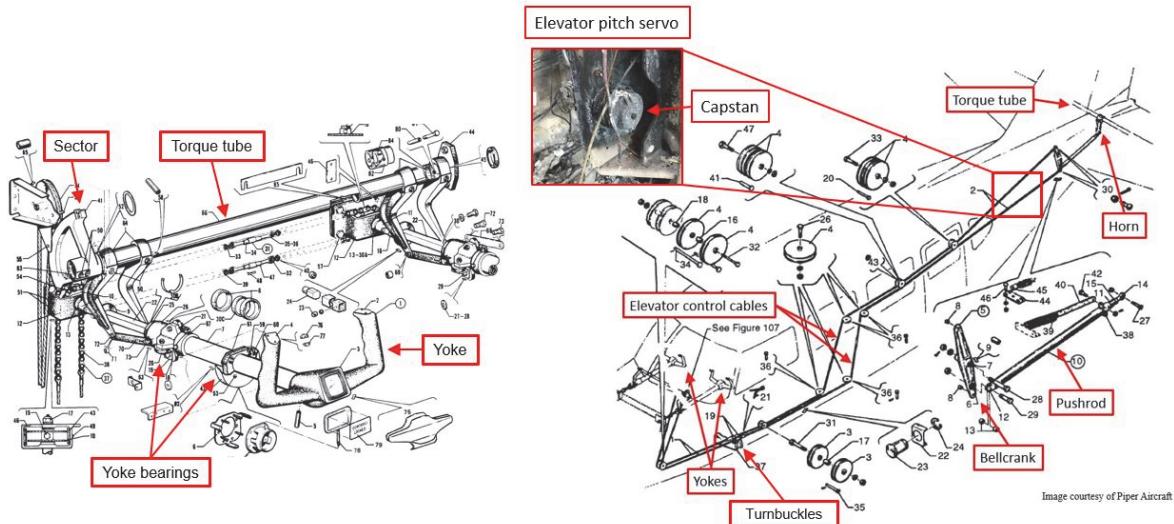
It was not possible to functionally test the left and right control yoke slide assemblies (Figure 6), which translate pilot pitch demand into elevator control cable motion, due to fire damage. Visual examination however confirmed the presence of all the required yoke slide bearings and the correct connection of the yoke slide assemblies to the elevator control torque tube and elevator cable control sector. The elevator control cables were correctly routed and terminated at the elevator control sector.

Figure 6
PA-31 elevator controls

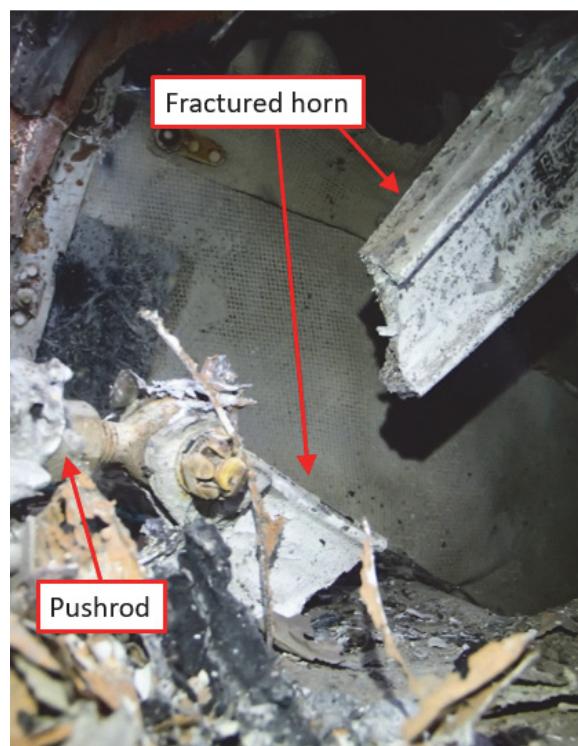
The elevator horn, which connects the pushrod to the elevator torque tube, was found to be fractured on initial examination of the wreckage at the accident site (Figure 7).

Figure 7
Fractured elevator horn as found at accident site

Both parts of the elevator horn had partially melted in the post-accident fire. The lower section of the horn was attached to the pushrod's aft rod-end and the upper section of the horn remained attached to the elevator torque tube. Both parts of the fractured horn were subjected to specialist metallurgical examination.

The fracture damage observed on the broken elevator horn was most probably sustained when the aircraft initially struck the runway as, had the horn fractured during flight, the small area of unburned ductile overload would not have sufficient strength alone to remain intact during the accident sequence.

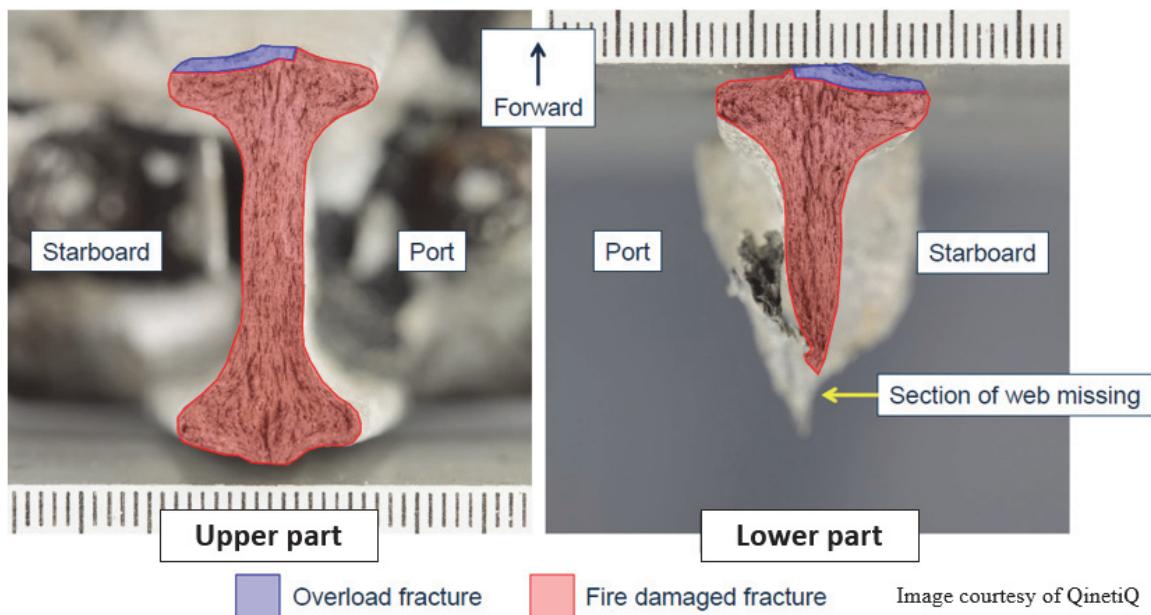
Figure 8
Fractographic assessment of elevator horn fracture surfaces

This examination revealed that most of the horn fracture surface exhibited features consistent with localised melting and fire damage (Figure 8). The fracture surface had a rough macro appearance, with the topography following the underlying grain microstructure of the material. No evidence of progressive crack growth, such as fatigue, was observed and no flat areas of fracture surface were evident that would be consistent with this type of crack growth.

A small area of non-fire damaged ductile overload, equating to 4% of the fracture surface, was visible at the forward section of the horn indicating that this area had separated after the post-accident fire had been extinguished. This may have occurred during disturbance of the wreckage during fire-fighting operations or due to wind blowing on the elevator after the accident.

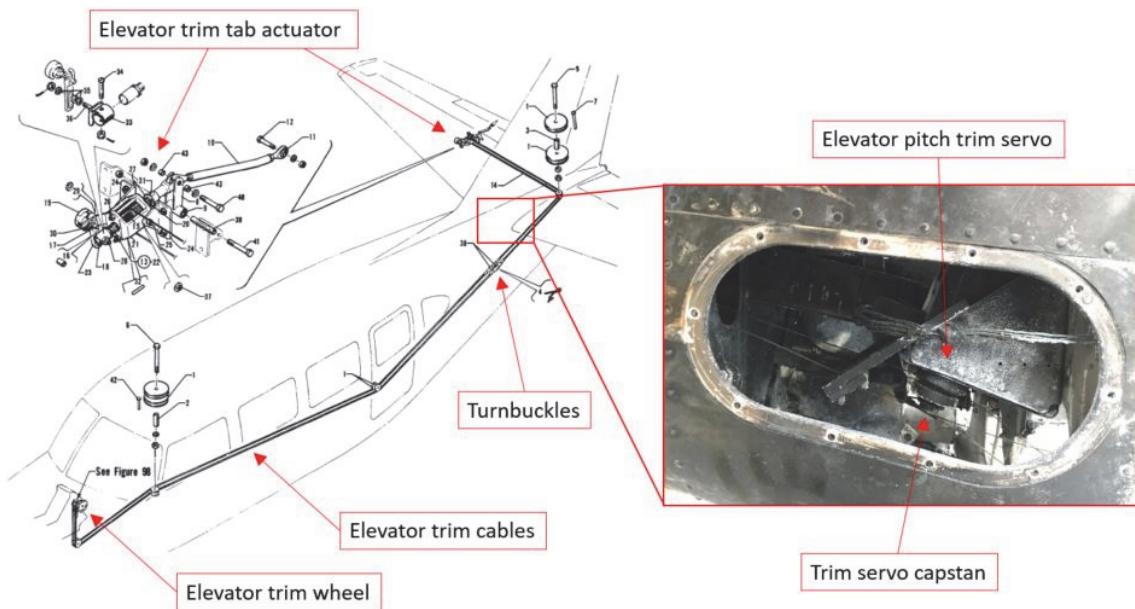
The elevator trim system cables were identified in the aircraft wreckage and found to be continuous from the elevator trim wheel in the cockpit to the elevator trim tab actuator in the right tailplane (Figure 9). Both adjustment turnbuckles within the elevator trim cable system were correctly assembled and wire-locked. The elevator trim cable was correctly wrapped around the pitch trim servo capstan and idler pulley assembly, and the pitch trim servo was securely attached to the airframe within its mounting bracket. Fire damage prevented any electrical wiring or functional checks of the pitch trim servo.

Figure 9
Elevator trim system

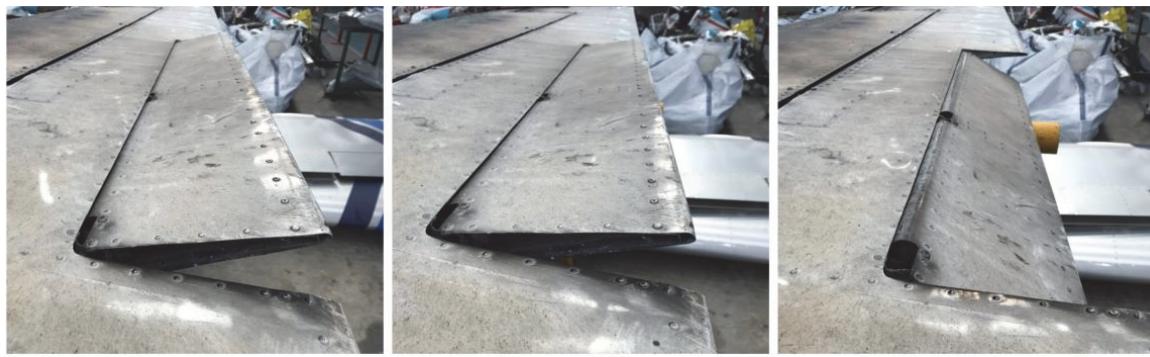
The elevator trim tab was functionally tested and was free to move between the extreme trailing edge up and down positions. The elevator trim tab position as observed at the accident site was 12.4° trailing edge up, with the elevator held in the neutral position²⁰. The range of elevator trim tab deflection is $16^\circ \pm 1^\circ$ trailing edge up (providing nose-down pitch trim), and $29^\circ \pm 1^\circ$ trailing edge down (nose-up pitch trim), with the elevator in a neutral position (Figure 10). The elevator trim tab position as observed at the accident site was therefore close to, but not at, the full nose-down trim position.

Maximum nose down trim,
tab 16° up

Tab position as found, 12.4° up

Elevator trim tab position as found at accident site, and range of movement

The elevator trim tab was found close to, but not at, the full nose-down trim position. This is not a normal position for an approach and landing, and it would have caused the pilot considerable difficulty in controlling the aircraft due to the large control forces. The nose-down forces would have tended to increase as the aircraft slowed down, and with the application of flaps and landing gear.

The elevator trim tab was found in an almost fully nose-down trim position. The flight path of the aircraft was consistent with an aircraft experiencing a significant nose-down trim.
