# National Transportation Safety Board Aviation Accident Final Report

<b>Location:</b>	McKinleyville, CA	<b>Accident Number:</b>	WPR16FA153
<b>Date &amp; Time:</b>	07/29/2016, 0105 PDT	<b>Registration:</b>	N661TC
<b>Aircraft:</b>	PIPER PA-31T	<b>Aircraft Damage:</b>	Destroyed
<b>Defining Event:</b>	Fire/smoke (non-impact)	<b>Injuries:</b>	4 Fatal
<b>Flight Conducted Under:</b>	Part 135: Air Taxi & Commuter - Non-scheduled - Air Medical (Medical Emergency)

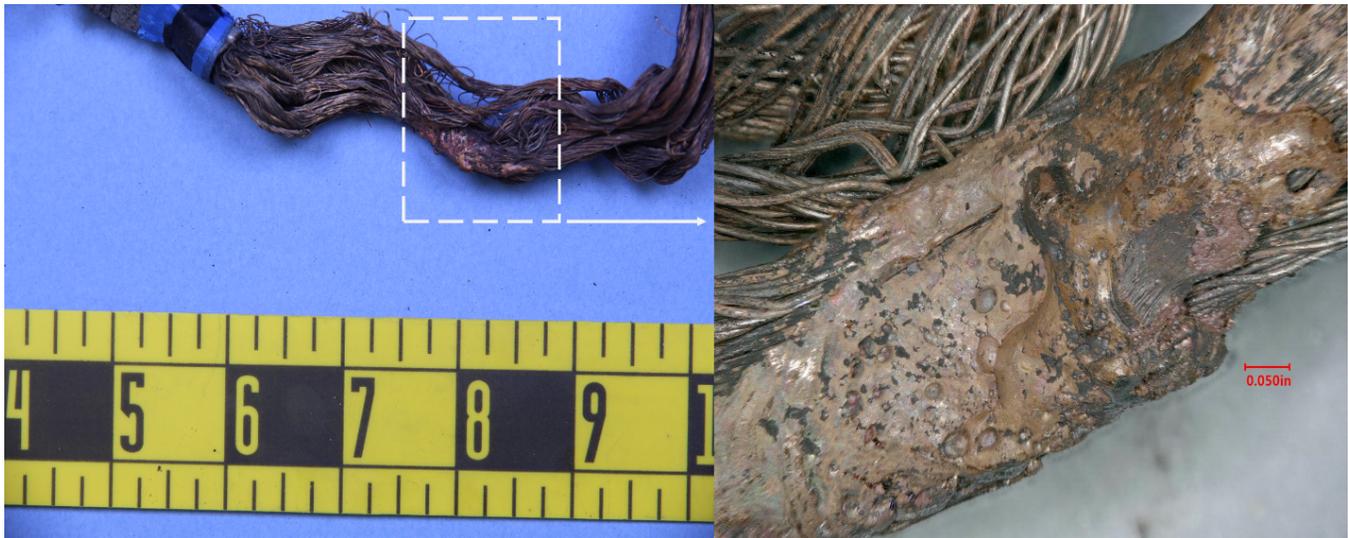
The wire identified as P3H contained both terminal ends. The entire wire section was missing insulation. A large area of welded conductors/arcing was present about 2 inches and 4.5 inches from the terminal ends. (See figure 1 and figure 2.)

Figure 1 - Photograph of welded area on P3H

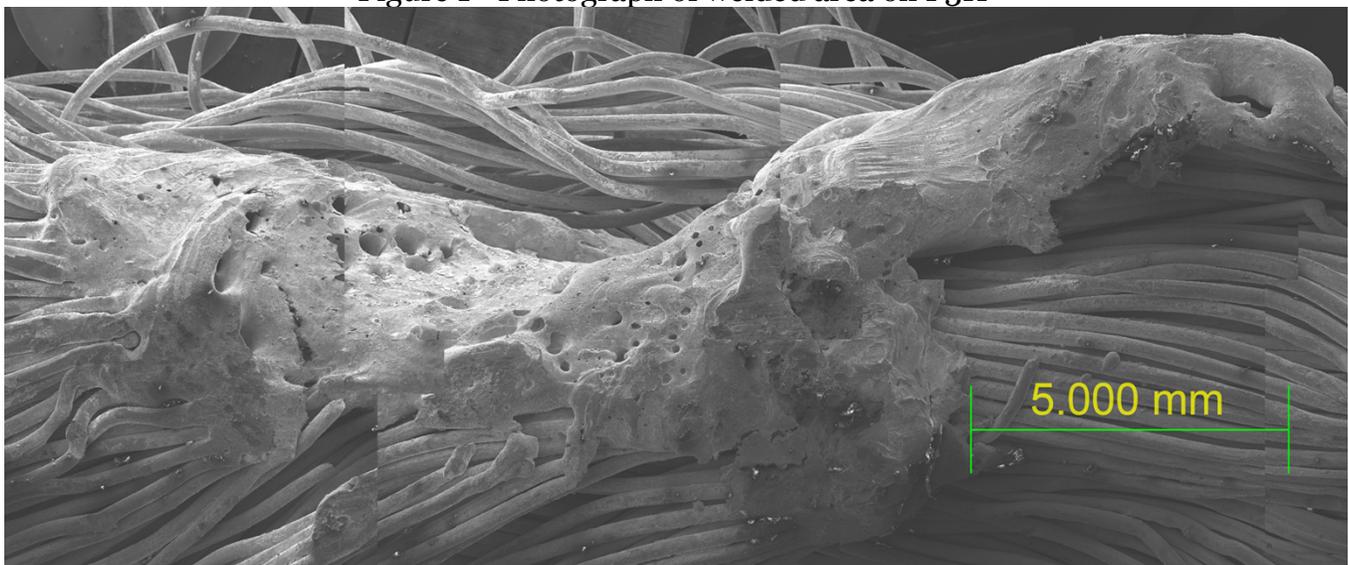
Figure 2 - Micrograph of welded area on P3H

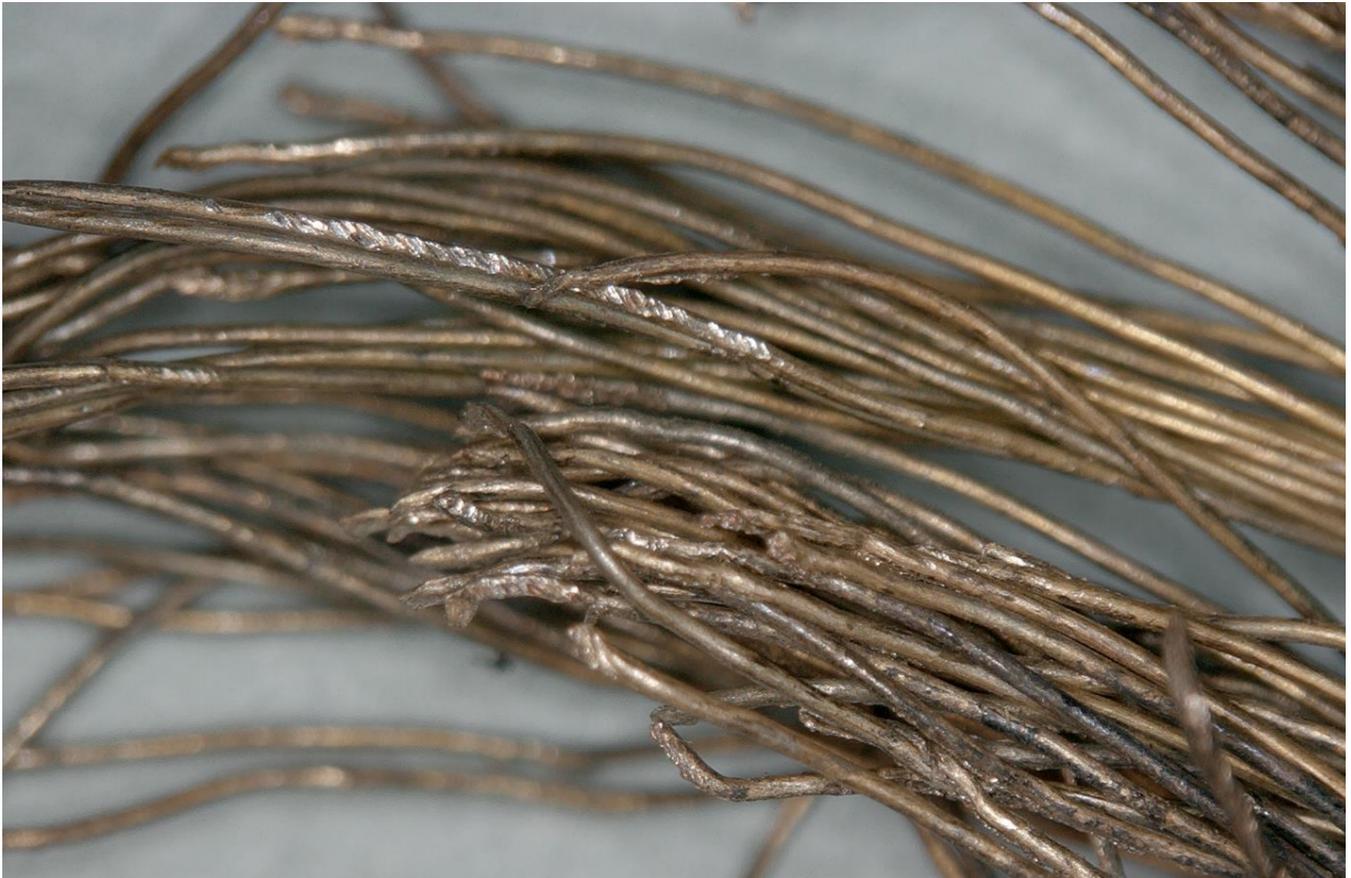
The wire identified as L Main 2 was trapped inside a section of aircraft structure. A portion of the circuit breaker remained attached to the wire. About 11 inches of wire insulation were missing from the fractured end of the wire. The remaining insulation exhibited thermal discoloration and shrinking. Signs of thermal damage were present and decreased in severity moving away from the main bus tie circuit breaker end. The fractured end was frayed, and the exposed conductor exhibited notching. The fractured end was examined using a scanning electron microscope. No obvious signs of arcing on exposed sections of conductor were found. Several areas of the cross diameter on several conductors were flattened and appeared to have

missing material. In addition, the fractured end was examined using electron dispersive spectroscopy to look for the presence of foreign materials on the wire conductors. No foreign material was found. (See figure 3 and figure 4.)

Figure 3 - Photograph of fractured end of L Main 2

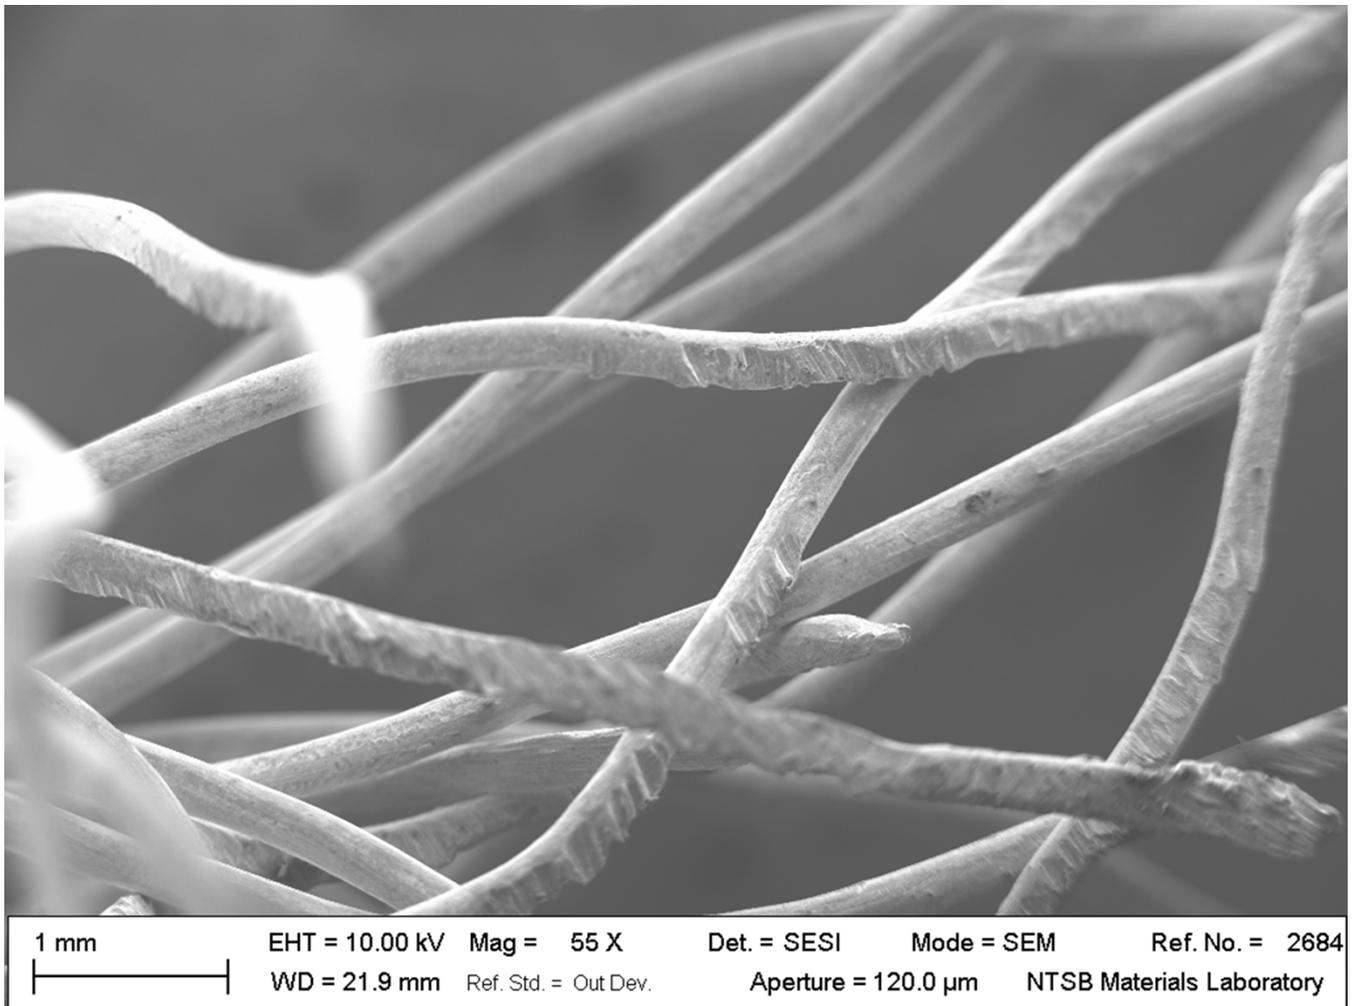
Figure 4 - Micrograph of notching on conductor surface of L Main 2
