Bureau Enquêtes-Accidents

REPORT

*on the accident on 12 November 1999
North of Pristina (Kosovo)
to the ATR 42-300 registered F-OHFV
operated by SI FLY*

F-FV99112A

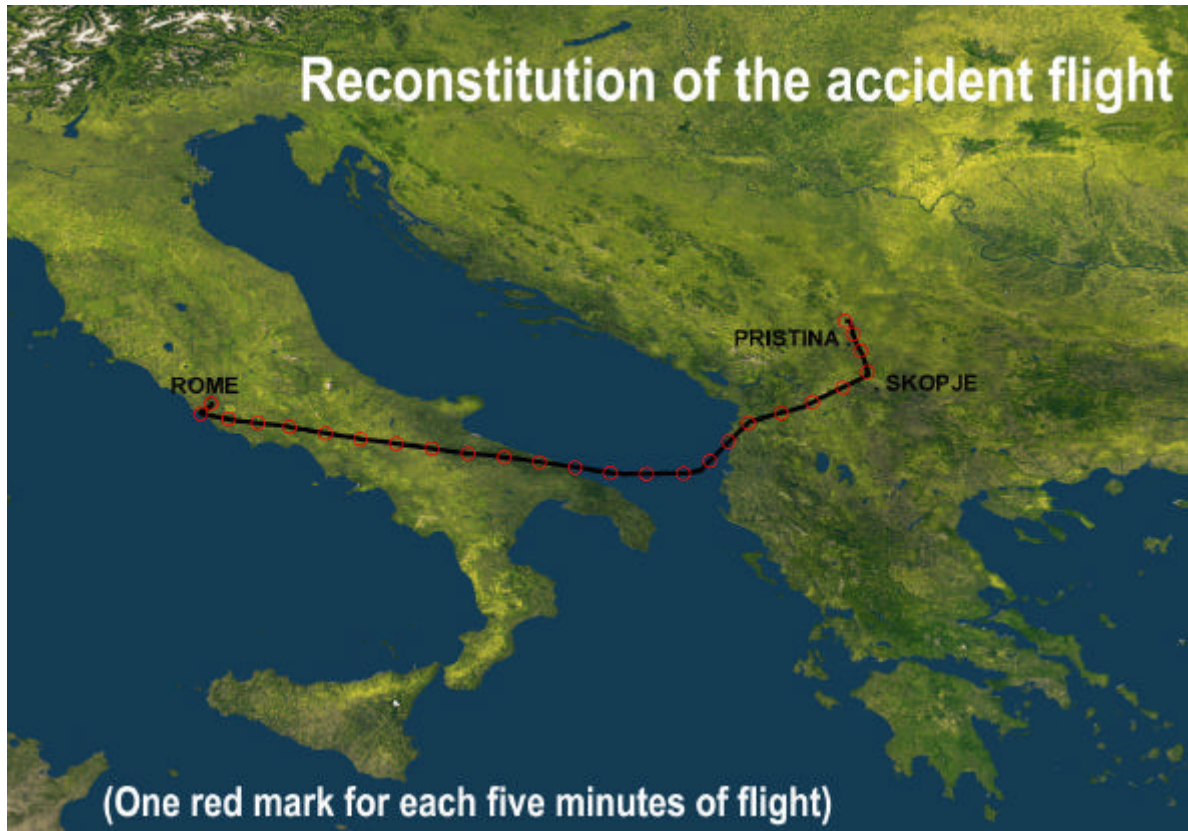
Figure 1 : Track of the accident flight

On 12 November 1999 at 8 h 11, the ATR 42-300 registered F-OHFV, operated by the Italian airline Si Fly and chartered by the World Food Program, took off from Rome to undertake Flight KSV 3275 to Pristina with three crew members and 21 passengers on board.

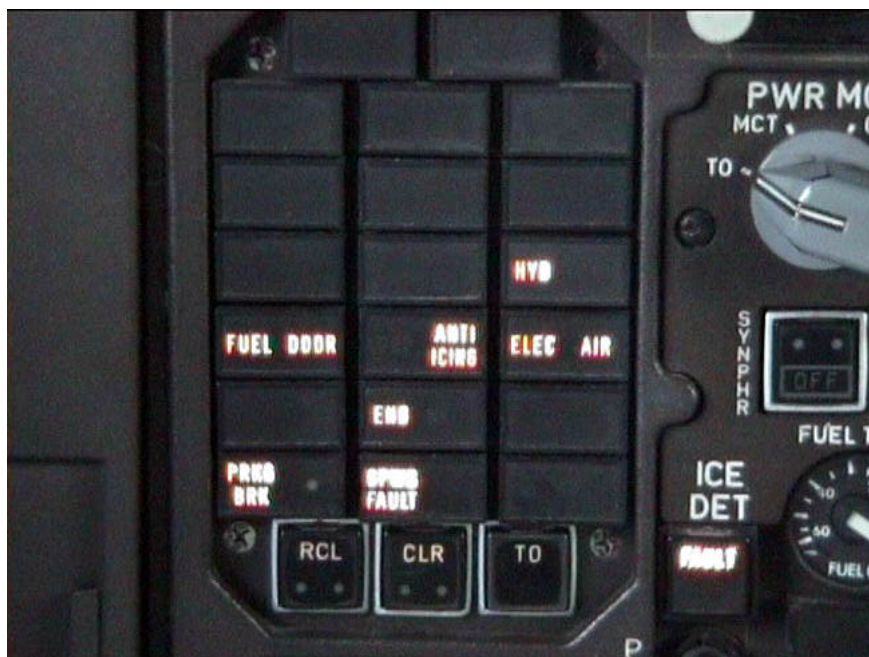
Figure 7 : Crew Alert Panel

The GPWS has an integrated test, which, in case of breakdown of one of the parts of the system, can display a "GPWS FAULT" warning on the Crew Alert Panel (CAP) : the "GPWS FAULT" warning is also displayed when the GPWS switch is in the OFF position.

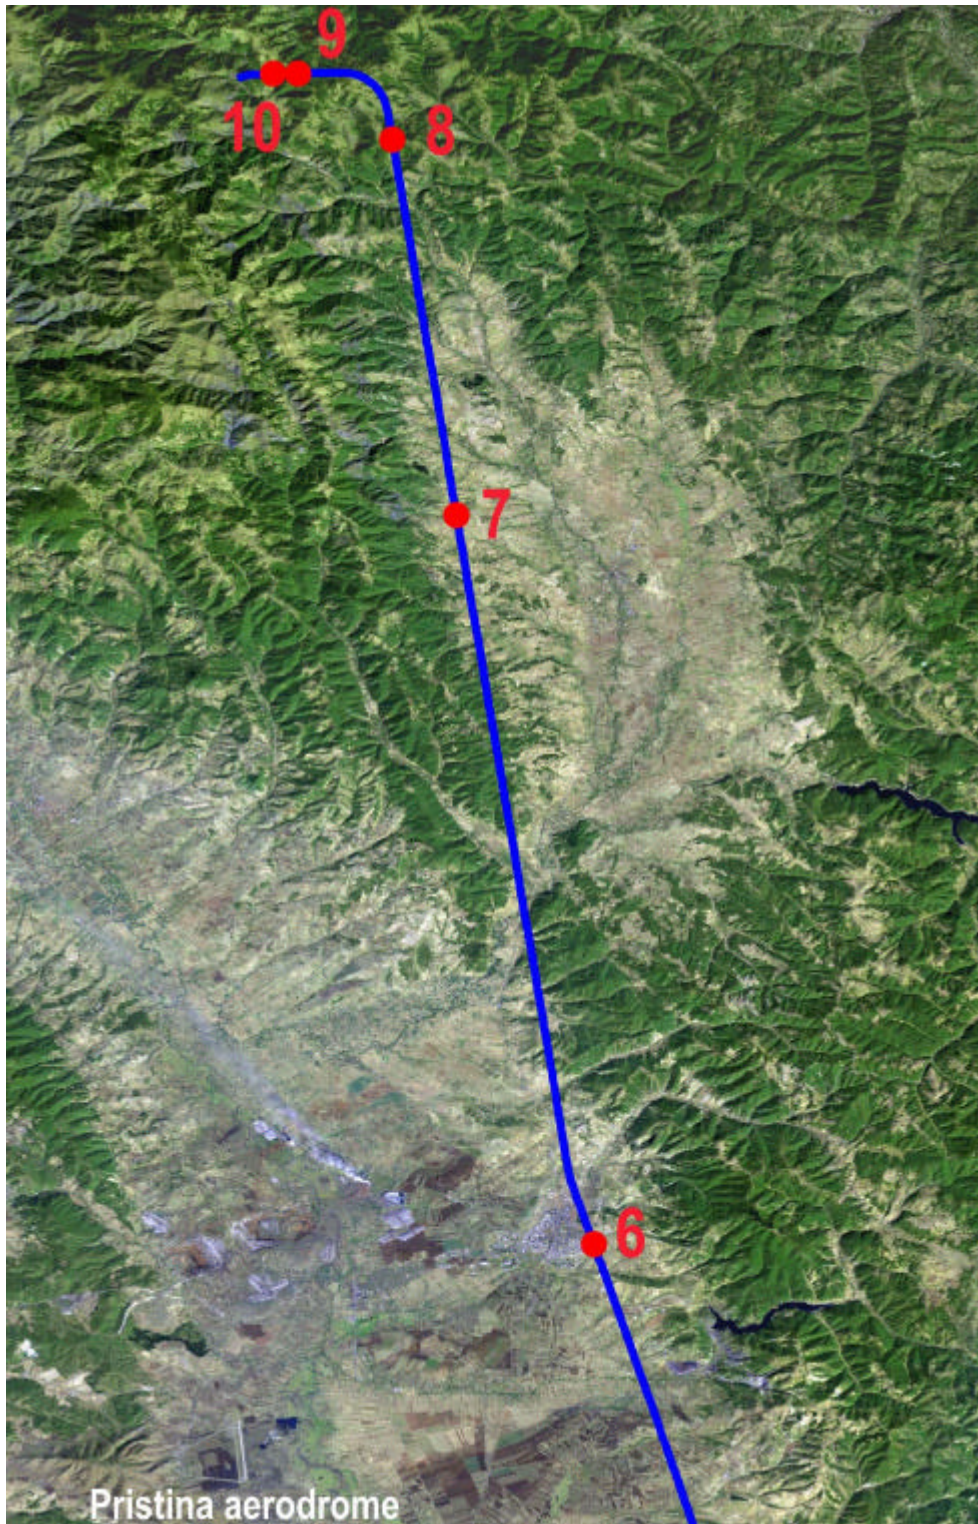
Figure 10 : Track of KSV 3275

At the time of the accident, a French Air Force AWACS was on a mission in the
region. Information relevant to the tracks of KSV 3275 and HCN 993 was provided
to the investigators. It showed an approximate speed of 250 kt for KSV 3275 and
of 400 kt for HCN 993. It allowed them to validate the track calculated from the pa-
rameters recorded on the aircraft's Flight Data Recorder (see 1.11.3) and to de-
termine the relative position of the two aircraft at the moment when HCV 993 be-
came number one for landing (see § 2.2).

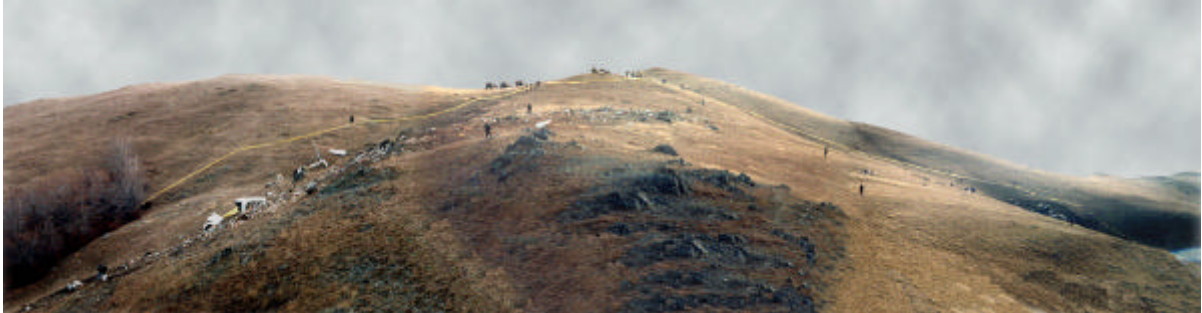
Figure 11 : View of accident site

The accident site is situated 25 NM north of Pristina Aerodrome (10 NM NE of Mitrovica) at an altitude of 4,600 feet. The first impact occurred 15 metres from the top of a ridge, in a rocky mid-mountain area. The peaks in this area vary between 3,380 and 5,800 feet.

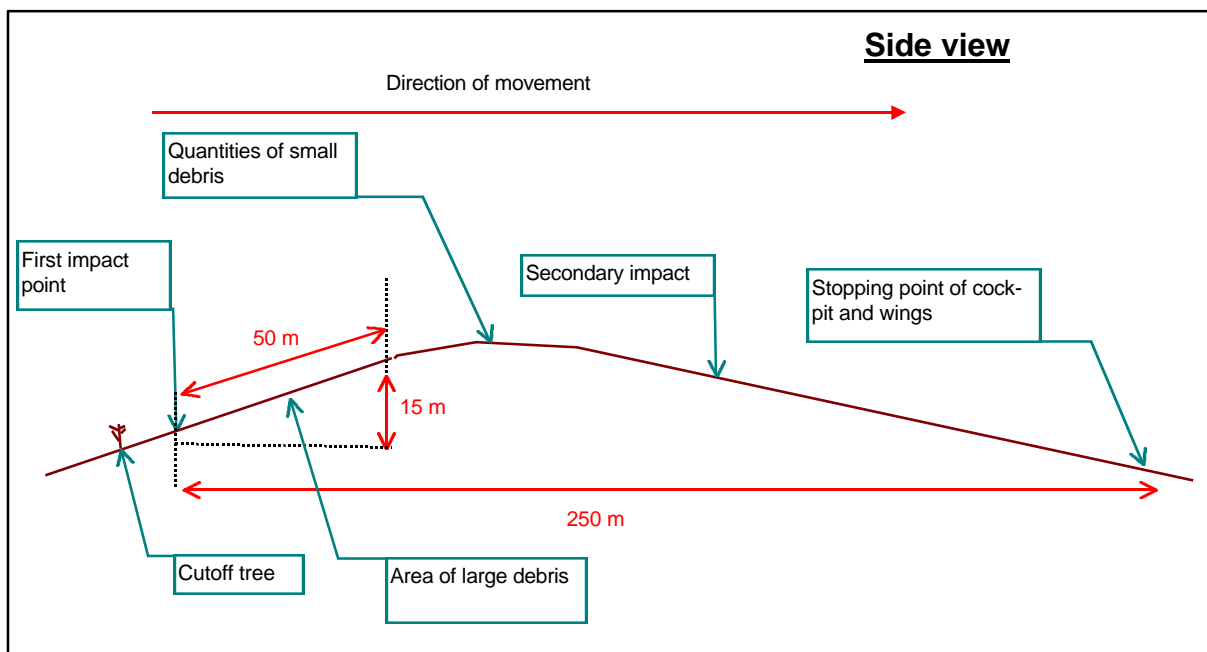
Figure 12 : Side view of site

Twenty-five metres before the impact point, the top of a seven-metre-tall tree had been chopped off on the right side of the track. Then the point of impact of the engine and left propeller slashes were found.

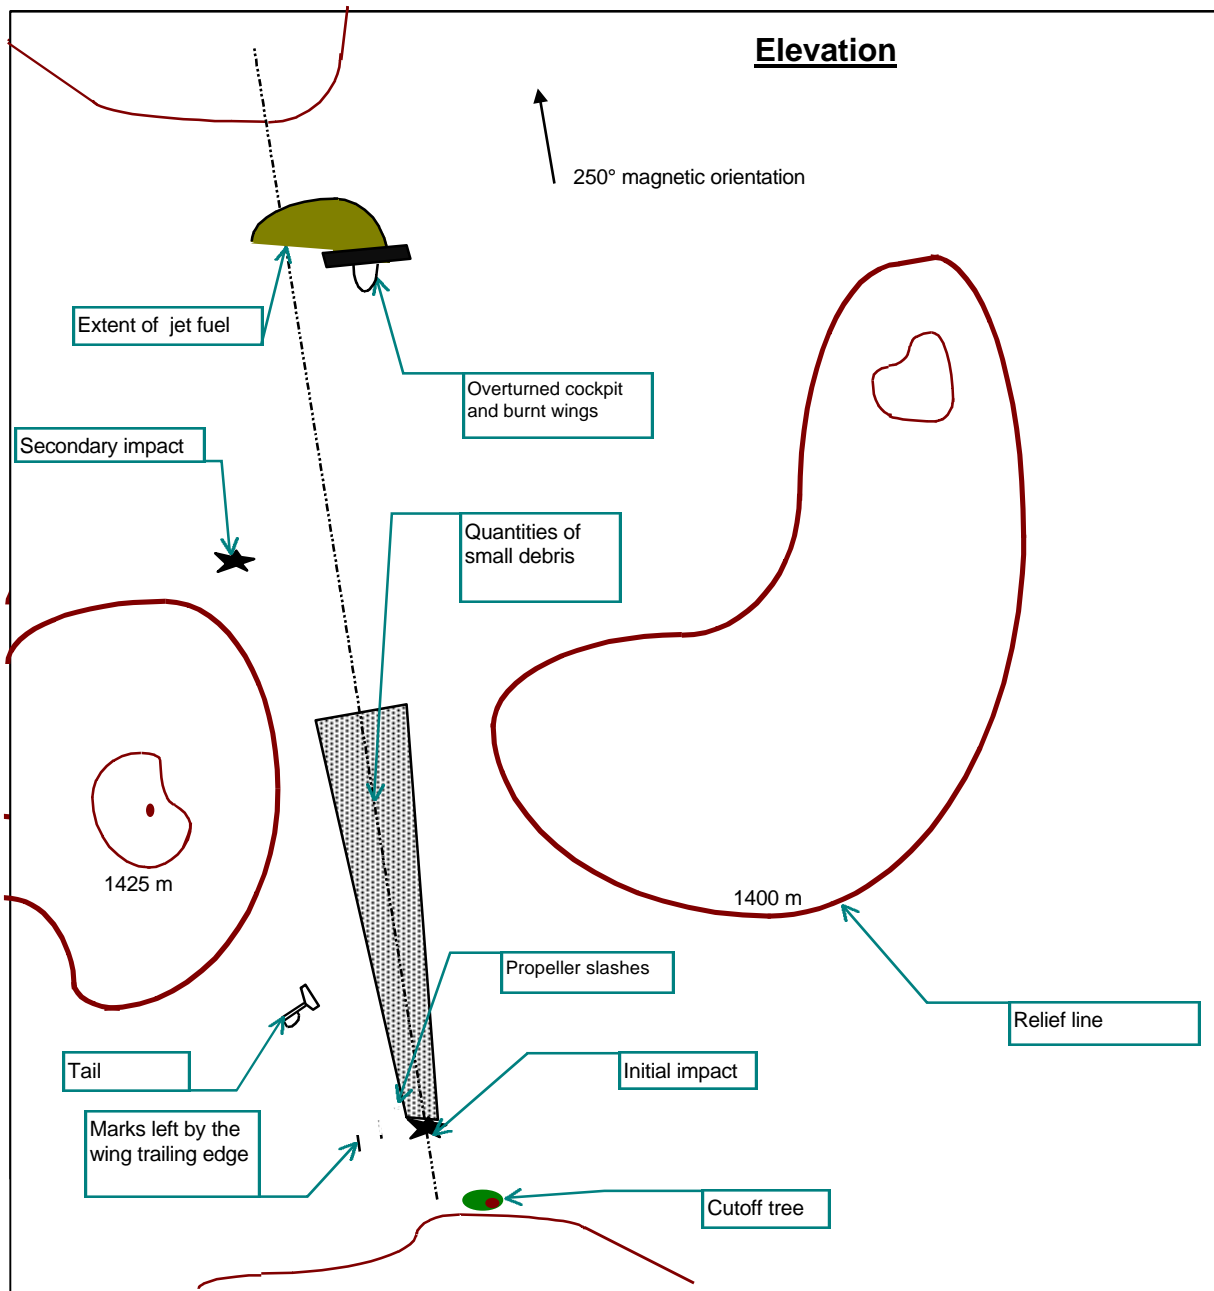
Figure 13 : Accident site seen from above

The fuselage impact point was a little further, about fifty metres from the top of the ridge. The tail, from which half of the left stabiliser was detached, was found on the left.

The debris was then spread about over a length of about 250 m on a line at 250°, on either side of a pass. The lower part of the fuselage had disintegrated on the rocks on a slope rising at 30%. On the other side of the ridge, the two main landing gears were found in relatively good condition, along with two items of electrical equipment (the GPS and an ADC) and the right engine.

At the end of the track, at about 150 m after the ridge, the main part of the fuselage was found : the upper part of the cockpit, the left engine and the wings, showing signs of fire. The cockpit and the wings were upside down. Slightly to the right the engine control pedestal was found.

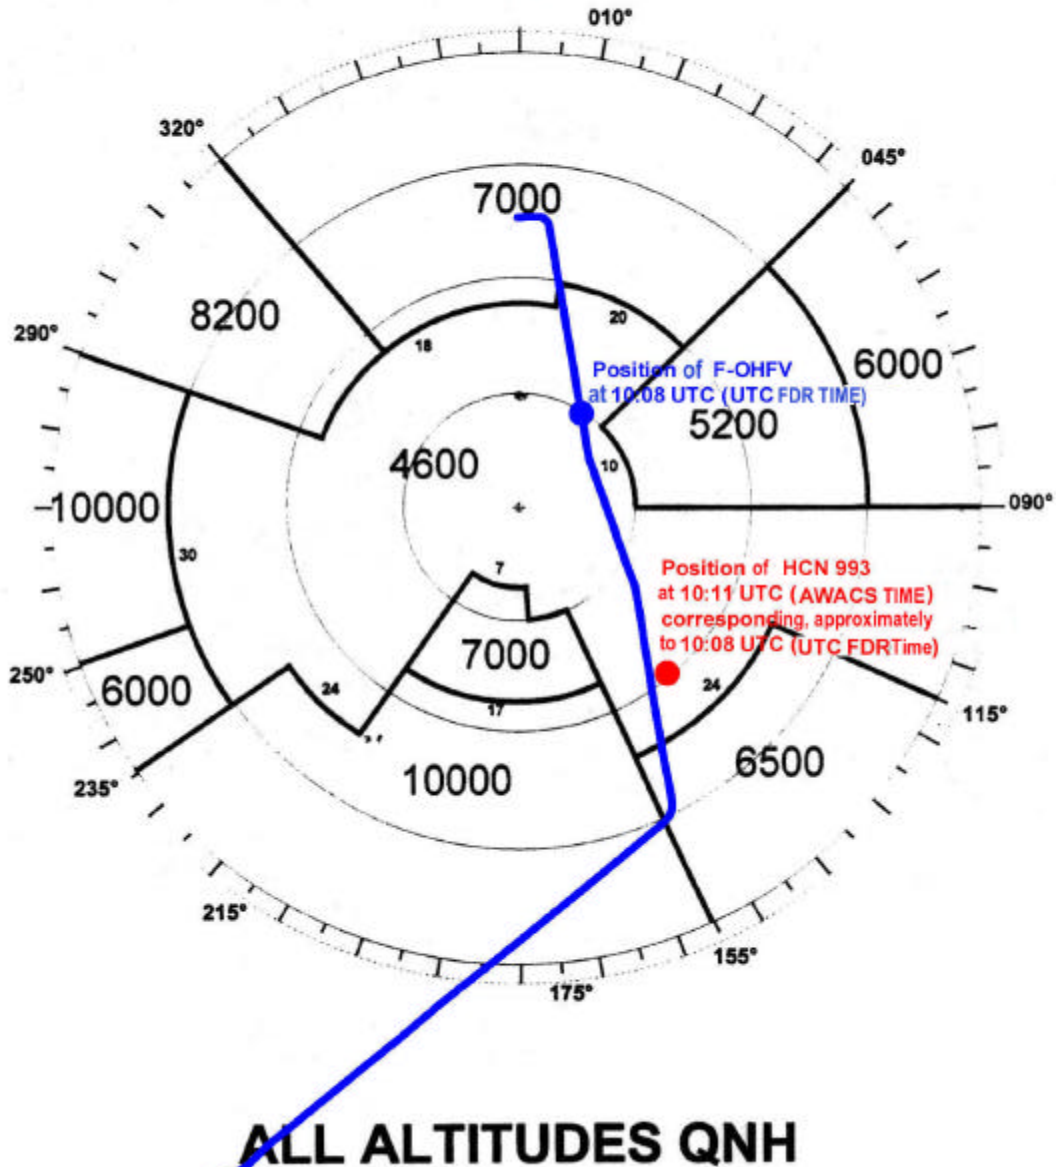
Figure 18 : Relative position of aircraft F-OHFV and HCN 993 when HCN 993 took number one position for landing

Position of **F-OHFV** and **HCN 993** at 10:08 UTC

These relative positions must be viewed with caution due to the low sample rate of data related to HCN 993, and to the difference of around 3 minutes between the UTC time on F-OHFV's FDR and that of the AWACS which recorded the track of HCN 993
