Report 831-1053

**Beech 200 Super King Air
VH-KTE
Adavale, Queensland**

28 August 1983

BUREAU OF AIR SAFETY INVESTIGATION

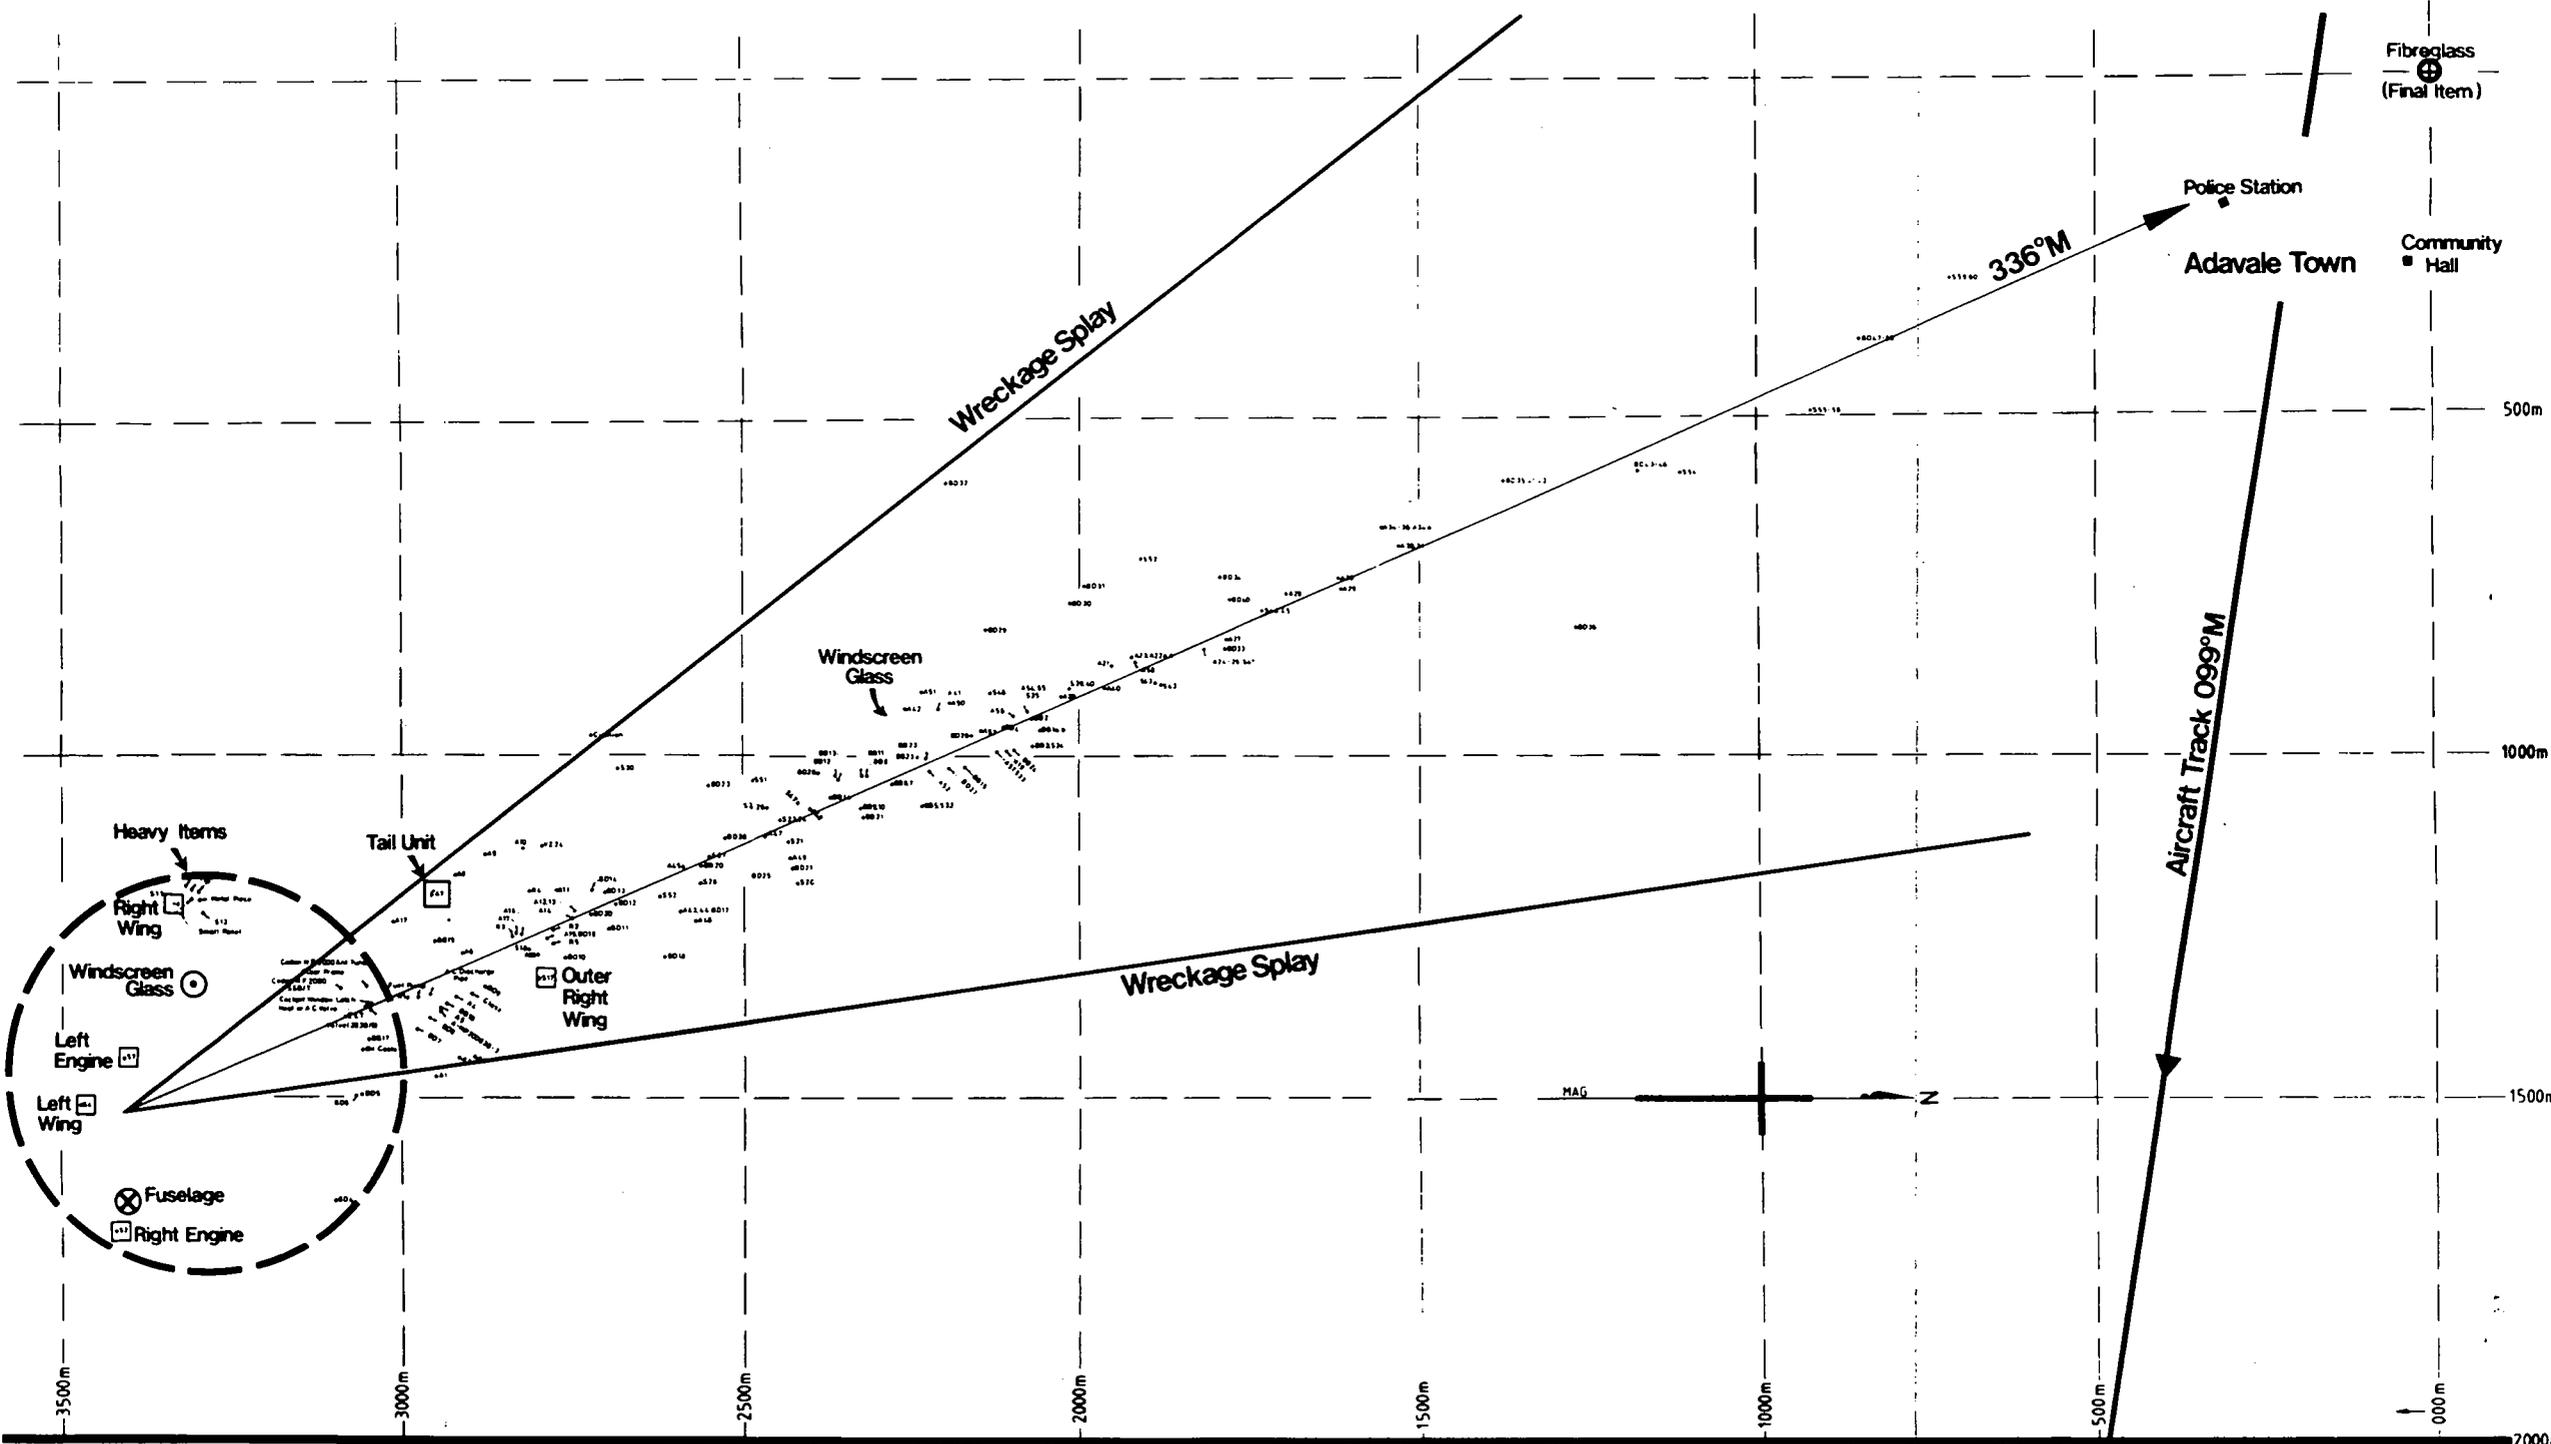
APPENDIX D Wreckage distribution near Adavale

A diagram of the wreckage, as found, is at Appendix D. Distribution of the wreckage on a basic line of 336 degrees M from the fuselage for 3.6 km was mainly due to wind effect. A trajectory analysis of items of wreckage was carried out to determine the height of breakup. The analysis depends on the bulk and mass of the item and the distance it would have been carried by the wind i.e. rate of fall versus wind speed and direction. Calculations determined that the aircraft broke up at 5000-8400 ft altitude. The intended track from Windorah to Charleville was 099 M and Adavale was on that track.
