AIRCRAFT ACCIDENT REPORT 1/2020

Report on the accident to
Piper PA-46-310P Malibu, N264DB
22 nm north-north-west of Guernsey
on 21 January 2019

Air Accidents Investigation Branch

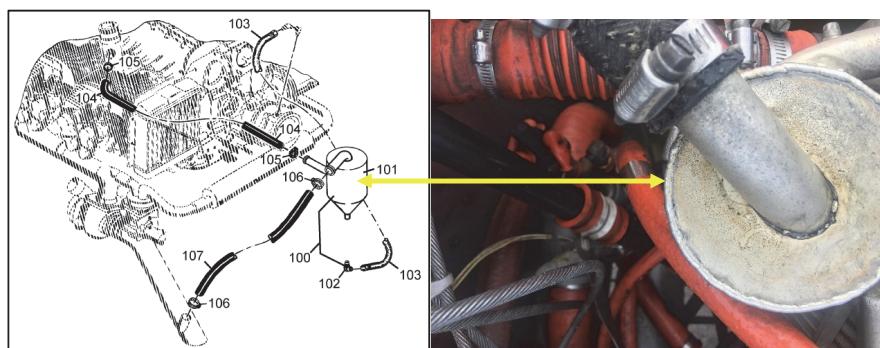
Figure 10

Following the engine ground run carried out at Nantes to investigate the bang on the outbound flight, the pilot noticed what he thought might be a small oil leak from the top of the oil accumulator, which he believed had been present for some time. The pilot took photographs, which he sent to the individual who managed the aircraft who then forwarded them to the FAA IA. From one of the photographs, the component was identified by the engine manufacturer as the air / oil separator assembly (Figure 10).

Photograph sent by pilot showing location of oil leak from the air / oil separator (item 101 in the left image)

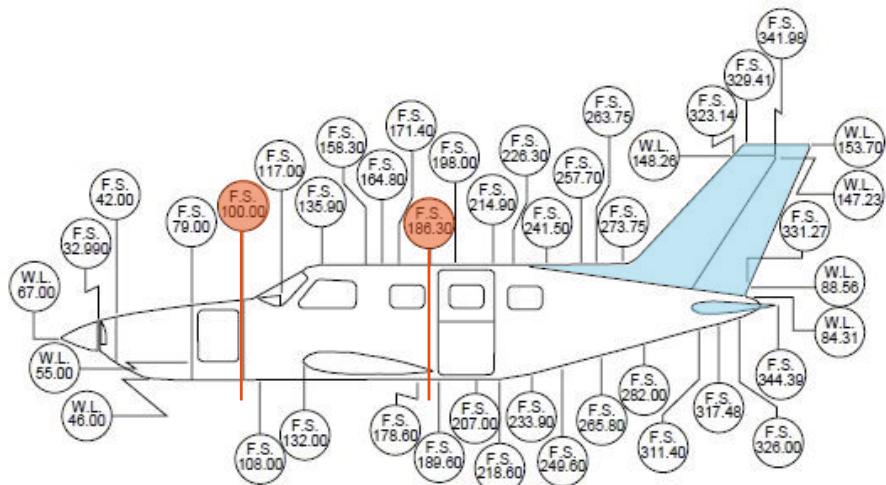
Figure 13
PA-46 fuselage

The central fuselage had broken away from the nose section at Fuselage Station (F.S.)100 and from the tail section at F.S. 186.30 (shown in orange in Figure 13). The roof section of the central fuselage aft of the front seats was missing. There was significant compression damage along the top of the aircraft from the windscreens to the tail cone. There was no evidence of compression damage on the lower surface of the tail section. The fin and horizontal stabiliser assemblies had detached from the tail section at their attachment points (shaded blue).

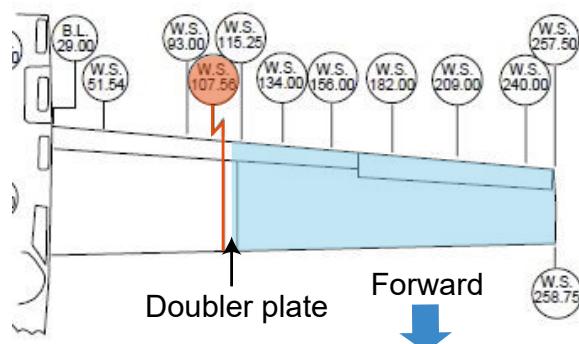
Figure 14
PA-46 left wing

The left wing and flap had failed at Wing Station (W.S.) 107.56 (shown in orange in Figure 14) beneath the skin doubler plate where the inboard section of the wing joins the outer section (shaded blue) at the splice joint. The inboard section of the main wing spar appeared to be undamaged. The failure of the main spar splice joint and the adjacent structure was consistent with the wing failing due to a downward bending force. The top wing surface displayed evidence of a compressive force that had pushed the skins inwards with the edges having been torn away from the fasteners. The remainder of the wing structure and flaps were extensively damaged.

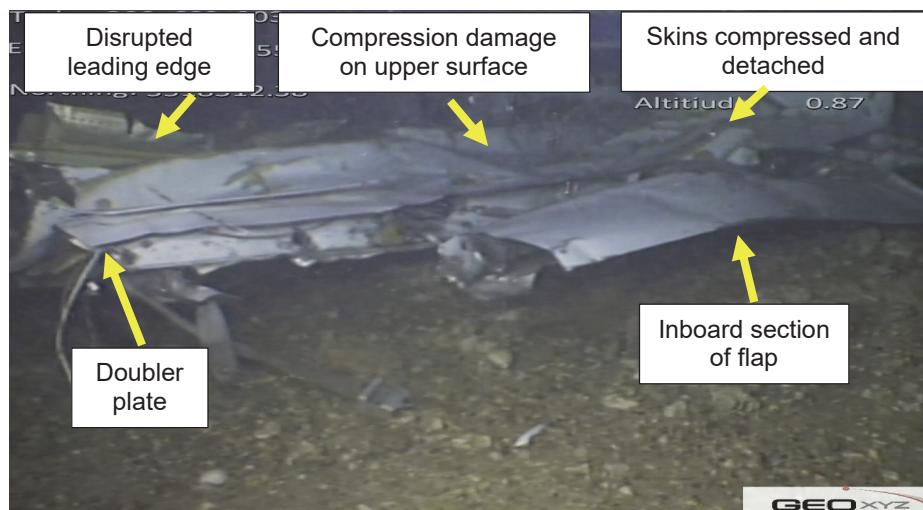
Figure 15
Damage to left wing

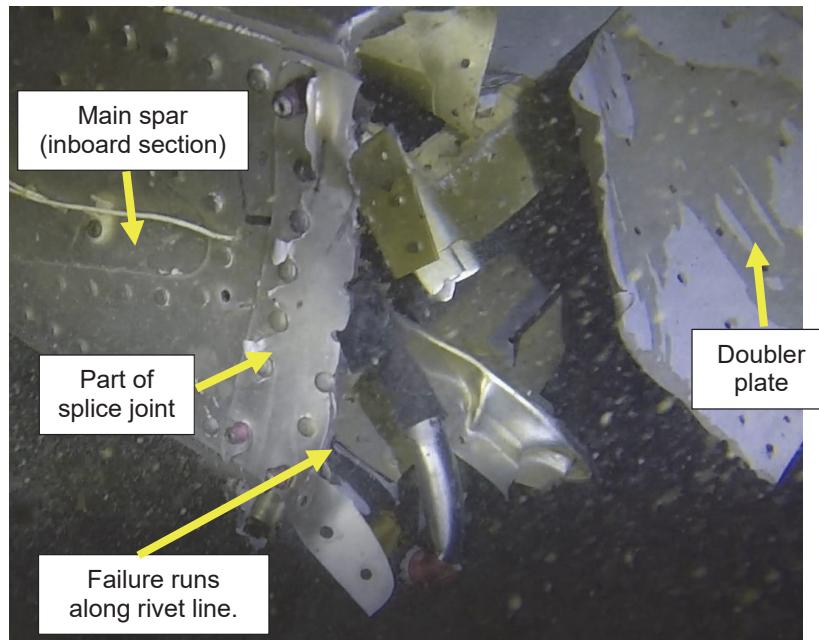
Figure 16

Failure of left-wing main spar at the splice joint
(Image taken from a video provided by Blue Water Recoveries)

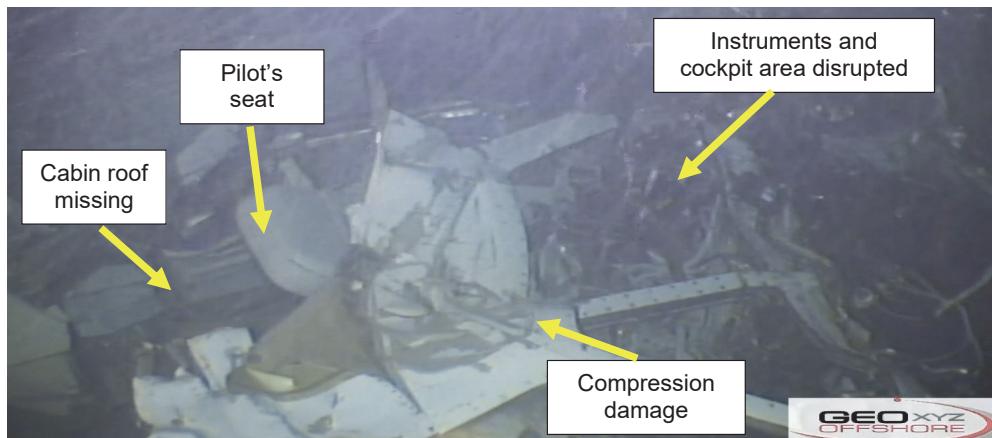
Figure 17
Damage to cockpit roof

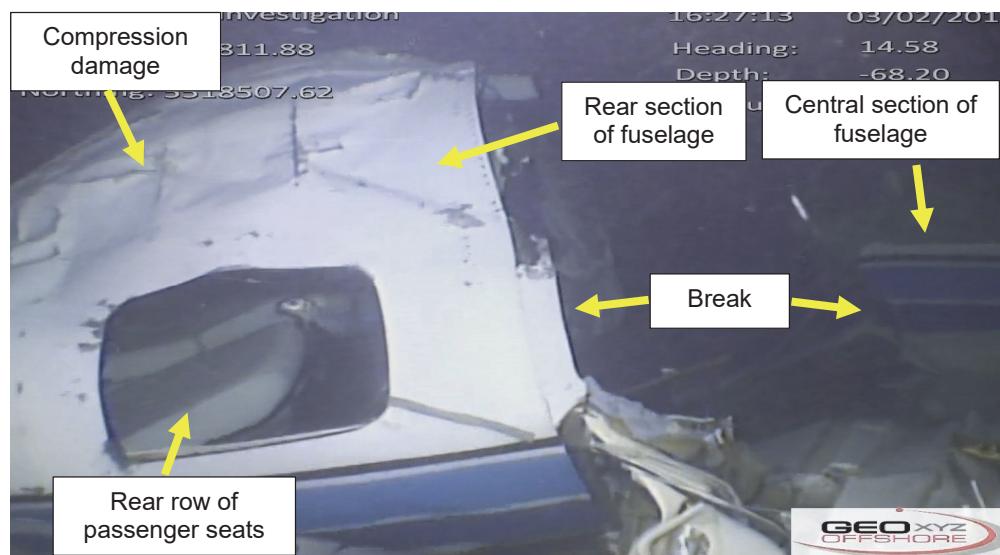
Figure 18
Break in central fuselage

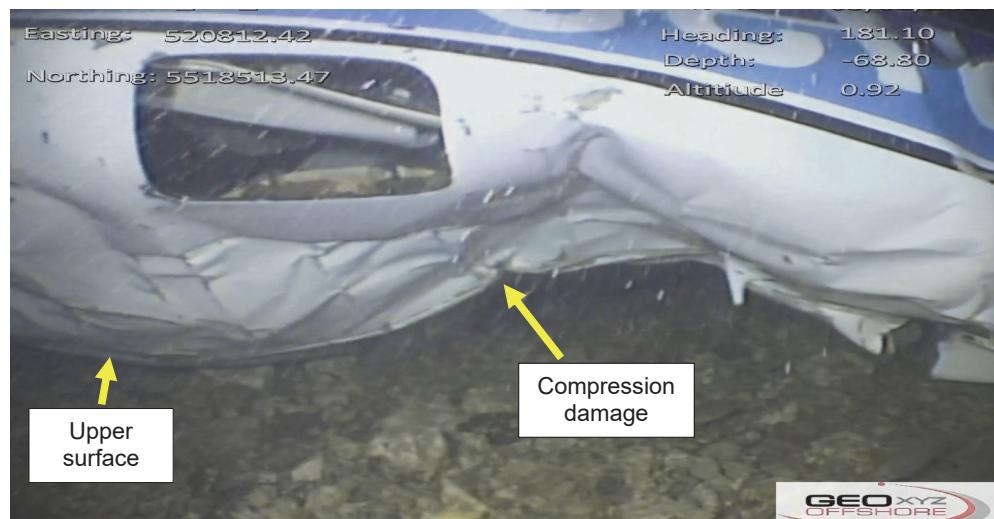
Figure 19
Damage to roof of rear section of the fuselage
(This section of the fuselage has been rotated by the tidal flow)

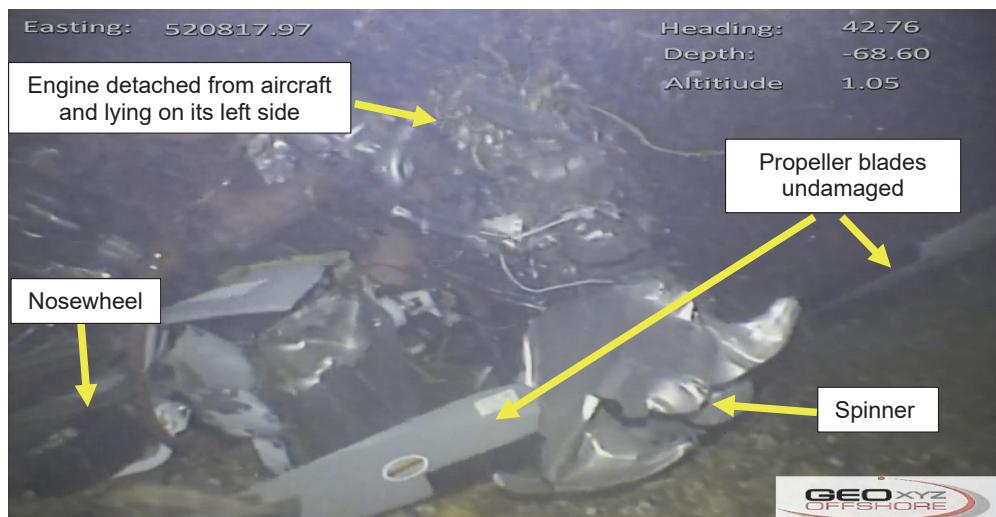
Apart from a slight rearward bend in one of the blades, the propeller blades were undamaged. The engine cowlings had detached and the engine and nosewheel had rotated 90° relative to the front of the cockpit. Several components had detached from the engine. The right tailpipe / heater shroud was still attached to the right turbocharger and video footage of part of the right tailpipe showed no evidence of scoring on the inside. There was no evidence of burnt oil residue on the inside of the exhaust. The induction, heating and ventilation pipes, and the engine baffles had been disrupted. The ignition harness was still connected to the engine.

Figure 20
Propeller and engine

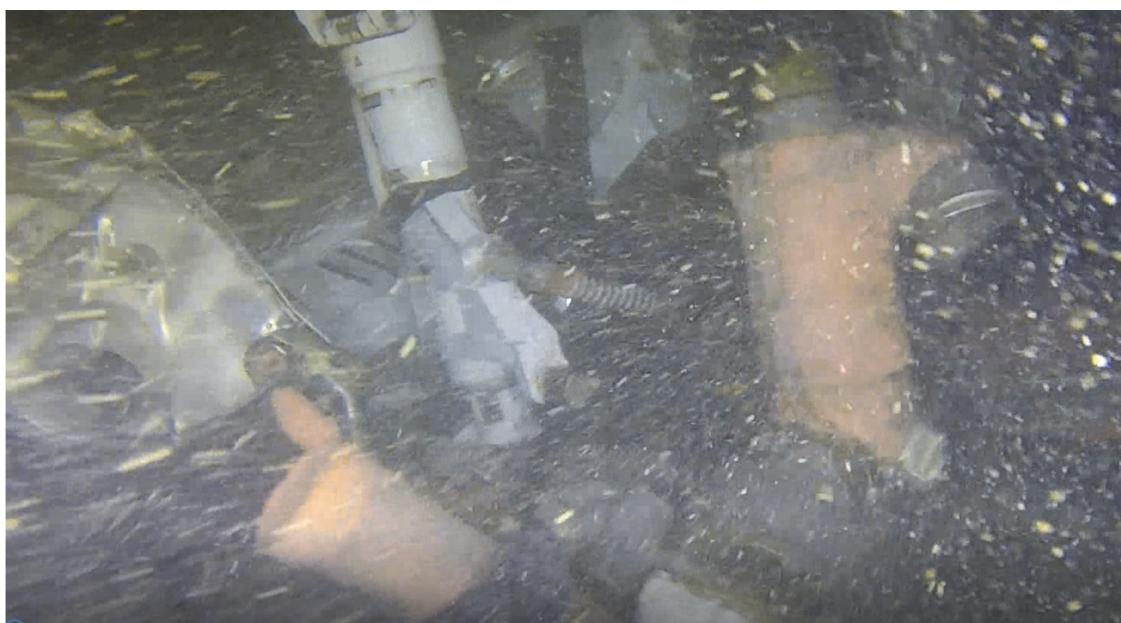
**Figure B-7**

Right tailpipe and heater muff / shroud
(image taken from video provided by Blue Water Recoveries)

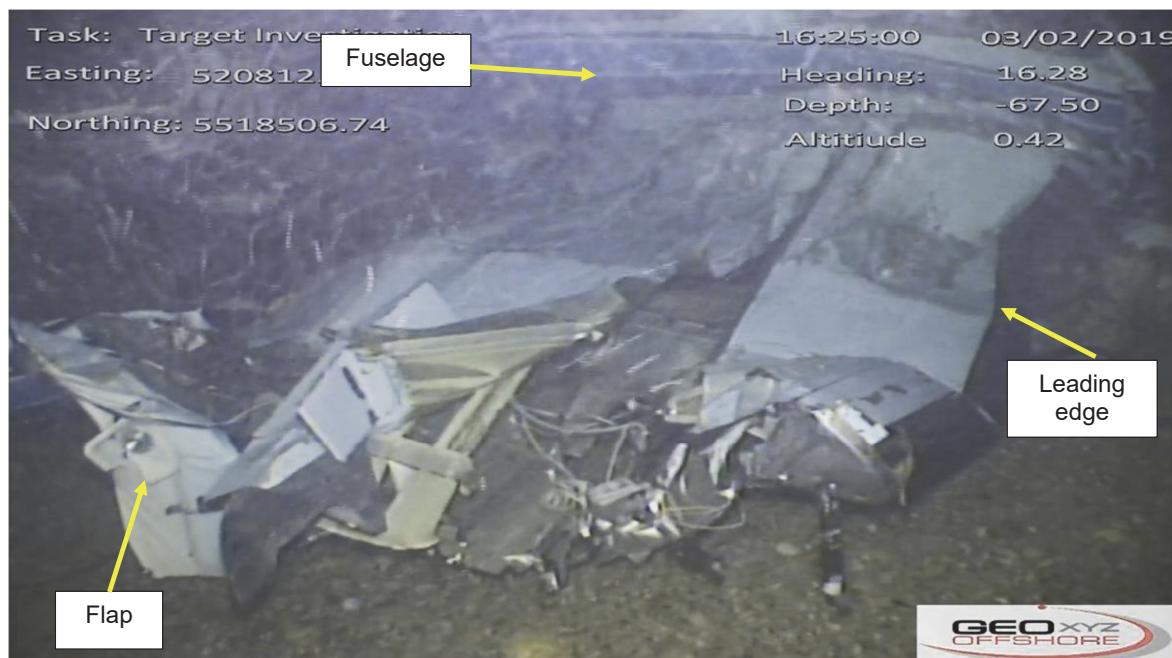
Figure B-8
Remains of right wing

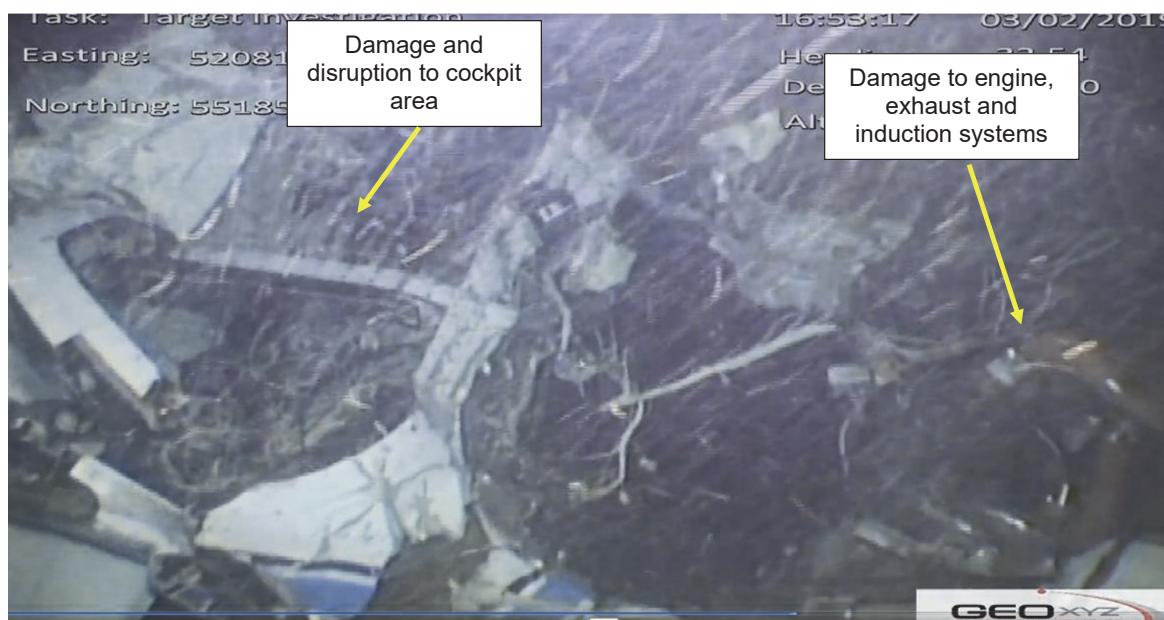
Figure B-10
Disruption to cockpit and engine

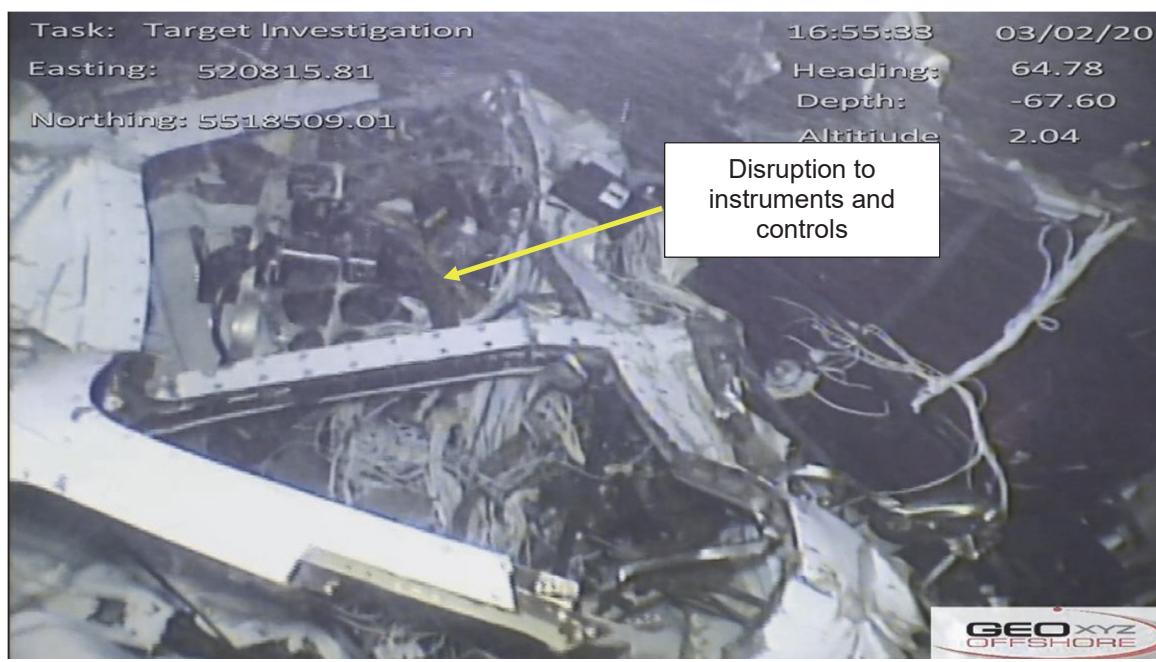
Figure B-11
Damage and disruption to instruments and controls

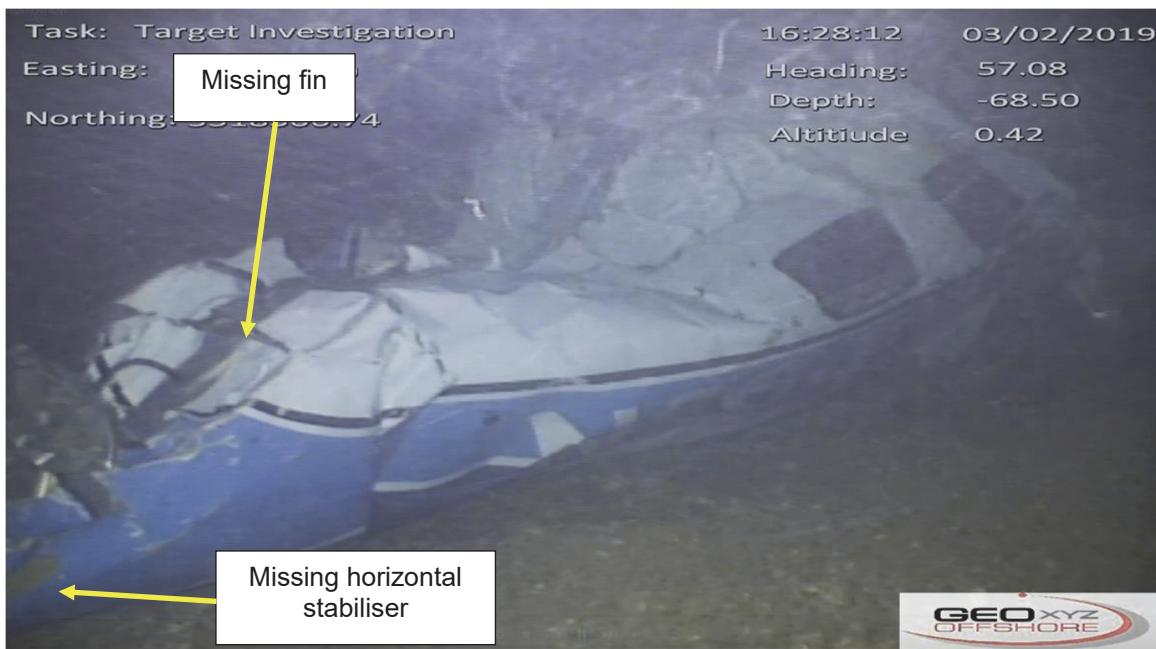
Figure B-12
Missing fin and horizontal stabiliser
