SL 2013/29

REPORT ON SUPPLEMENTARY INVESTIGATION - AIR ACCIDENT AT TORGHATTEN NEAR BRØNNØYSUND ON 6 MAY 1988 WITH DHC-7-102, LN-WFN

Date of submission: 16.12.2013
SL Report: 2013/29

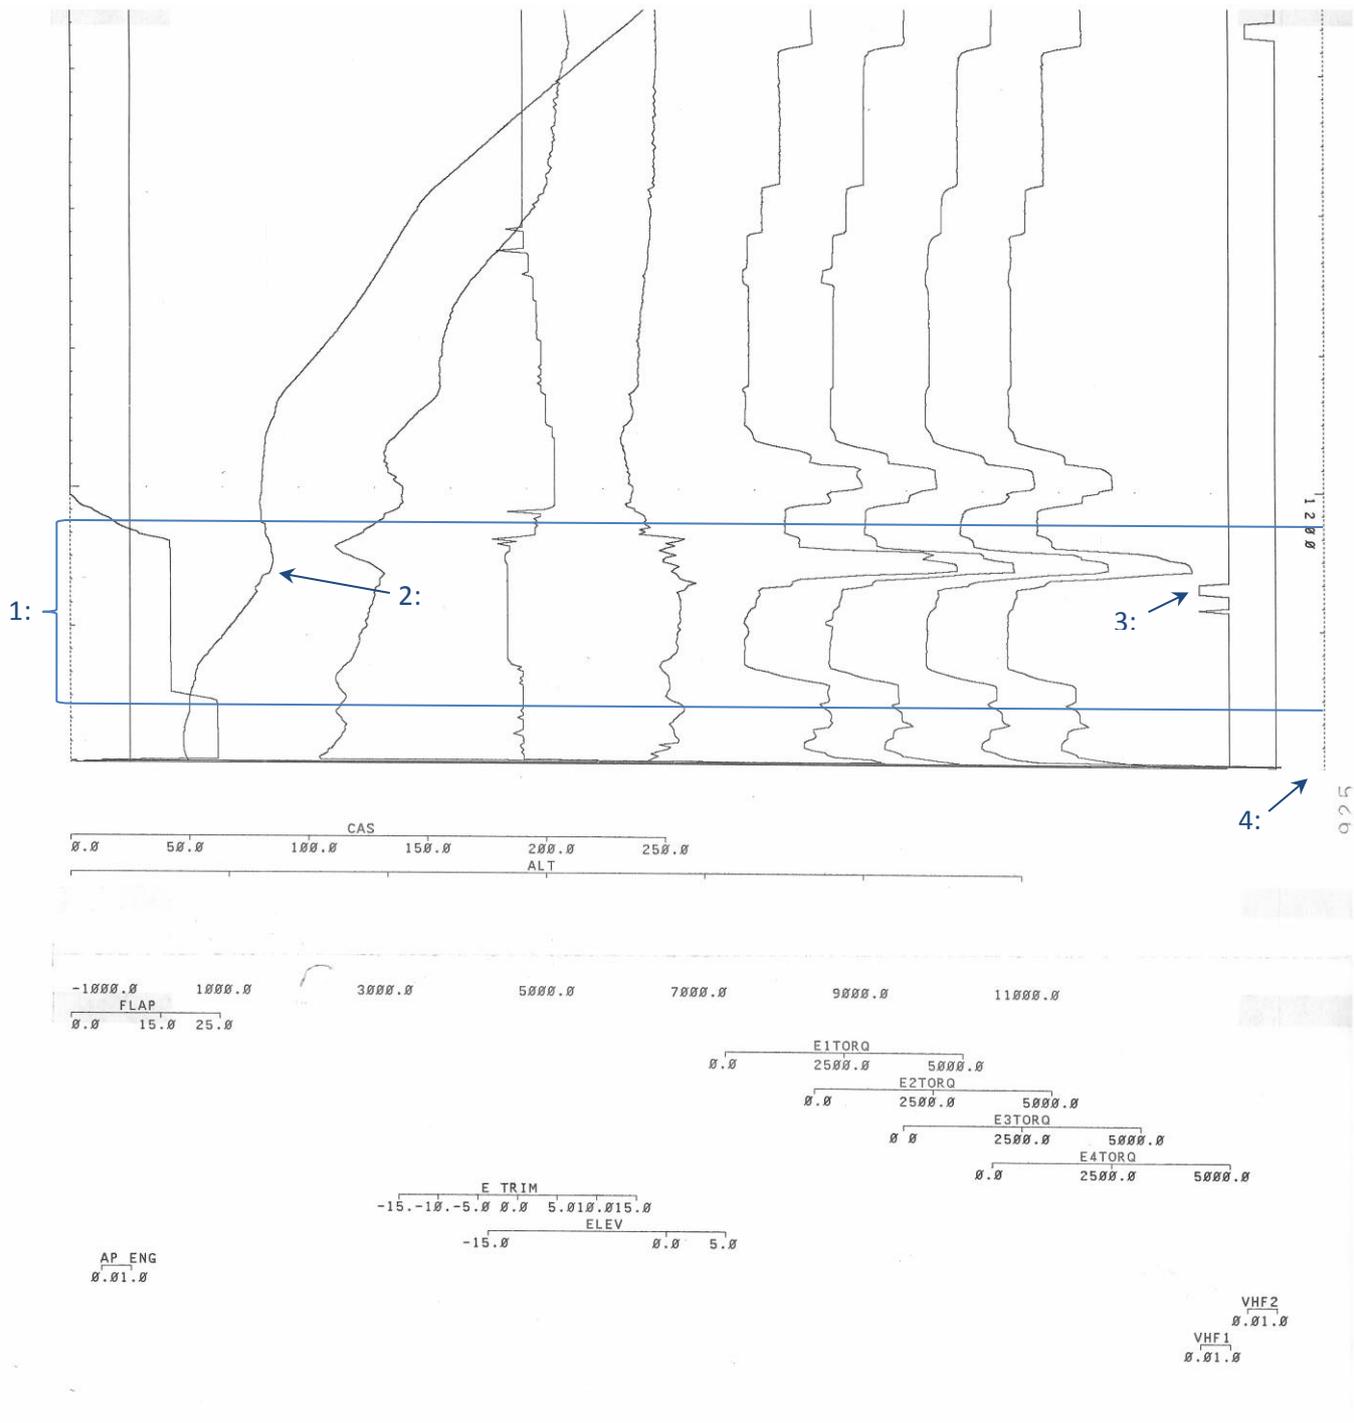
The SHT will in addition direct attention to the fact that the crew adjusted engine power as one would with a controlled descent (see Appendix B) and that the air speed was adjusted in a systematic and planned manner (see also Appendix B).

- 1: Sequence that was omitted in Attachment 5 to Report 1989/04 by a printing error
- 2: Start of descent from 1 500 ft on the altitude presentation (about 8 NM from the airport)
- 3: The crew reports to Brønnøysund TWR that LN-WFN is 8 NM from the airport
- 4: Time line

From the accident flight: Flight Data Recorder graphs showing the final part of the approach towards Brønnøysund airport

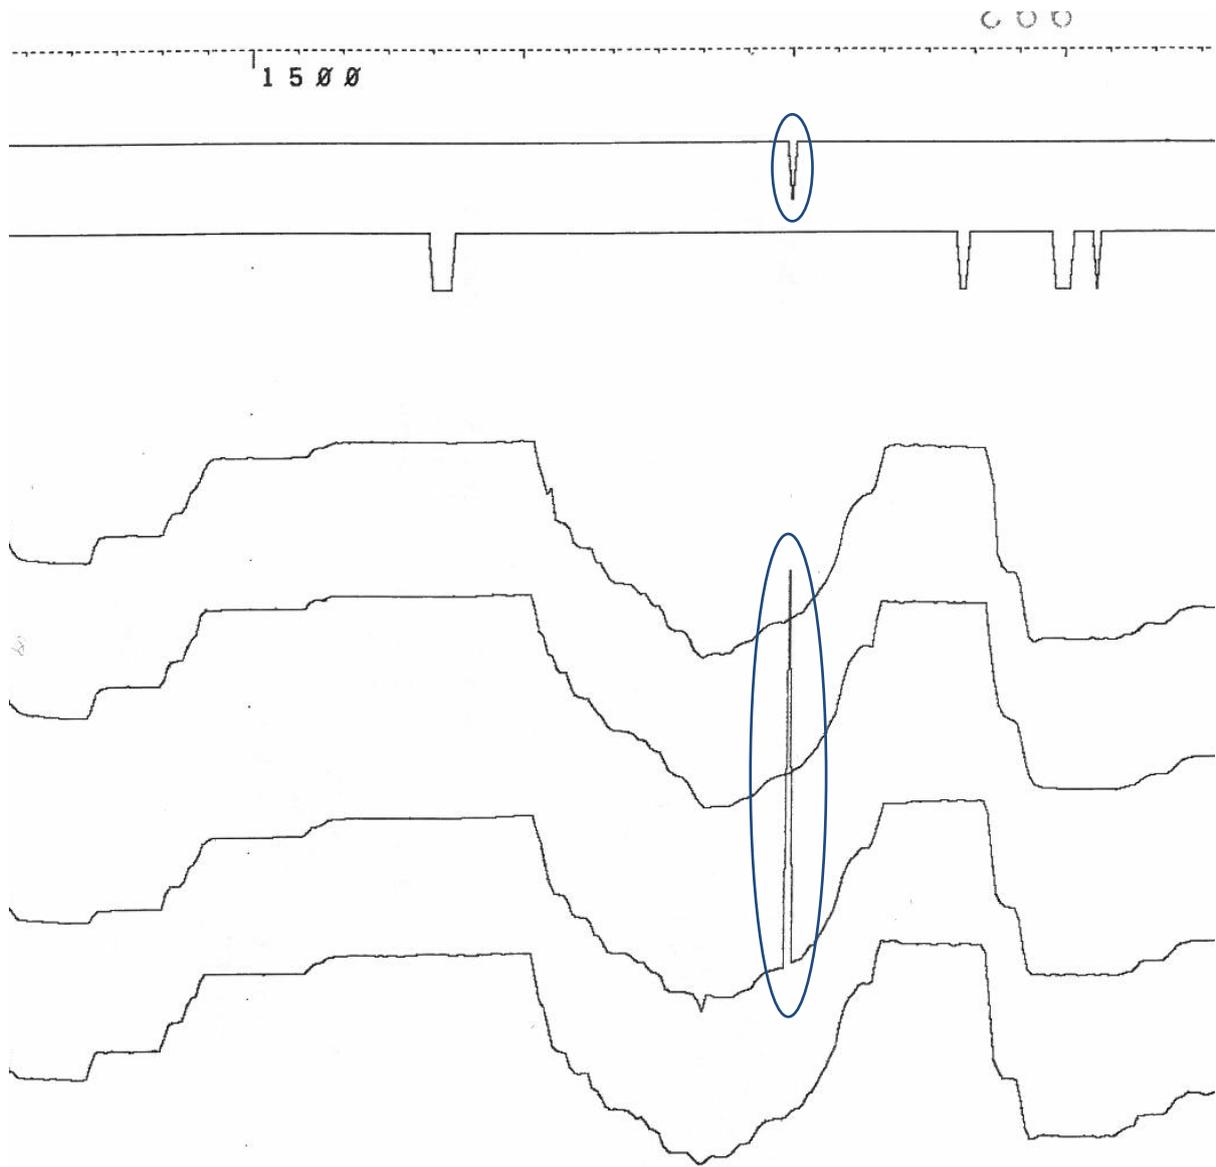
Trondheim to Namsos, for instance, the performance graph for engine number two (E2TORQ) showed a sudden, short peak (see Appendix C). The SHT wanted to know if this was a possible sign of disturbance from one or more mobile telephones.

Concerning the peak on engine no. 2 on the flight between Trondheim and Namsos, the UK AAIB expert points out a coincident peak on the VHF2 parameter (radio no. 2) and explains that these two parameters are quite close in the data frame layout. It is therefore, according to the UK AAIB, likely that this is a single bit of the data stream (data dropouts/minor corruptions). This is a well-known and frequent phenomenon with this type of flight recorders, and is not considered to have any connection to interference from mobile phones.

Flight Data Recorder graphs from the previous flight (Trondheim to Namsos). The sudden peak on the performance graph for engine number two (E2TORQ) and the coincident peak on the radio no. 2 (VHF2) are circled in.

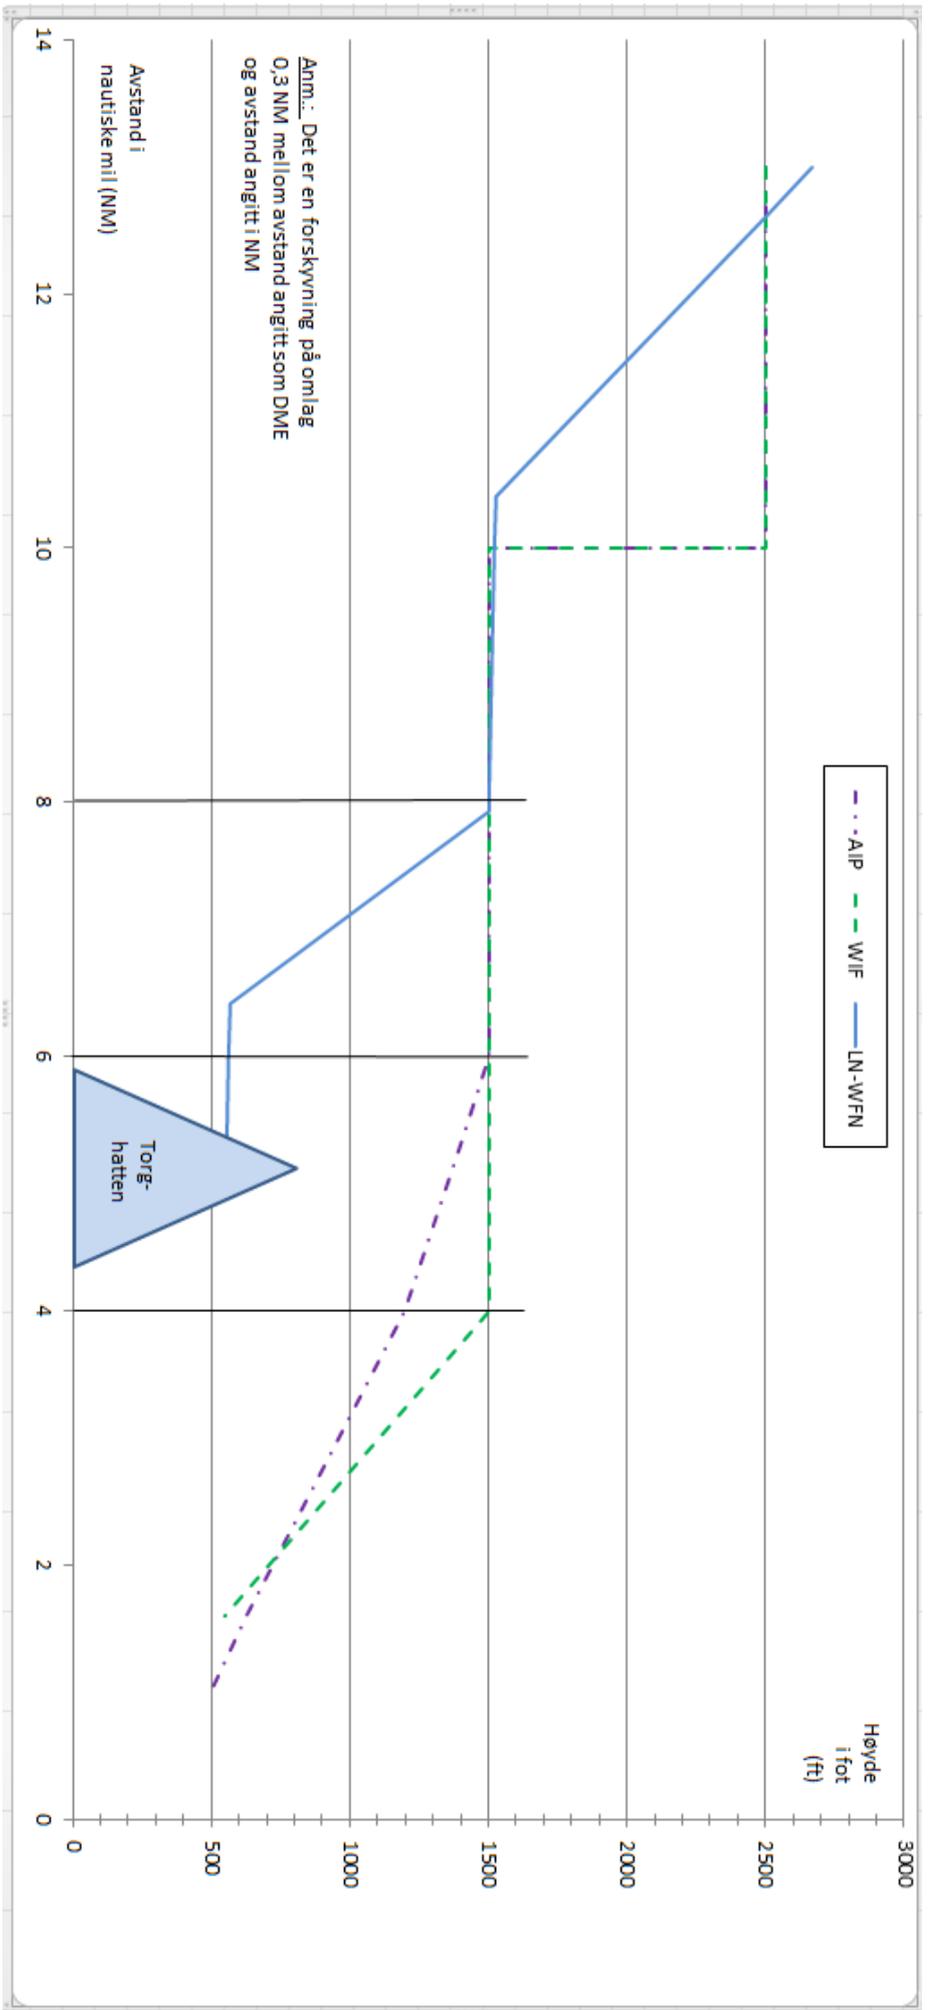
Based on flight recorder data, and our own calculations, the SHT has prepared a new sketch showing the approach in the vertical plane. This provides a simplified presentation of the altitudes and distances LN-WFN had to the runway during its approach, seen in relation to the two approach procedures mentioned in the previous paragraph (see Appendix D).

Schematic presentation of the approach to Brønnøysund Airport – seen in the vertical plane. The lines marked AIP and WIF shows the AIP Norway and the Widerøe step-down – procedures, respectively. The graph for LN-WFN: The distances with corresponding altitudes are based on measurements taken from the FDR-graph (Appendix B), together with factual information in Report 1989/04. Each coordinate in the graph has subsequently been calculated and connected with straight lines.

Note: Due to the VOR/DME location on the airport there is a difference of about 0.3 NM between “DME” and “NM” distances.
