PB91-910401
NTSB/AAR-91/01

AIRCRAFT ACCIDENT REPORT

GRAND CANYON AIRLINES
FLIGHT CANYON 5
DE HAVILLAND TWIN OTTER,
DHC-6-300, N75GC
GRAND CANYON NATIONAL PARK AIRPORT
TUSAYAN, ARIZONA
SEPTEMBER 27, 1989

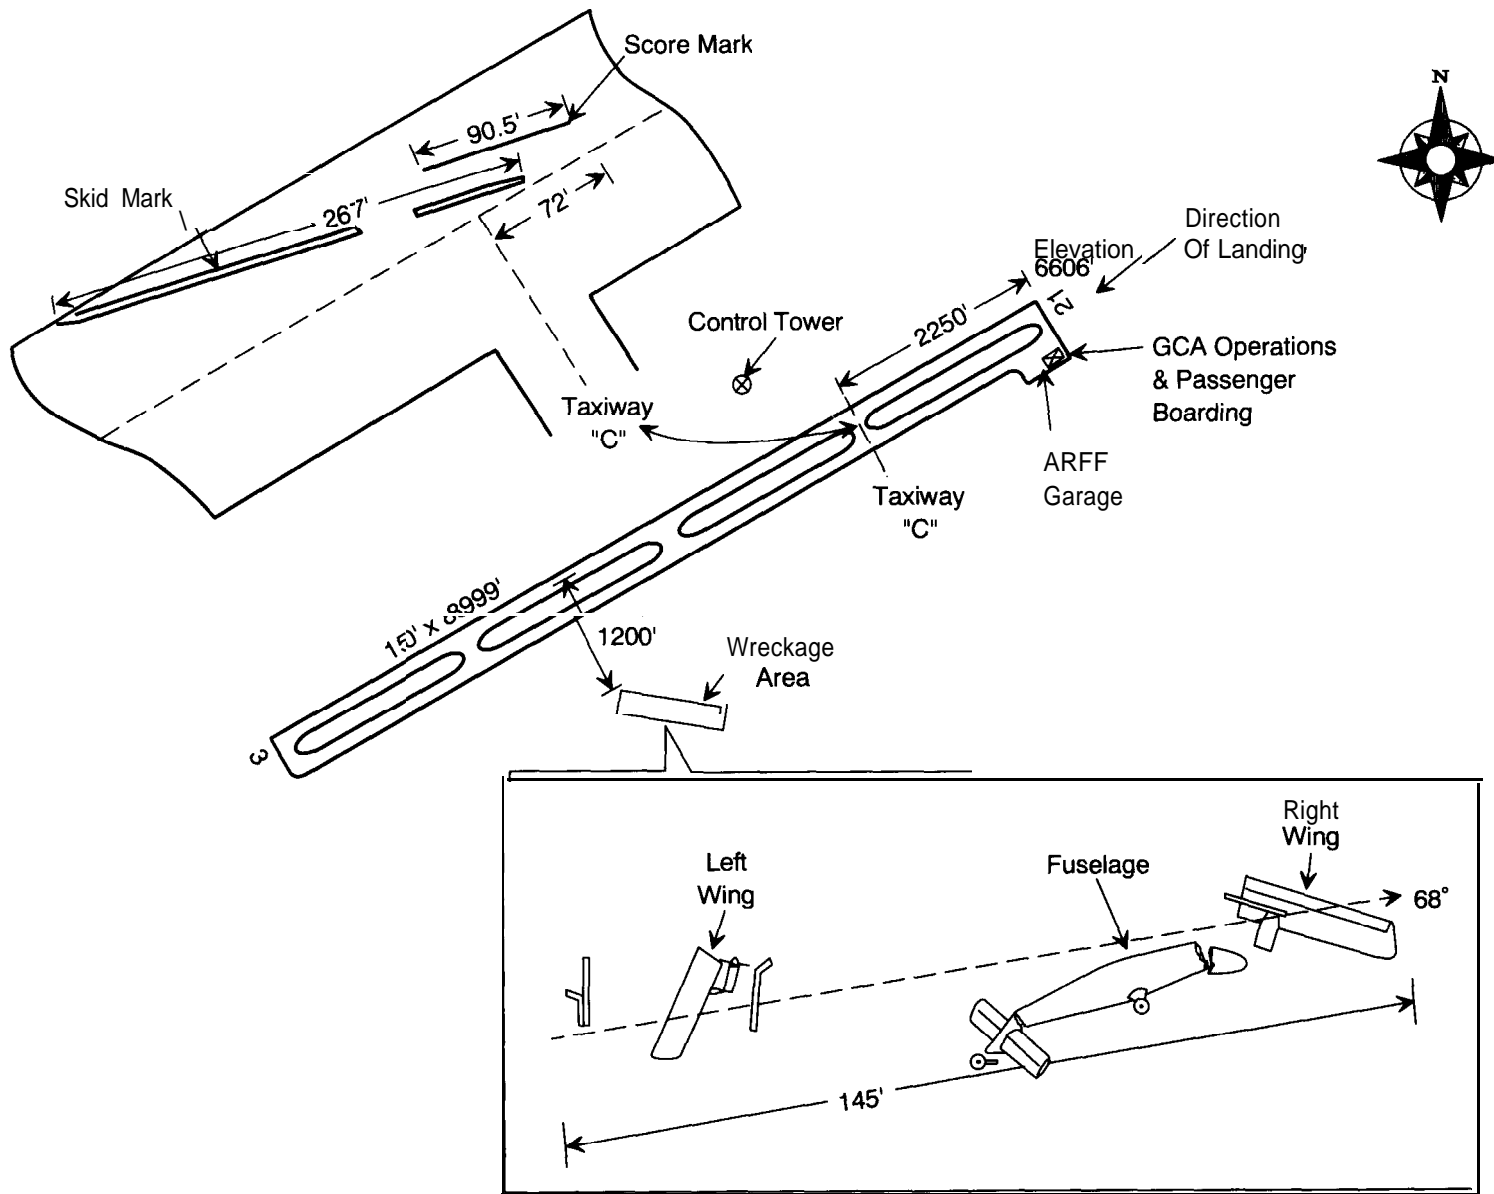
Figure 1. -- Wreckage orientation and skid/score marks on runway.

A thin scoring mark with metal transfer was found on runway 21. The mark began 72 feet north of the extended centerline of taxiway "C" and 27.75 feet right of the centerline of runway 21. The mark was continuous for 91.4 feet and was 36.7 feet to the right of the runway 21 centerline at its termination point. About 2.25 inches to the right of this score mark were three parallel marks spaced .75 inch apart. These parallel marks began 70.5 feet beyond the start of the score marks and were 8 feet 1 inch long. These three marks were parallel to the score mark.

The investigation found that the tire skid track made by the airplane initially curved slightly to the right, consistent with the right wing down attitude. Further, the right main wheel showed extensive scuffing on the outboard face of the tire. It is therefore believed that the skid mark was caused by the airplane being yawed nose left relative to its direction of travel consistent with the scrape marks on the wing tip.

The three scoring/paint transfer marks on the runway and the scraping marks on the rivets on the right wing tip indicate that the aileron/flap hinge had been crushed up into the wing during the wing tip strike. The investigation found that the displacement of the aileron/flap arm up into the wing tip affected the full and free movement of the aileron. When the right wing's outboard aileron/flap hinge arm was crushed into the wing tip and while the wing was in contact with the runway, down aileron travel would have been improbable. Because the control linkages were still intact, right wing up, aileron travel may have been possible after the wing was clear of the runway. The range of up or down aileron travel, relative to normal travel, could not be determined because of the postaccident condition of the aileron and aileron control system. The extent of aileron control loss and interference with control wheel movement could not be determined. The Safety Board considers it likely that the flightcrew experienced at least some degree of difficulty with aileron control during the attempted go-around. The Safety Board could find no evidence that rudder or elevator control were in any way hampered.
