Bureau of Air Safety Investigation

**MU-2 ACCIDENT INVESTIGATION**  
and  
**RESEARCH REPORT**

**VH-BBA near Leonora WA, 16 December 1988**  
**VH-MUA at Meekatharra WA, 26 January 1990**

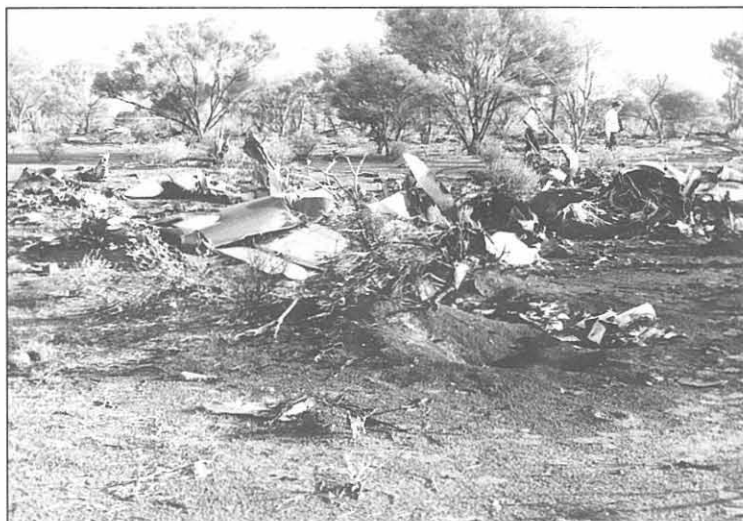
### 1.3 Damage to Aircraft

The aircraft was destroyed by impact forces and the subsequent fire.

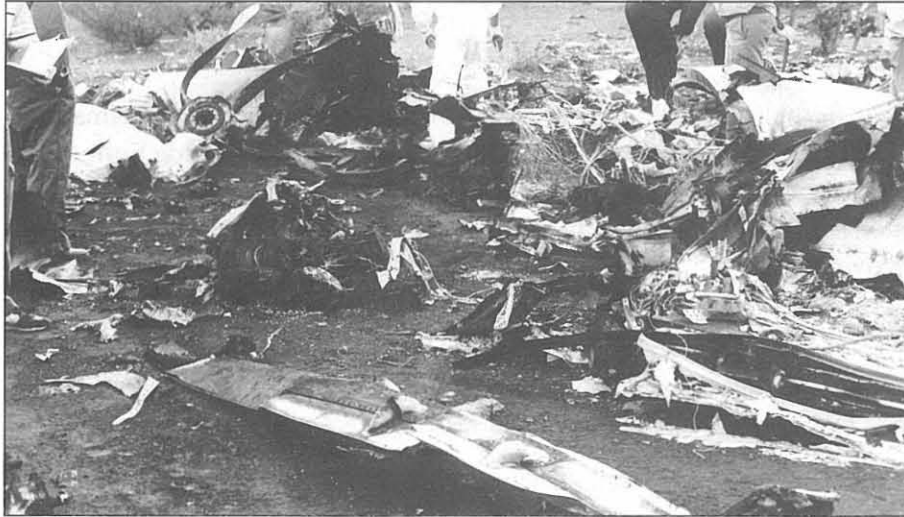
Wreckage with control surface in foreground and a propeller assembly in top left.

All aircraft extremities were identified as well as the control surfaces, trim tabs, doors and windows, suggesting that the aircraft did not suffer an in-flight break-up or control surface separation.

An intense, post-impact fire was confined mainly to the right side and had consumed most of the right wing and fuselage. The fire was fed by fuel from the ruptured fuel tanks.

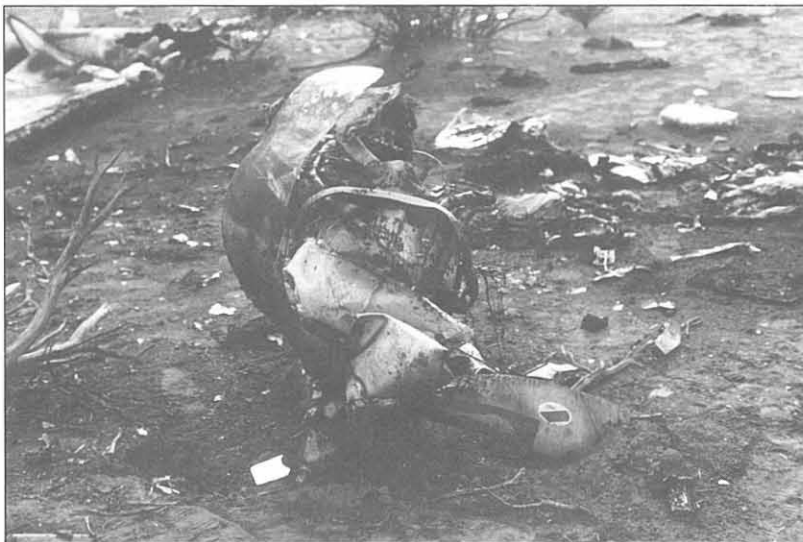
Propeller assembly

The propellers had both suffered extensive damage to their blades and mechanisms consistent with high rotational speed at impact.

An examination revealed that the engines and the propellers were fully serviceable and were operating at impact. The equivalent damage in both engines was matched by tachometer readings of about

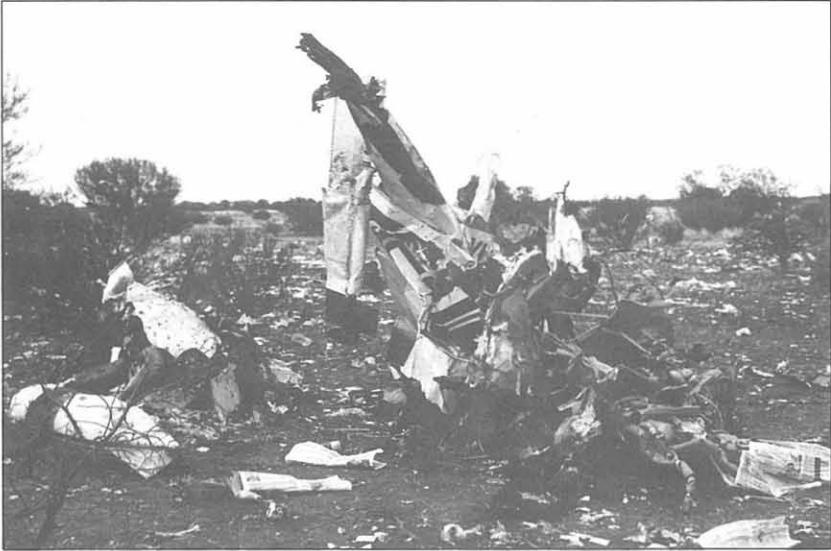
1.3 Damage to Aircraft

The aircraft was destroyed by impact forces and post-impact fire.

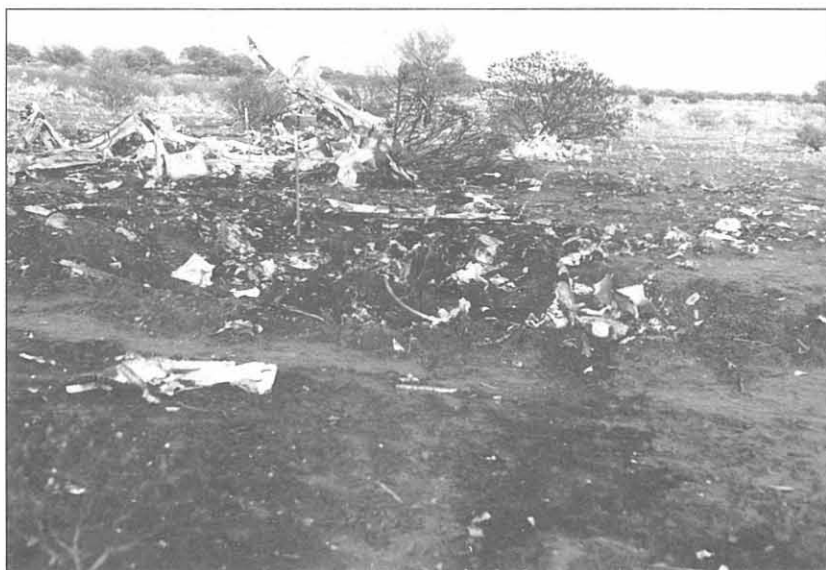
The aircraft impacted the ground in a near-vertical attitude and much of the forward section of the aircraft had penetrated the ground to a depth approaching 1 m. The vertical attitude was confirmed by forward-to-aft compression buckling of the wings along with the impact damage to the left tip tank. A lot of soil had been displaced by the impact and a crater approximating the head-on profile of the aircraft was created. Most of the wreckage lay in the crater and its immediate vicinity. At either end of the crater were imprints of both tip tanks and the imprints indicated left rotation at impact.

Some of the rear fuselage had been torn away from the forward section of the aircraft and was thrown approximately 30 m back along the 310° bearing.

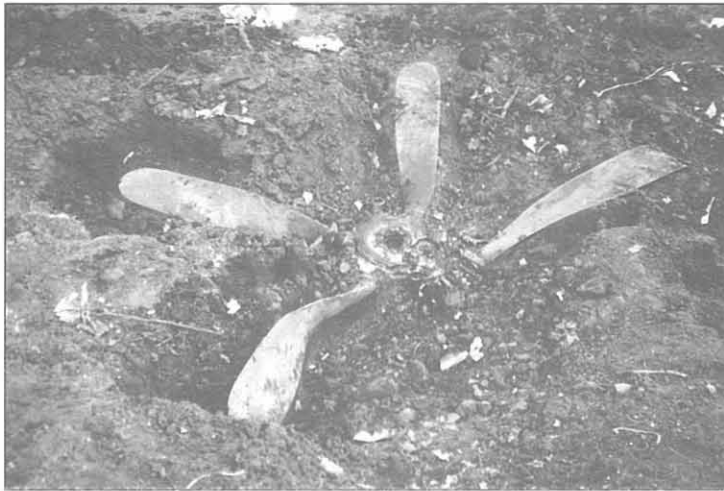
Each propeller had separated from its engine. The propellers were driven almost 1 m into the ground and their blades were detached. Workshop inspection concluded that both propellers were rotating in excess of 800 RPM at nearly identical power settings. At impact, the blade angle of both propellers was at least 29° with power settings approximating flight idle. No pre-existing defects were found in either propeller that would have prevented normal operation.

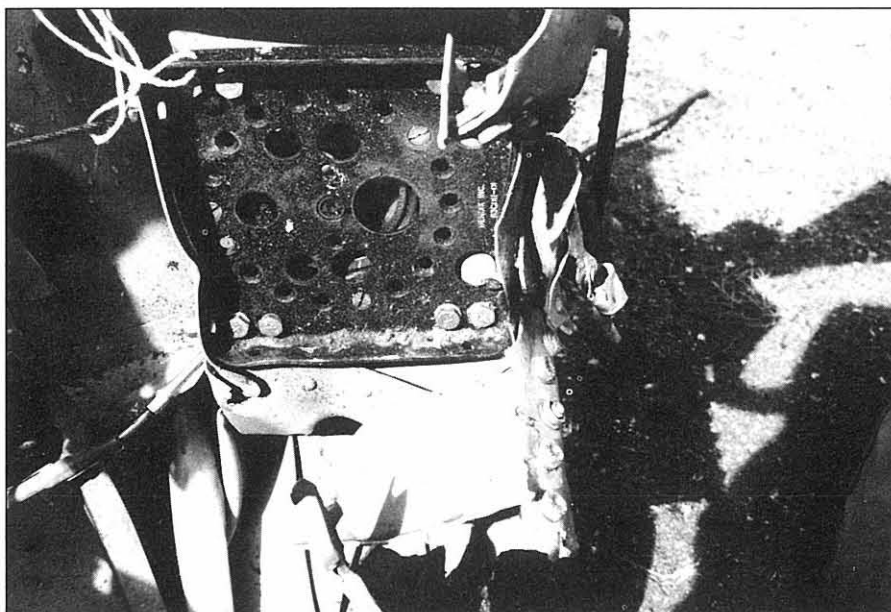
Yaw-damper servo attachment bracket

During the inspection of the wreckage, it was noted that the yaw-damper servo was missing. It was determined that this component was not in the aircraft before the flight left Perth, i.e. it had not become detached during the impact sequence. It was also noted that the rudder servo was electrically disconnected before the flight commenced and the plug had been tied back away from the servo attachment area.

Investigations revealed that the servos had probably been removed from the aircraft prior to its arrival in Australia in July 1988. There was no evidence that they had been refitted to the aircraft prior to the accident flight.

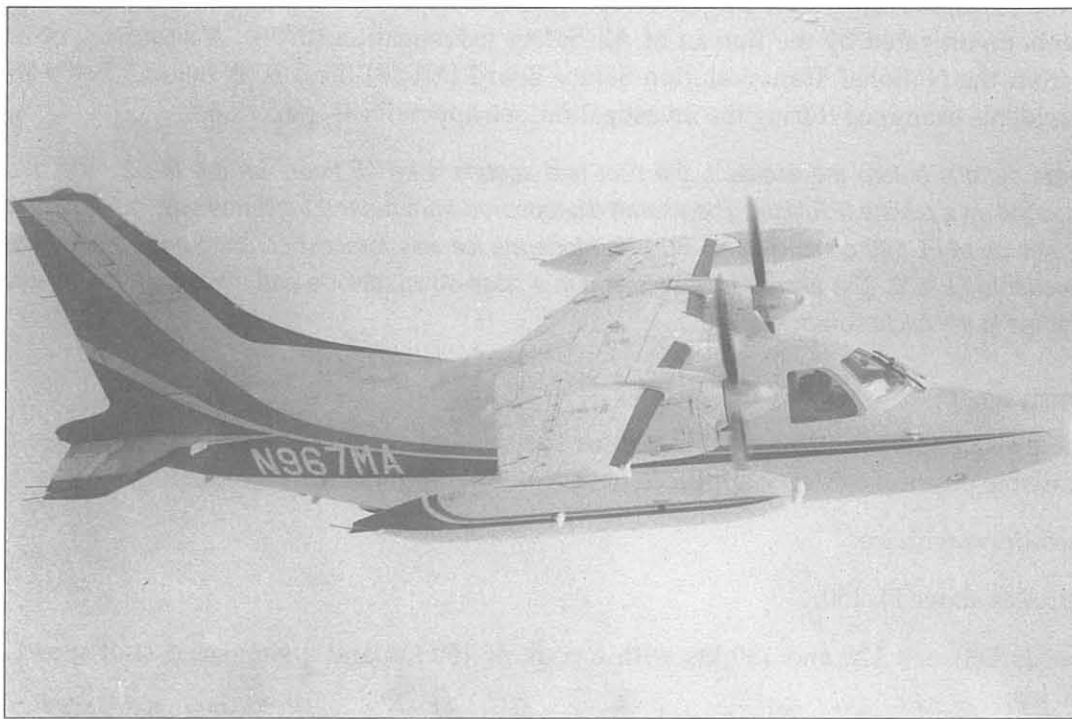
MU-2 aircraft showing commencement of ice accretion on leading surfaces
