AIRCRAFT ACCIDENT REPORT

No. 89-066

**BRITTEN NORMAN BN2A-26
ISLANDER, ZK-EVK**

**NEAR BLUE DUCK GLACIER,
UPPER DART VALLEY**

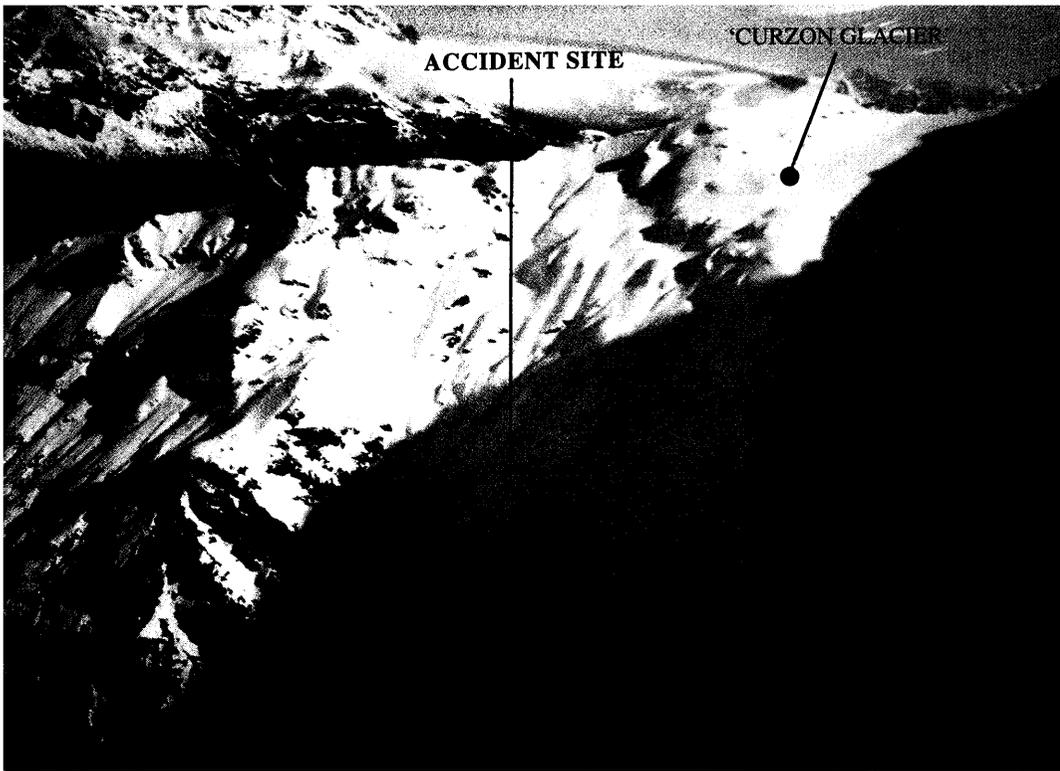
FIG 3. THE ACCIDENT AREA — VIEWED FROM THE EAST

1.12.10 Due to the nature of the terrain, surveys of the impact area were carried out by helicopter. Aerial inspection indicated that ZK-EVK had struck the slope between 5300 and 5400 feet amsl on a south-westerly to southerly heading. The impact crater suggested that the aircraft was banked steeply to the left, possibly beyond the vertical, when it struck the snow. It was probable that the severe forces resulted in a cartwheel sequence involving separation of the outboard portion of the left wing, deformation of the right wing and complete separation of the whole wing assembly from the fuselage at the time of the initial impact. Extensive disruption to the cabin area of the fuselage was likely to have occurred during the impact sequence.

1.12.11 As a consequence of the steepness of the mountainside, the angle at which the aircraft had struck the slope and its momentum, both engines together with their propeller assemblies had torn from their mountings and lofted over the slope to fall into a rocky gully, impacting about 300 m to the south and some 500 feet below the initial impact area.
