ACCIDENT INVESTIGATION REPORT
BUREAU OF AIR SAFETY INVESTIGATION

BASI REPORT B/901/1047

Beech King Air E90 VH-LFH
Wondai, Queensland
26 July 1990

Report B/901/1047

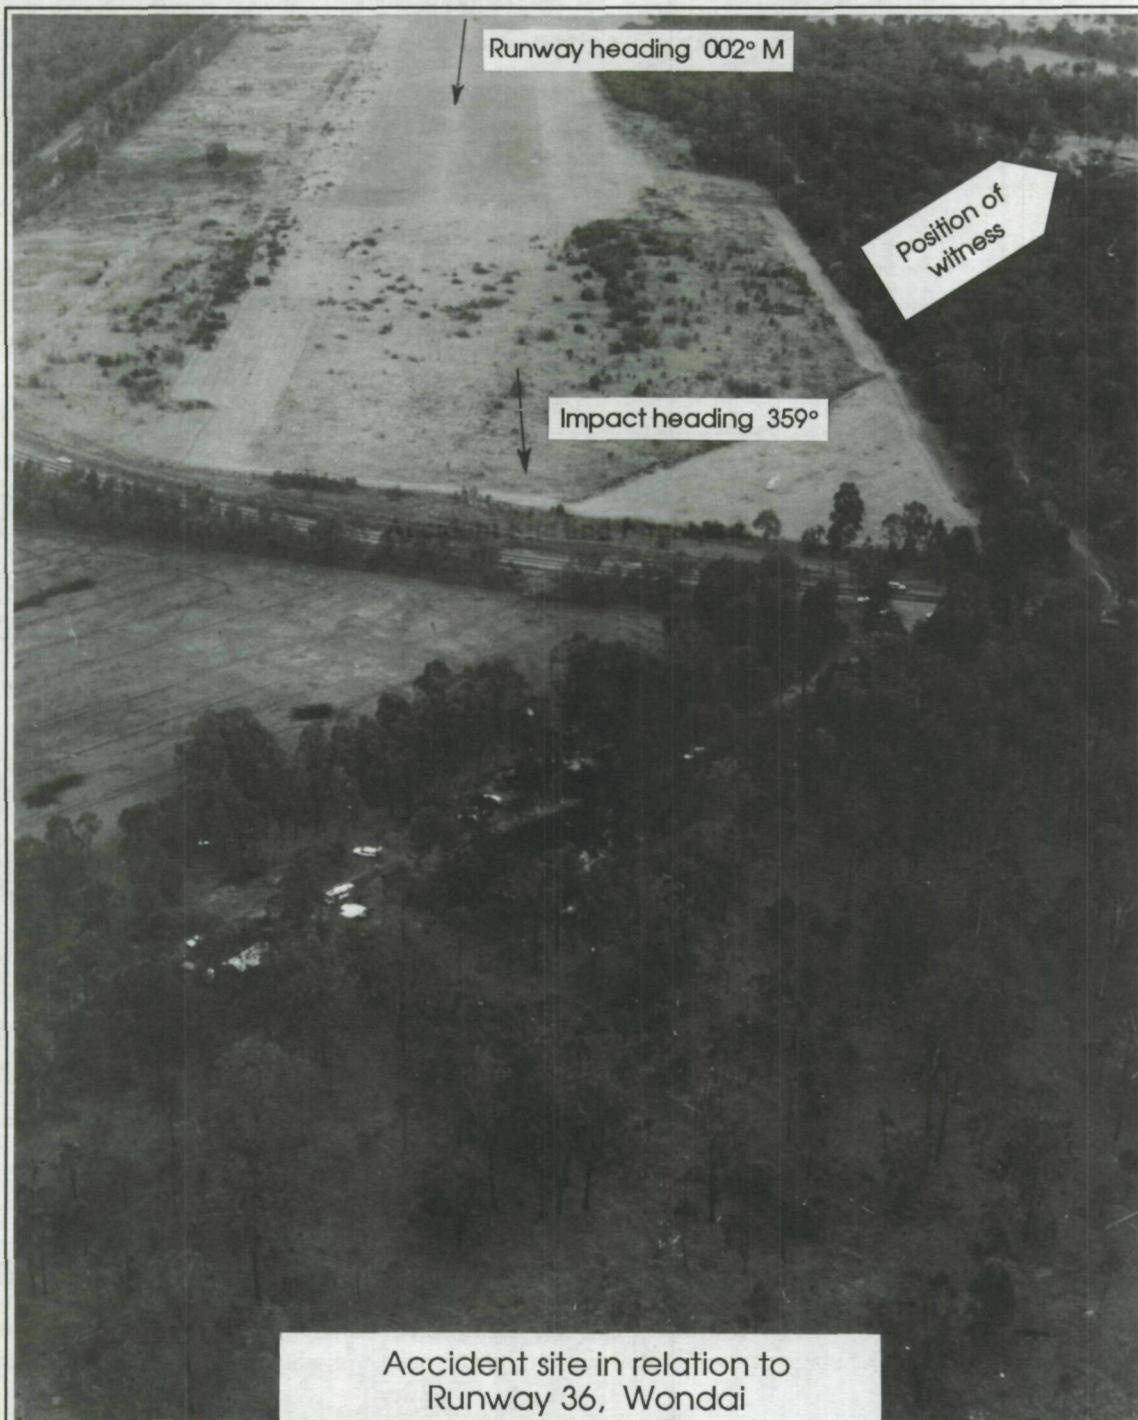
The aircraft struck a line of small trees 600 metres from the end of the runway and about 20 metres left of the extended centreline, on a heading of 359 degrees magnetic, while in a very shallow descent. The aircraft was in a wings level attitude at this time and in balanced flight. The right propeller contacted the ground 40 metres beyond the tree line followed by the belly of the aircraft and then the left propeller. Immediately after this, as the aircraft skidded along the ground, it encountered numerous 20 metre high trees. This caused the break-up of the airframe and was accompanied by a fuel-fed fire which further destroyed much of the aircraft, including the cockpit and cabin area. The distance from the initial point of impact with the small trees to the end of the wreckage trail was 217 metres.

The damage to the aircraft from impact forces and fire was extreme. Both propellers had separated from the engines at the shaft and both engines were torn from the wings. The wings had separated from the fuselage, as had the tailplane and rudder. The fuselage had broken at the wing trailing edge position and, apart from an area around and aft of the cabin door in the rear fuselage, was destroyed by the fire.

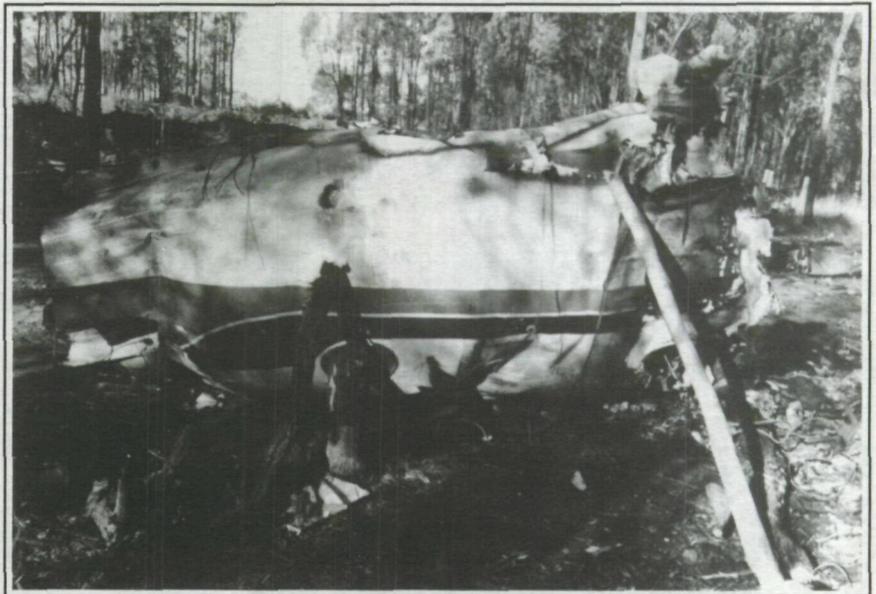
View looking back along flight path
