No: 10/91

Ref: EW/G91/07/25

Aircraft Type and Registration: Piper PA-31 Navajo, G-LYDD

Location: Lydd Airport, Kent

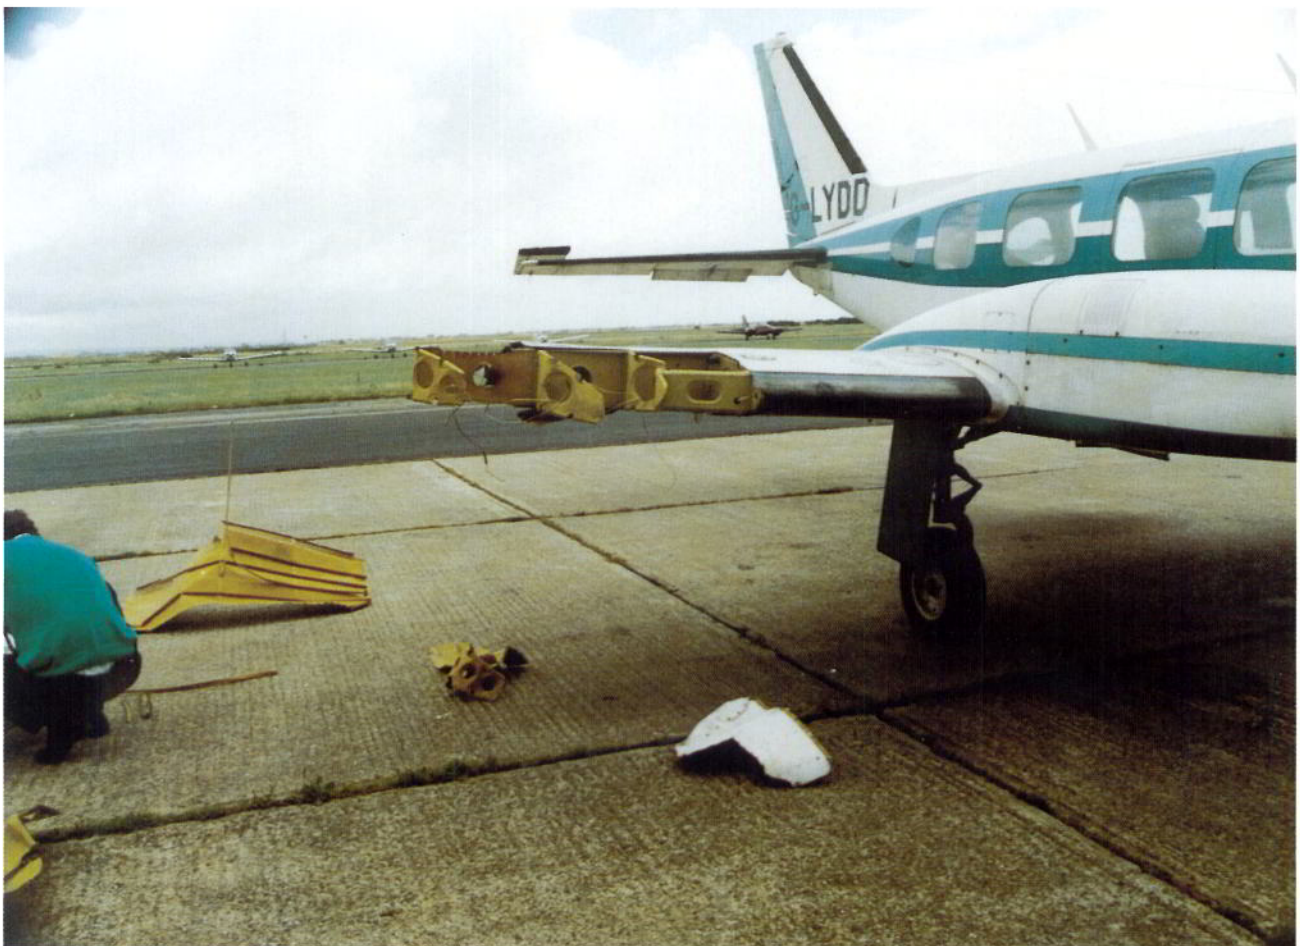
Examination of the aircraft revealed that the outboard 5 ft of the right wing, including the aileron, had explosively detached. The extent of the damage can be seen in the accompanying photograph. The fuel tanks, which were in that section of the wing which had not detached, had not been damaged in

the explosion, and there was no fire damage to the structure, apart from some 'sooting'. The focus of the explosion was determined by examination of the distortion that had occurred to the various ribs and panels; this was an area bounded by the rib at the outboard end of the outboard tank bay, the next rib towards the tip, the main spar and the rear spar. There was no 'pitting' or similar impact damage that would have suggested an exploding object within the wing, indicating that a fuel vapour detonation had occurred. The wing outboard of the tanks contains very little equipment, electrical or otherwise. The wires feeding the navigation lights pass through the area but the crew had pulled the associated circuit breaker before the attempted flight since the navigation lights were known to be unserviceable. The aircraft was not equipped with strobe lights. The one item of electrical apparatus located in the affected zone was the aileron trim position indicator transmitter. Some sooting was present on the surface of this unit and its two associated electrical wires were badly burned. One wire had pulled off its connector and although it was initially considered that it may have fallen off prior to the accident and struck an arc on the wing panel below, metallurgical examination showed that it was a tensile overload failure and therefore probably occurred during the explosion. No evidence of arcing was visible on the wing structure, but the possibility of this having occurred as a result of 'chaffing' at some point along the length of the wiring could not be discounted. The transmitter itself was discounted as a potential ignition source since the internal mechanism of this unit, a rheostat, was found to be in good condition with no evidence of arcing between the resistive element and the wiper-arm.

PA-31 G-LYDD
View showing damage to right wing

1. The CAA issue a directive, applicable to Piper PA-31 aircraft, requiring inspection of the fuel tank check valve unions for security.
2. The CAA conduct a review of the sealing characteristics of fuel bladder type tanks in Piper PA-31 aircraft, and other applicable types, with a view towards assessing the extent of any age-induced porosity/leakage problems and the need for remedial airworthiness action.
