**Department of Transport**  
**Bureau of Air Safety Investigation**

INVESTIGATION REPORT  
9301743

**Piper PA31-350 Chieftain VH-NDU**  
**Young, NSW**  
**11 June 1993**

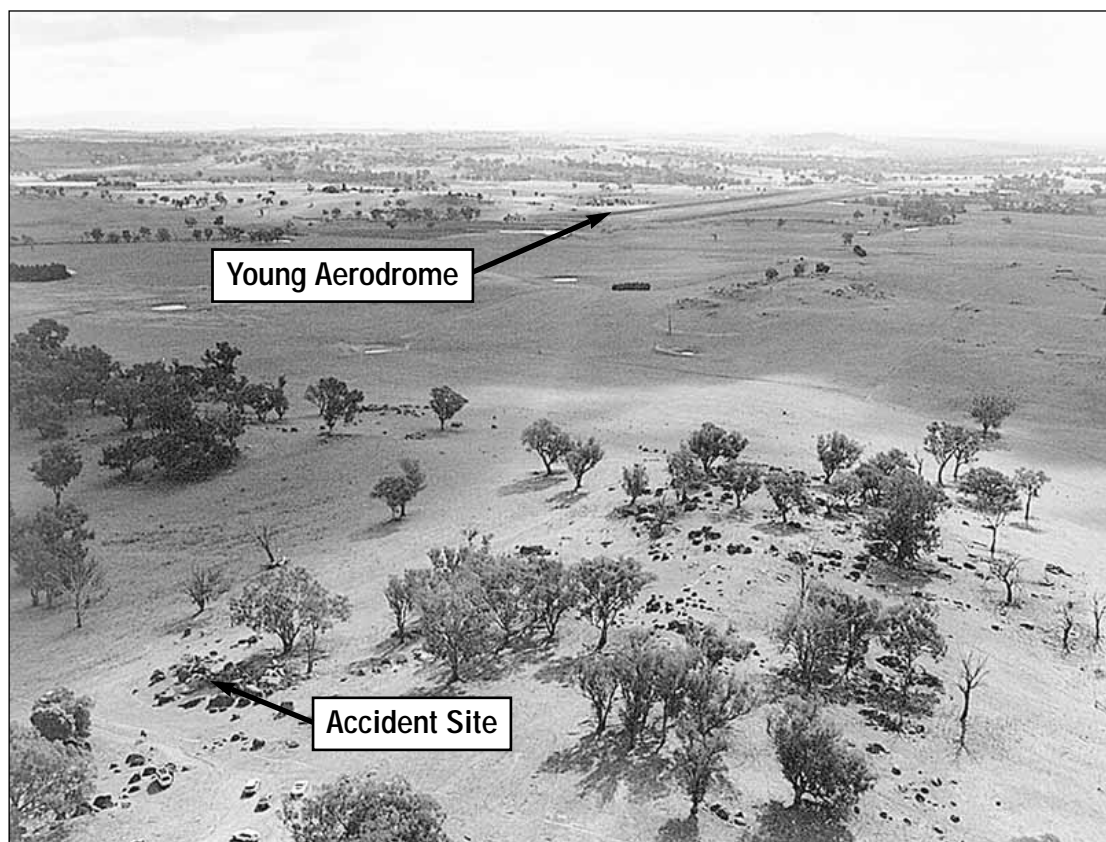
**Figure 5** Aerial view (towards NNW) of accident site in relation to Young Aerodrome

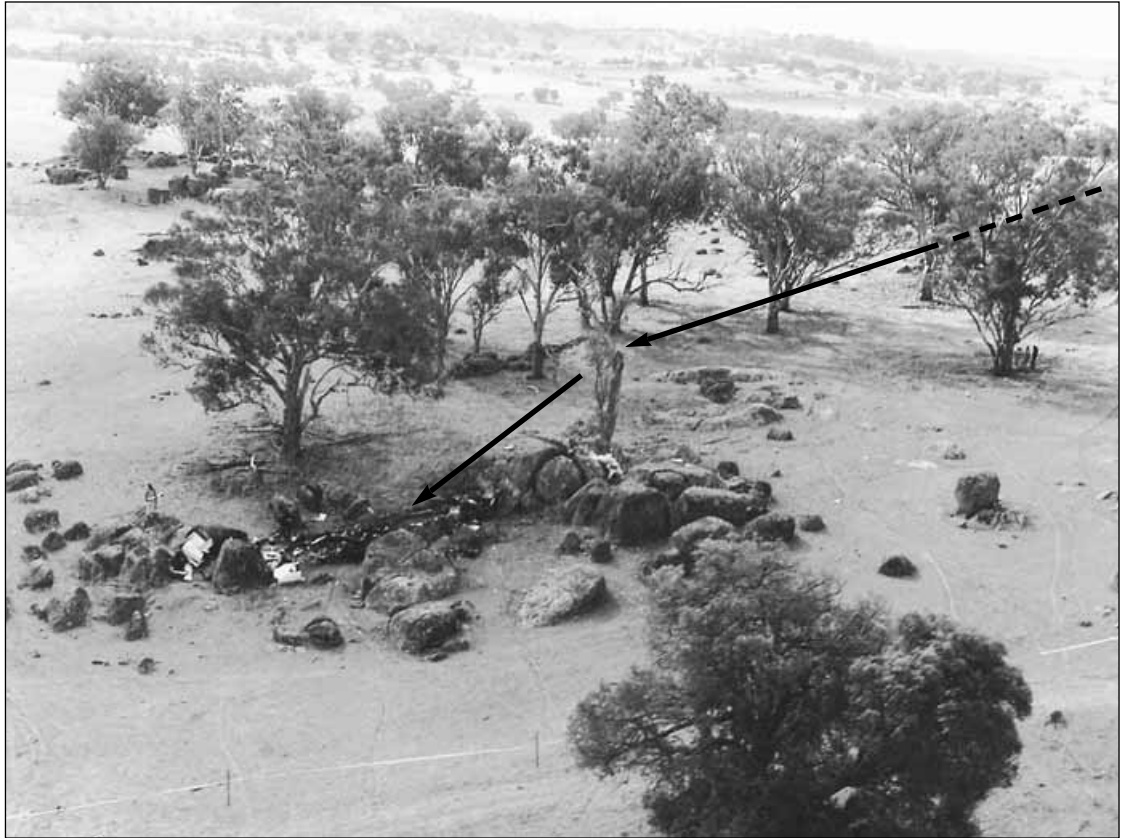
The accident site was located on 'Golambo', a property off Milly Milly Lane, Young, NSW. The main body of wreckage lay within a rocky outcrop on a hill, at a height of 209 ft above the elevation of Young aerodrome, bearing 161° from the threshold of runway 01, at a distance of 2,215 m (see figure 5). The height of the initial impact with trees was 275 ft above the aerodrome elevation. The geographical co-ordinates of the accident site were 34° 15' S, 148° 15' E. The hill was lightly timbered with trees to a height of about 20 m.

**Figure 6** General view (towards NNE) of accident site showing direction of final flight path

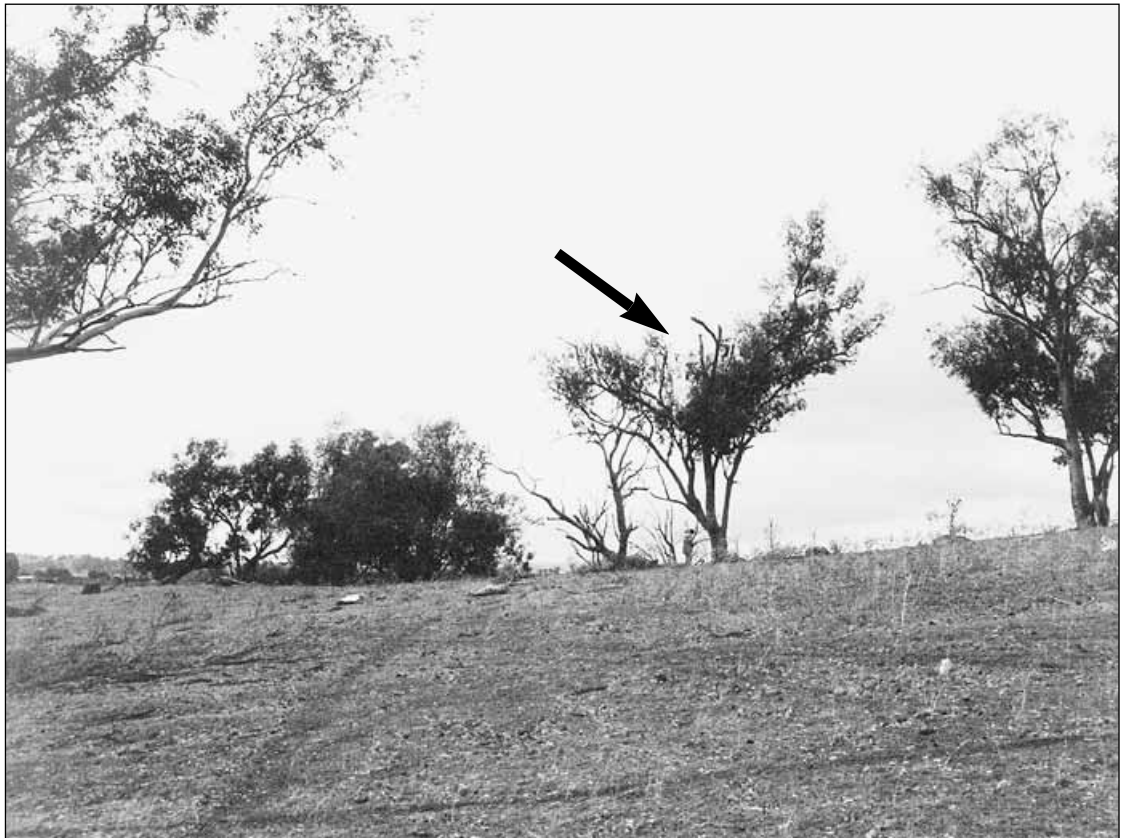
**Figure 7** Photograph of the first tree struck by the aircraft looking back along the flight path

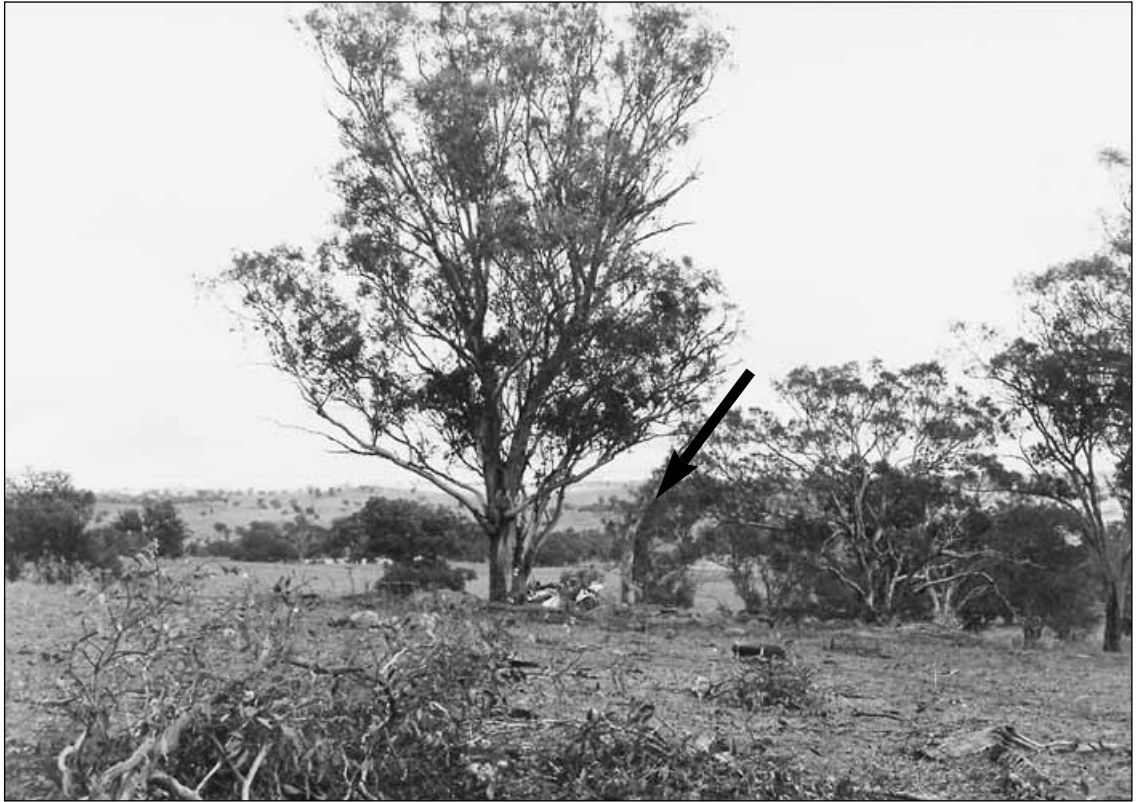
**Figure 8** Photograph, looking along the flight path, from the first tree struck by the aircraft. The aircraft brushed against the tree (centre) before colliding with a third tree (arrowed).

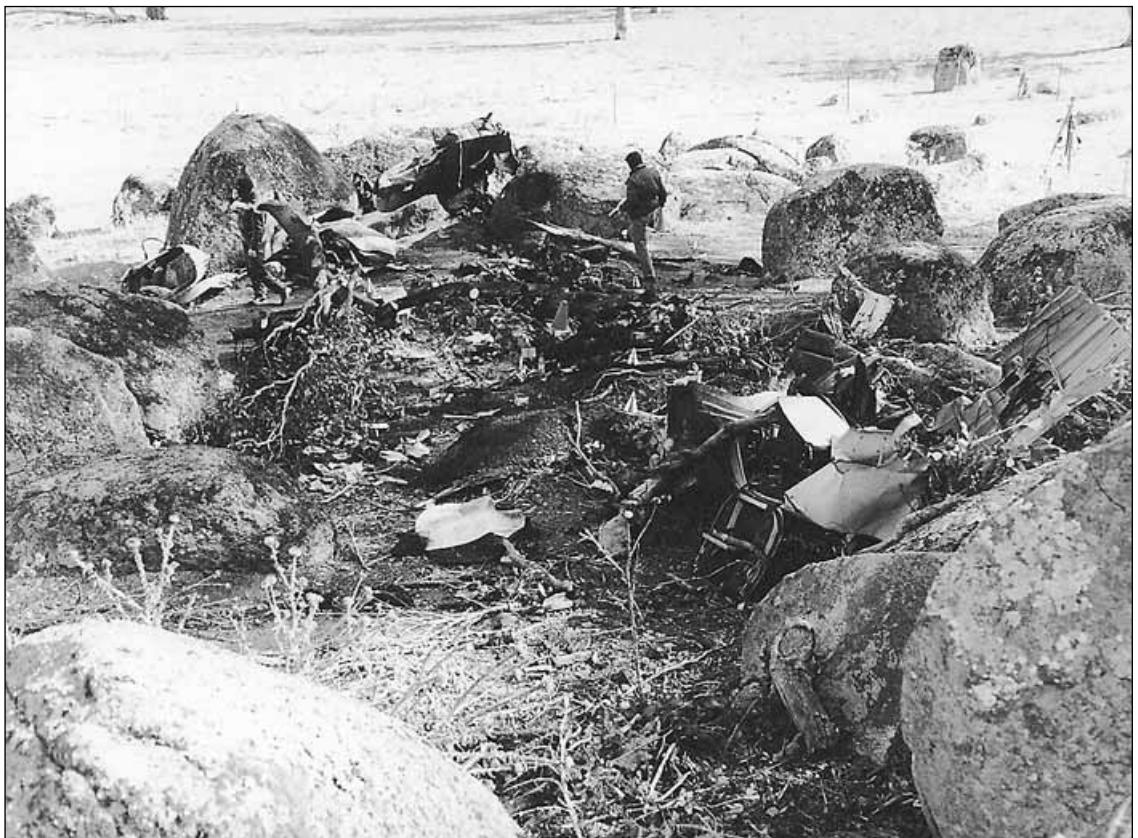
**Figure 9** The forward section of the aircraft was totally destroyed by impact forces and fire.

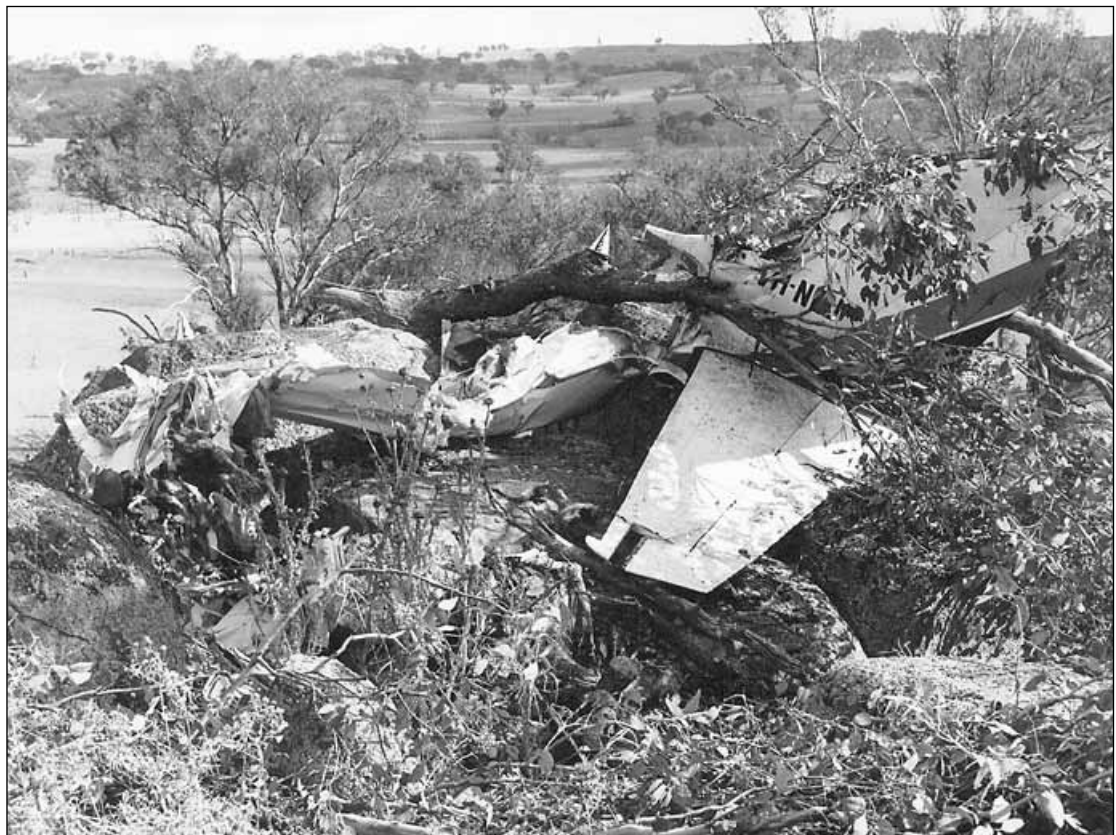
All aircraft extremities and control surfaces were accounted for on the site. The aircraft damage was consistent with the application of excessive loads during the impact sequence, and the

**Figure 10** The tail section of the aircraft was torn from the forward section by impact forces.

effects of the subsequent fire. No pre-existing defects likely to have contributed to the aircraft break-up were found.

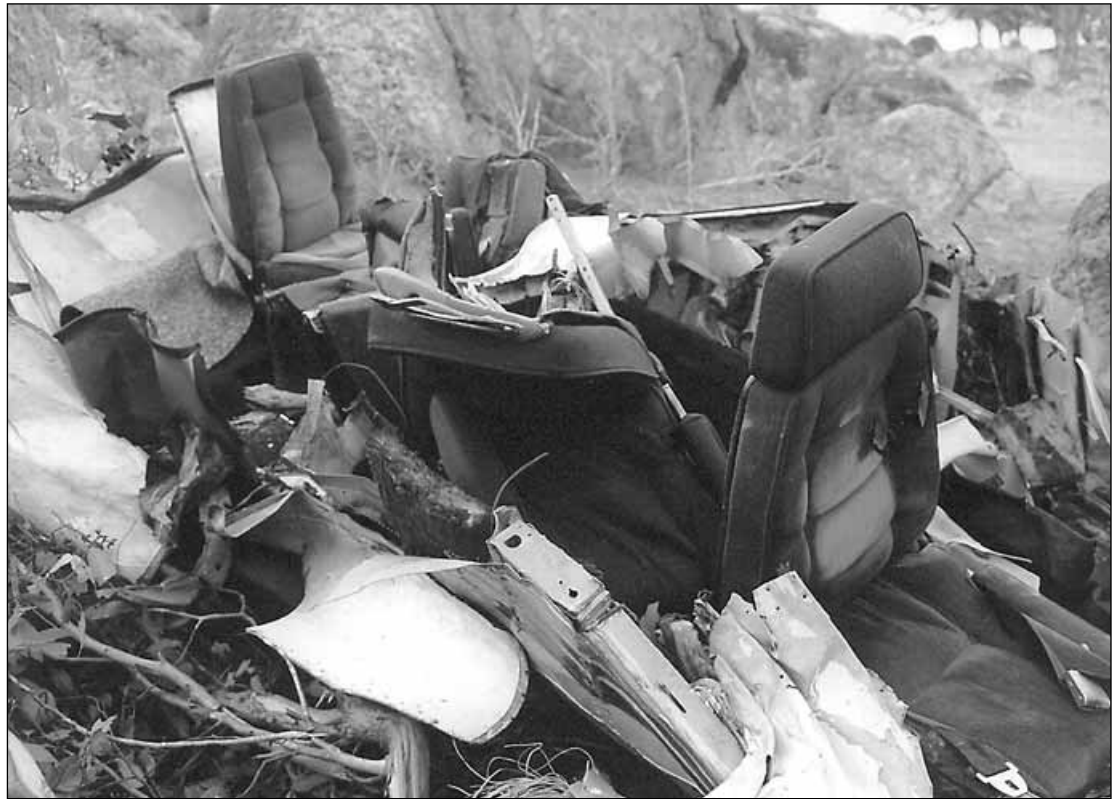
**Figure 11** Photograph showing the seat (right) occupied by the sole passenger who survived the initial impact.

All occupants of the aircraft had suffered injuries consistent with high impact forces, aircraft breakup, and consequent fire. One passenger seated in the detached rear section of the cabin (see figure 11) survived the impact but was unconscious when found by rescuers. Although restrained by a lap type seatbelt she had suffered severe head injuries and was severely burnt in the ensuing fire before being rescued, dying later in hospital. All the other occupants had been located in the forward section of the cabin and were incinerated in the post crash fire, which began during the impact sequence. The speed and intensity of the fire, and the impact injuries suffered by the occupants, prevented any possibility of escape from the aircraft. The circumstances of the impact dynamics and subsequent fire were such that the accident was considered to have been non-survivable. As a result, the investigation of the survival aspects of the accident was limited to the notification and response of the emergency services.
