AVIATION OCCURRENCE REPORT

FLIGHT CONTROL FAILURE

**PACIFIC COASTAL AIRLINES
DE HAVILLAND DHC-6-100 TWIN OTTER C-FDMR
PORT HARDY, BRITISH COLUMBIA 56 nm N
17 SEPTEMBER 1994**

REPORT NUMBER A94P0215

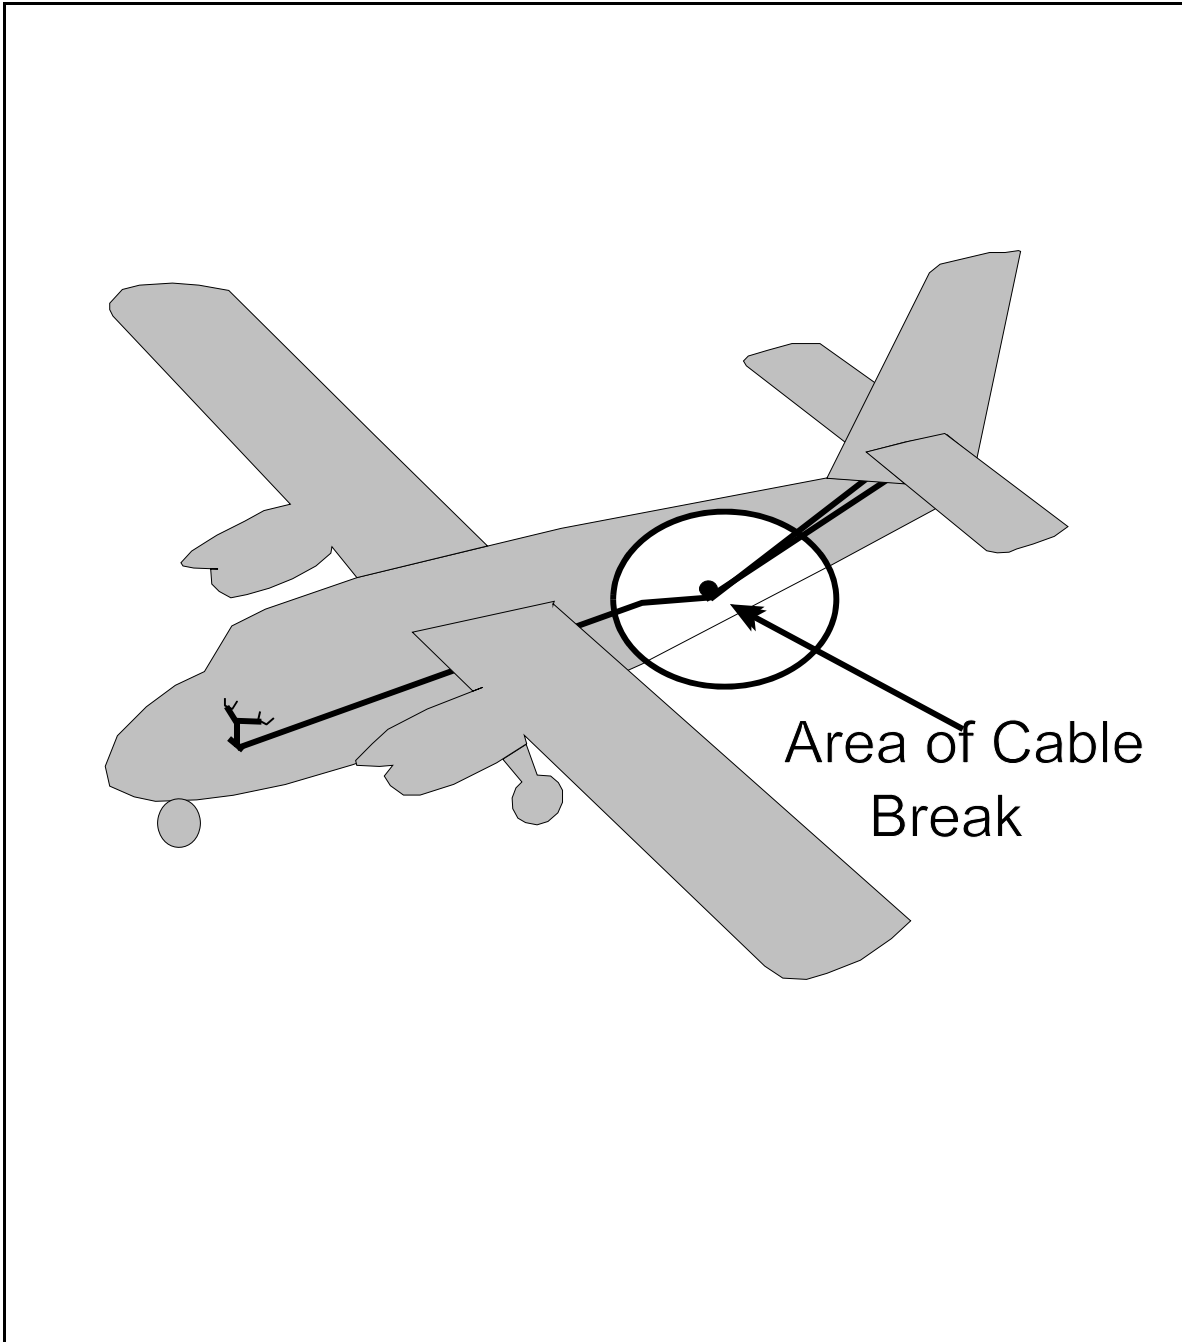
Appendix A - Location of Cable Failure

The broken cable was the down elevator cable (part number C6CF1146-1) which runs from station 426.75 to the elevator quadrant. The break occurred at the station 376 pulley cluster, and the frayed ends of the broken cable had chafed the paint from the pulley bracket before the cable broke.

The elevator cable failed as a result of gradual deterioration due to corrosion in an area which was in contact with the lowermost pulley of a pulley cluster. As the corrosion progressed, individual wires and strands started failing and the wire ends caused paint removal in the surrounding bracket.
