AIRCRAFT ACCIDENT REPORT

CONTROLLED COLLISION WITH TERRAIN
TRANSPORTES AEREOS EJECUTIVOS, S.A. (TAESA)
LEARJET 25D, XA-BBA
DULLES INTERNATIONAL AIRPORT
CHANTILLY, VIRGINIA
JUNE 18, 1994

**Adopted: March 7, 1995
Notation 6527**

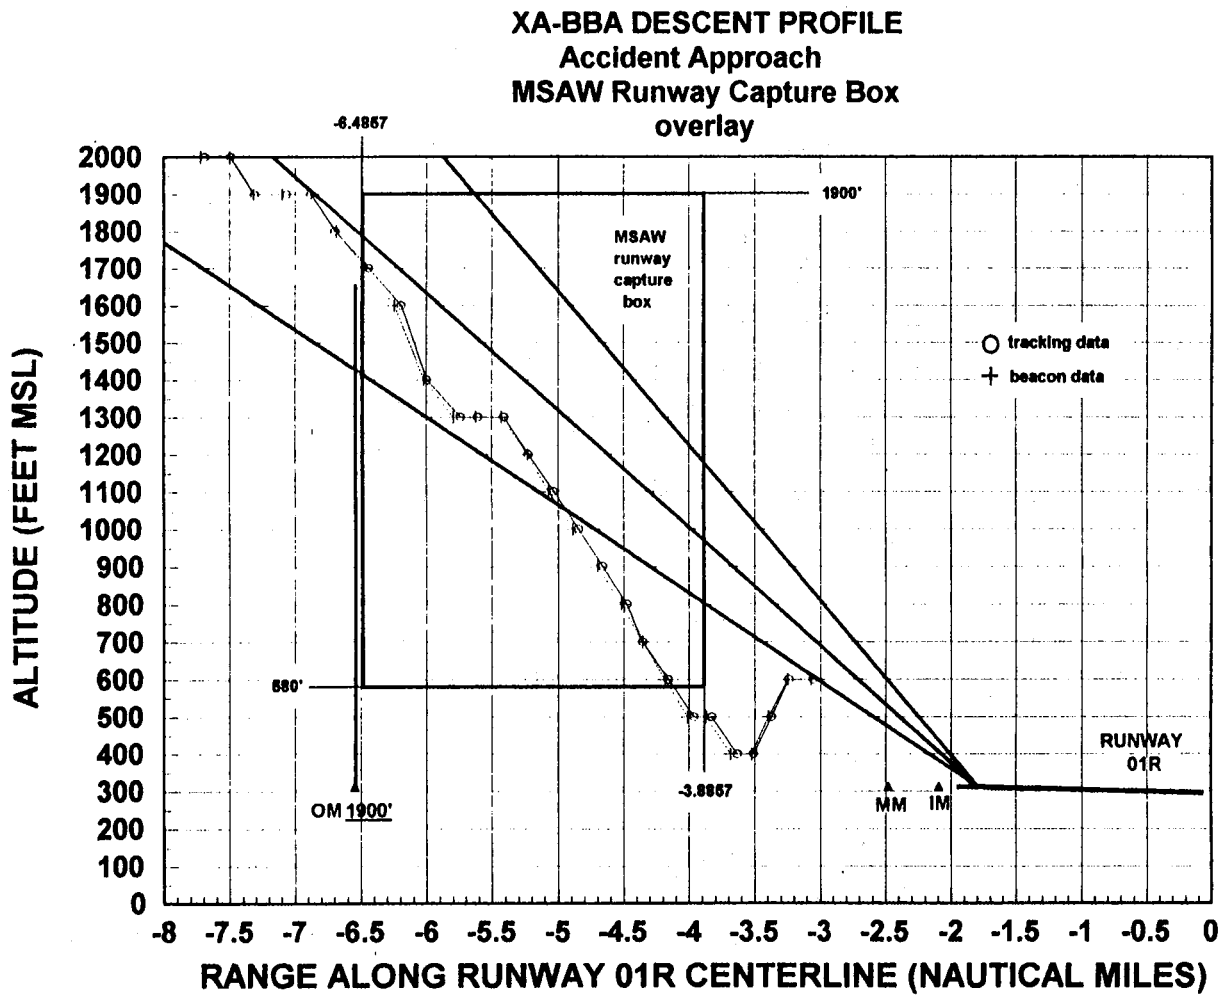
Figure 1.--Airplane descent profile.

There were no primary radar targets found in the vicinity of XA-BBA, and there were no minimum safe altitude warning (MSAW)⁷ alerts during the period of the approaches. A plot of the MSAW site variable parameters and the XA-BBA radar track indicated that XA-BBA had one return below the alarm altitude of the runway 1R capture box in both tracking and beacon data (see figure 1). However, the FAA states in their MSAW system functional specifications, two “current position” hits, or three “predicted position” hits must be received on radar before an alert will activate the aural and visual warnings.

Inspection of the MSAW site variable parameter that defined the runway threshold indicated a discrepancy between the MSAW-defined runway location and the actual threshold location. The prescribed magnetic variation of 10 degrees west was applied to the MSAW-defined threshold coordinates which created a position offset of 700 feet to the northeast from the actual runway 1R threshold. However, when a 7-degrees west variation was applied, a match between the MSAW-defined threshold and the actual runway threshold was established. Furthermore, inspection of the other site variables revealed that a localizer-only minimum descent altitude (MDA) was used to establish the base of the runway capture box (680 feet).

On November 21, 1994, the Safety Board issued Safety Recommendations A-94-186 and A-94-187 to the FAA concerning the MSAW system at IAD and all radar environments using the system, respectively. See appendix D for correspondence concerning these safety recommendations.

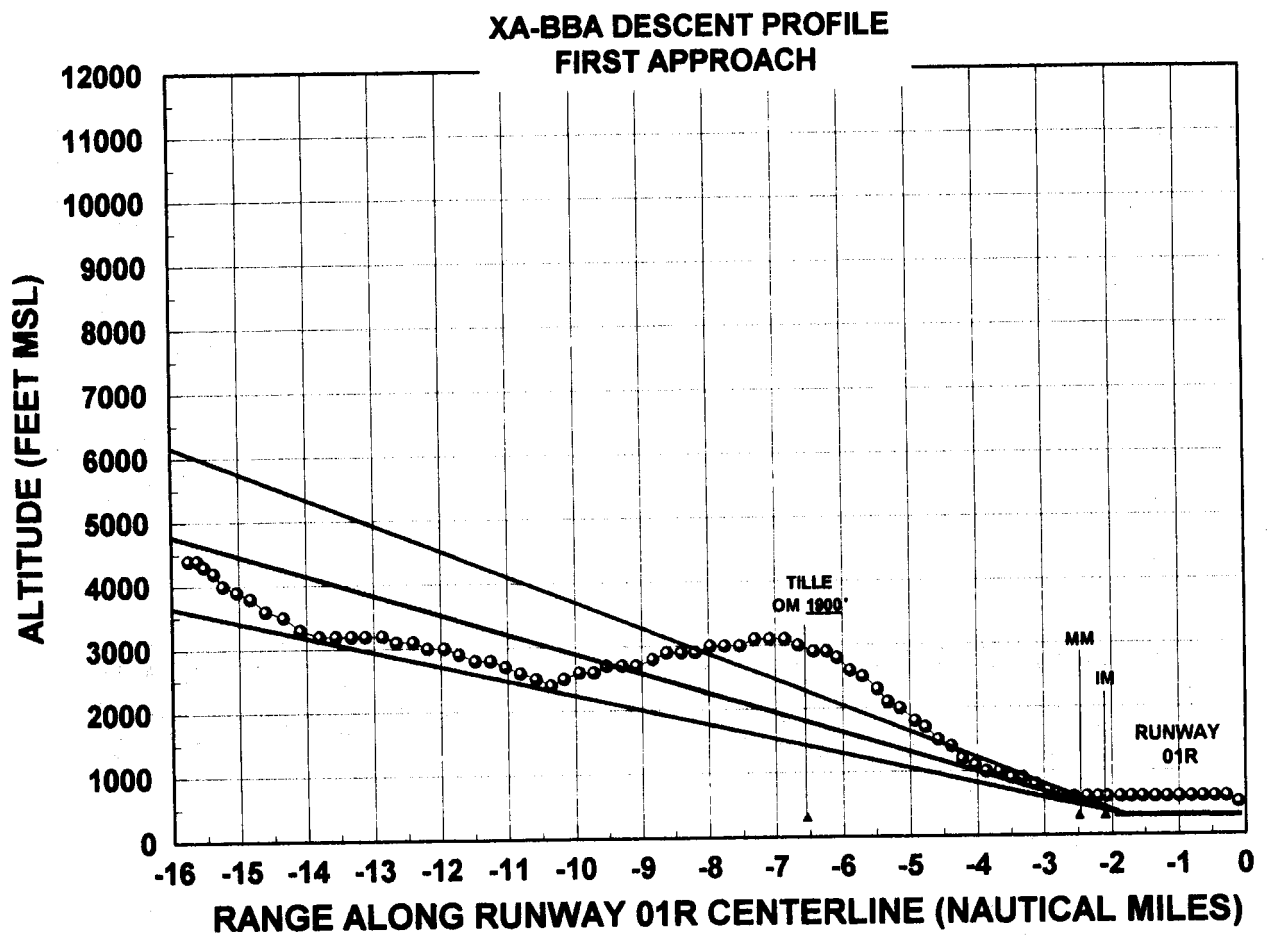
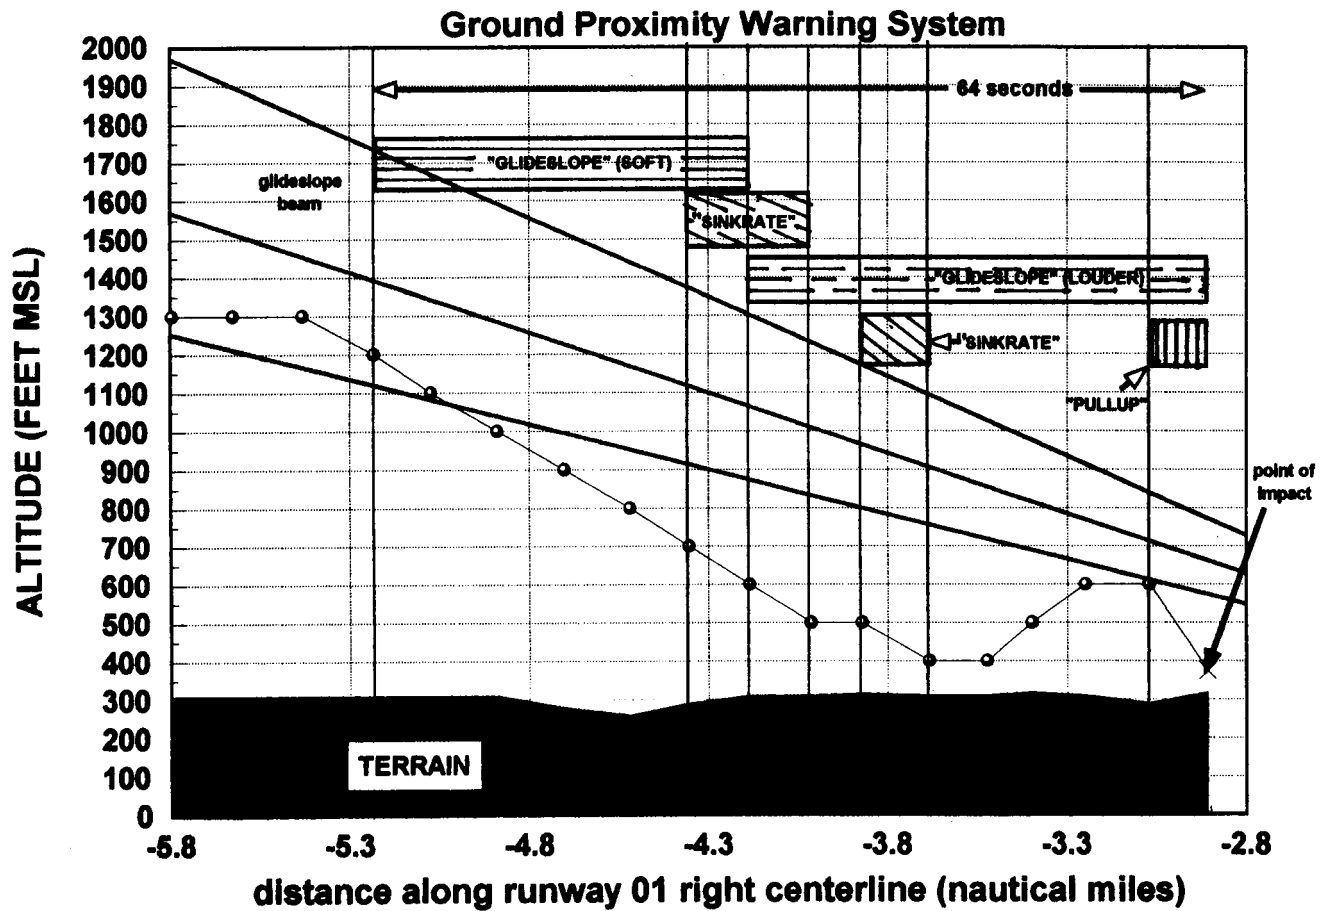
MODE 1 - Excessive Rate of Descent
 - "sink rate"
 - "pull up"

MODE 5 - Descent Below Glideslope
 - "glideslope"

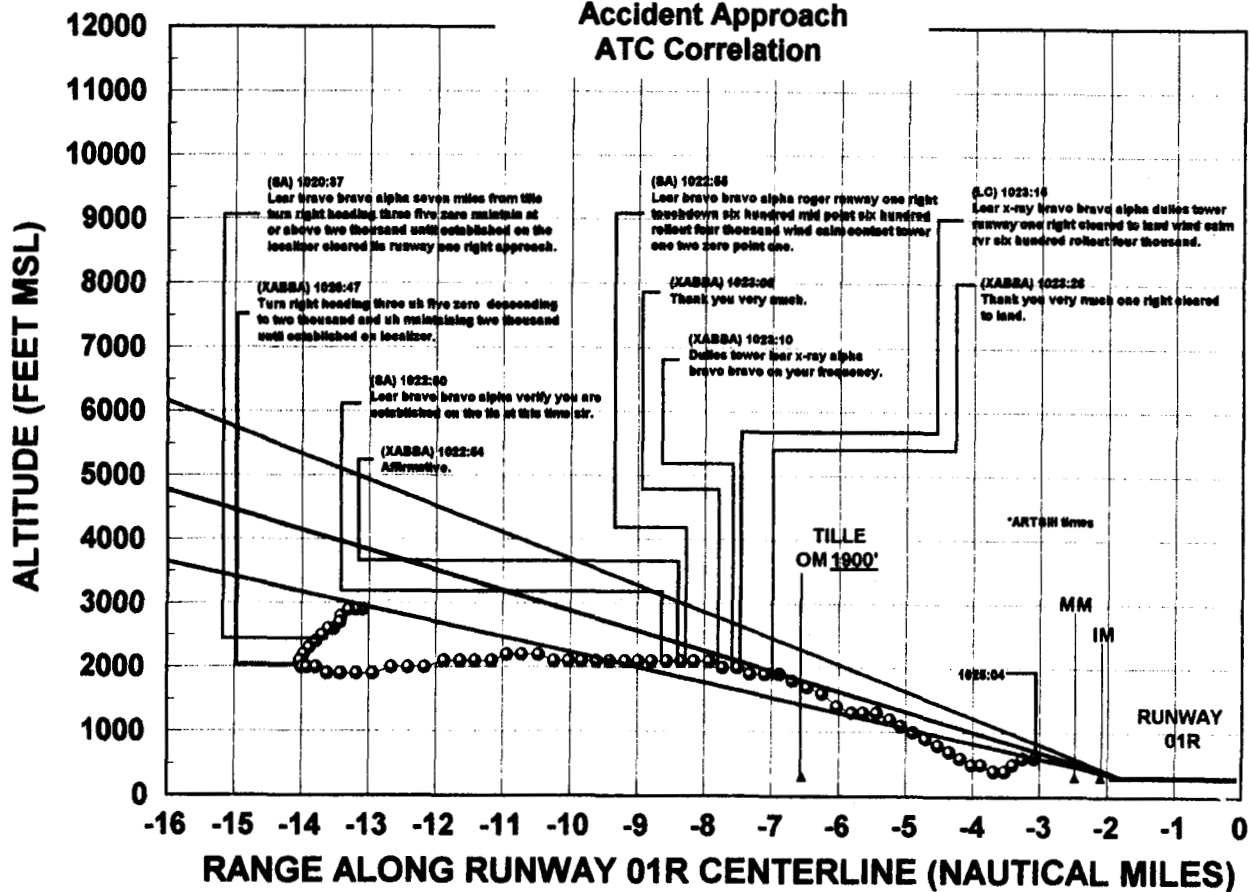
XA-BBA DESCENT PROFILE

Accident Approach ATC Correlation
