Air Accidents Investigation Branch

**Report on the accident to Fokker F27-500, G-BNCY
at Guernsey Airport, Channel Islands
on 7 December 1997**

Aircraft Accident Report No: 4/99

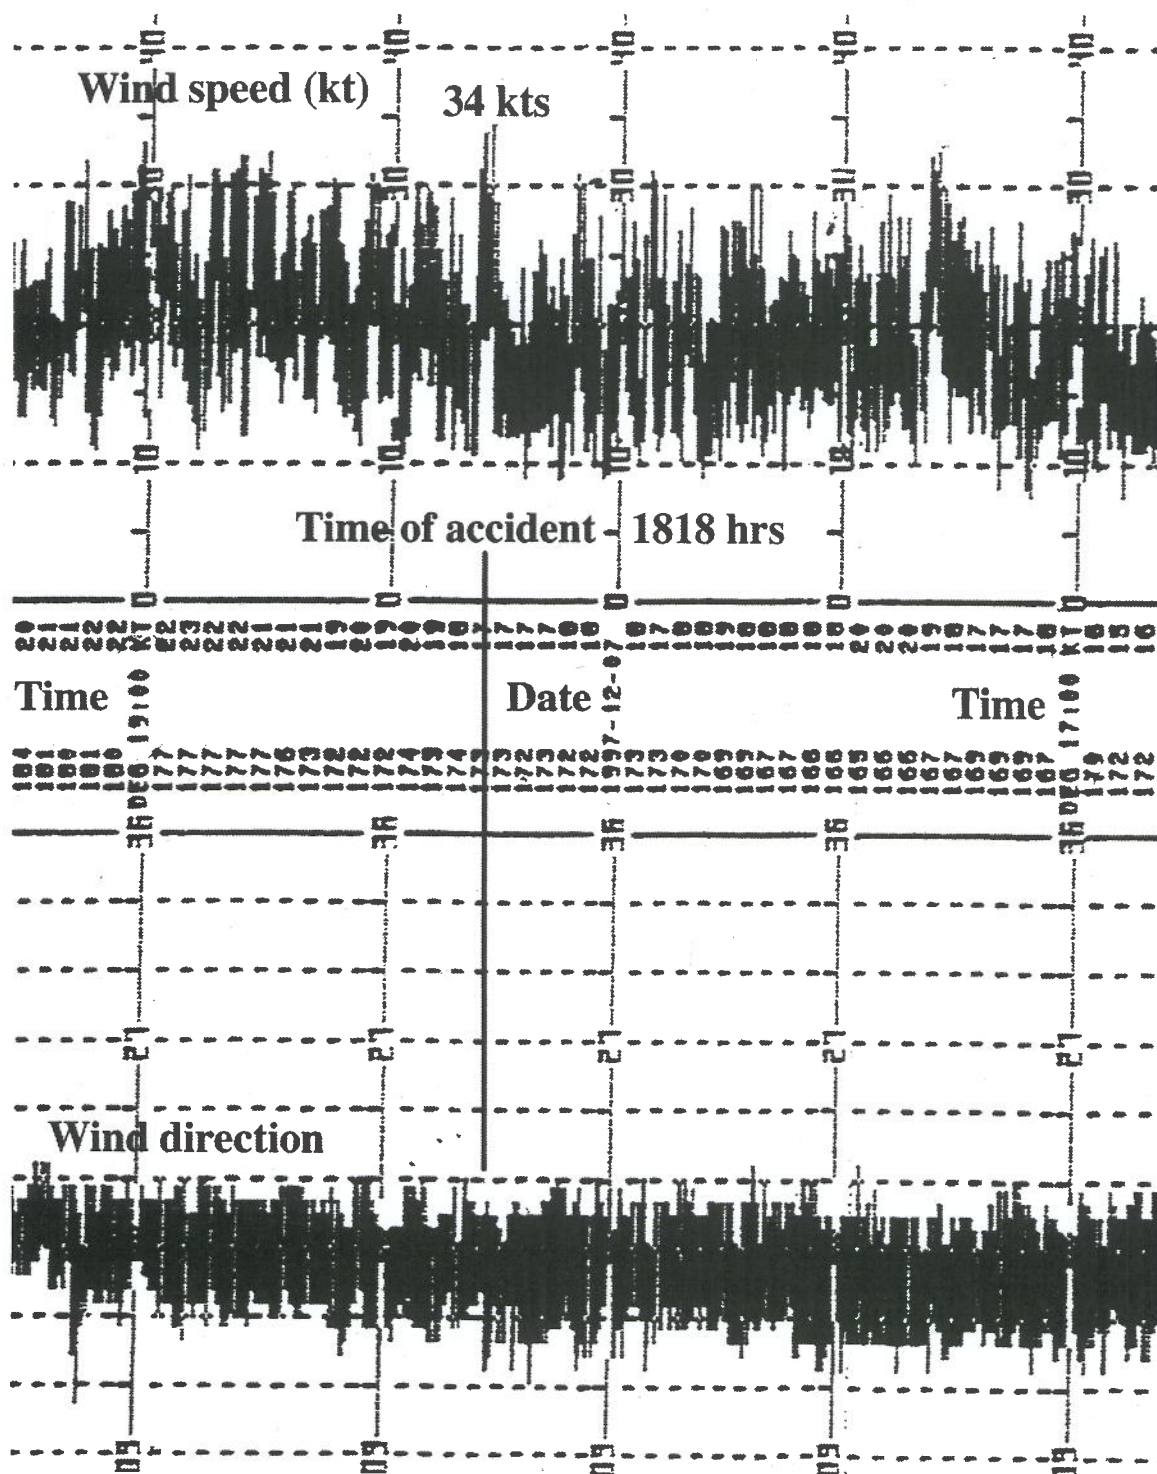
Wind speed and direction recording
for Guernsey Airport on 7 December 1997

The commander thus made his assessment of the wind condition based on information that was only 19 seconds old. Justifiably he was satisfied that the conditions were acceptable for landing. It was therefore unfortunate and unpredictable that the crosswind component at the time of touchdown, measured by the anemometer, was gusting outside the aircraft's limits.

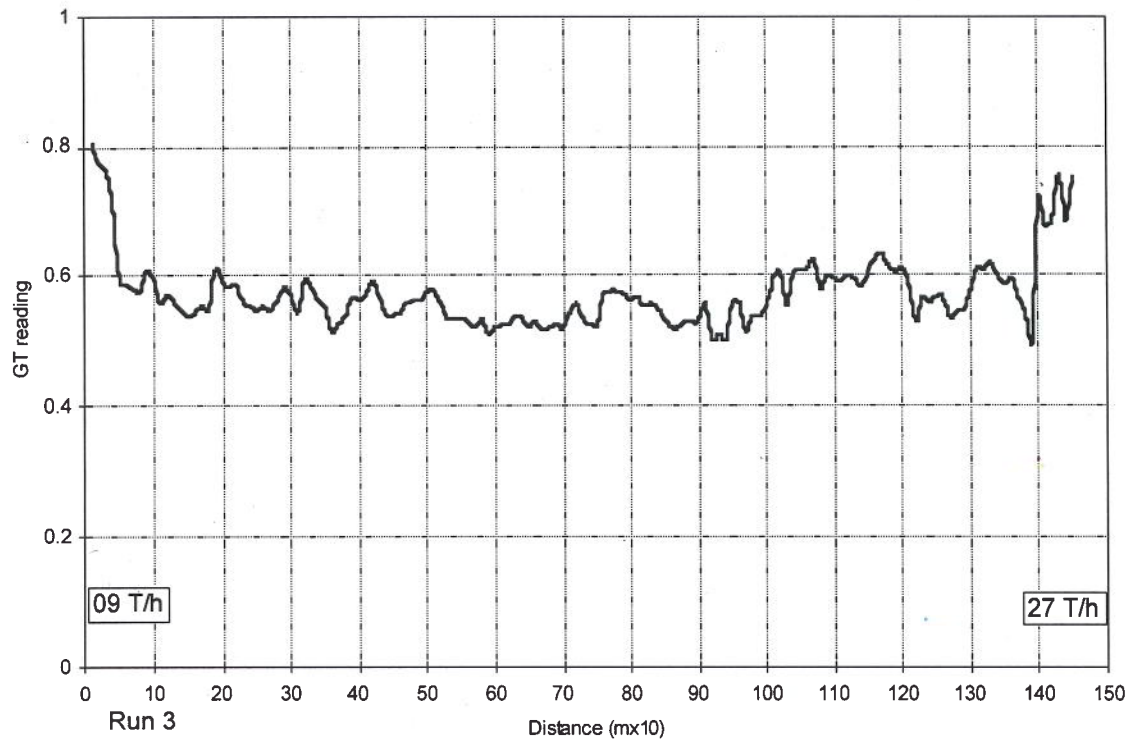
Figure 1 Run 3, 09 direction, 1.5m right of centreline

The average Friction Classification readings for this runway are just above the maintenance planning requirements of the NOTAL 2/94 guidance material (Table 1). The Friction Monitoring runs give no indication of significant low friction areas caused by standing water. It is unlikely therefore that the surface friction was a significant contributory factor in this accident. However, this trial has shown that the runway surface would benefit from some attention to improve the surface friction and prevent the loss of further aggregate. Action to improve the visibility of the painted markings whilst retaining their friction value should also be considered.

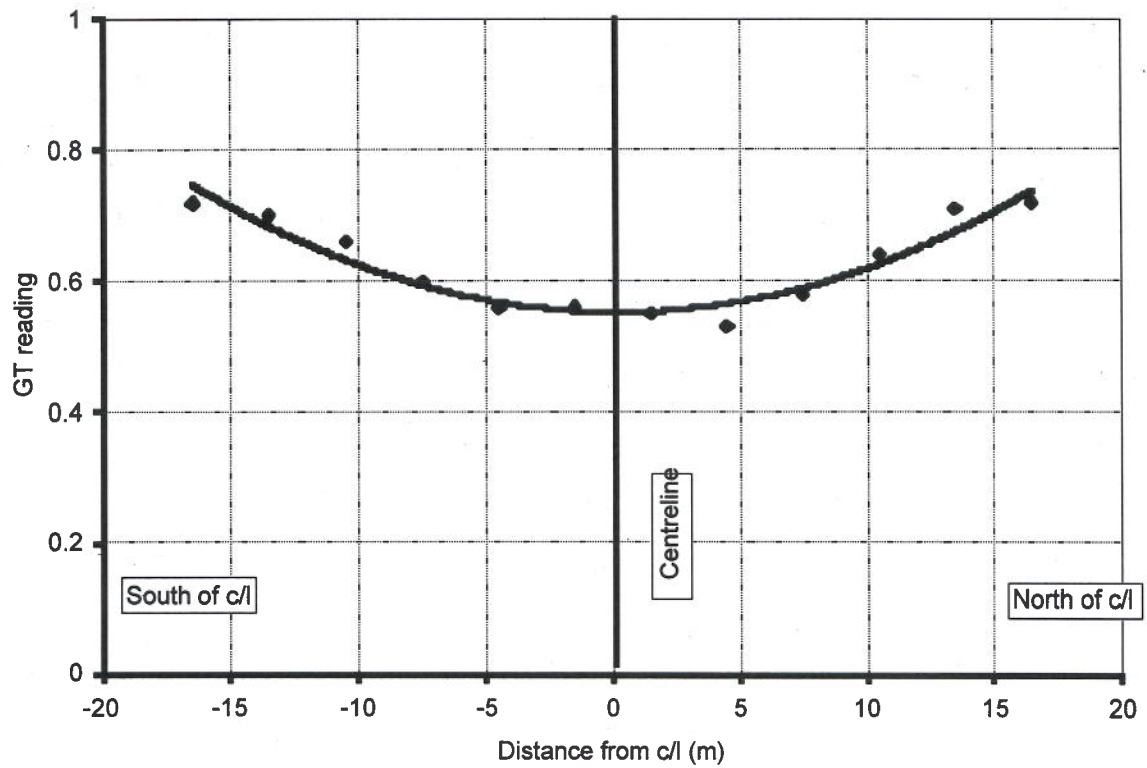
Figure 5 GT reading v Distance from centreline runway 09/27

Table 5 shows the average readings on the runway during rainfall. Typical traces of the runs performed in rainfall are shown at Figure 6 to Figure 8. The same general variability about the mean found in the classification trial is evident in these traces. There are no rapid reductions in friction of the type which would be caused by areas of standing water, except for a very short duration excursion at the 09 threshold in run 8 (Figure 8) approximately 1.5m from the edge of the runway and thus not in a trafficked area. The shape of the graph of friction reading against distance from the centreline, Figure 9, mirrors that obtained during the classification trial, Figure 5. The increase in friction toward the runway edges is more marked.
