NATIONAL TRANSPORTATION SAFETY BOARD

AIRCRAFT ACCIDENT REPORT

IN-FLIGHT ICING ENCOUNTER AND
UNCONTROLLED COLLISION WITH TERRAIN
COMAIR FLIGHT 3272
EMBRAER EMB-120RT, N265CA
MONROE, MICHIGAN
JANUARY 9, 1997

**Adopted: November 4, 1998
Notation 6997A/B/C**

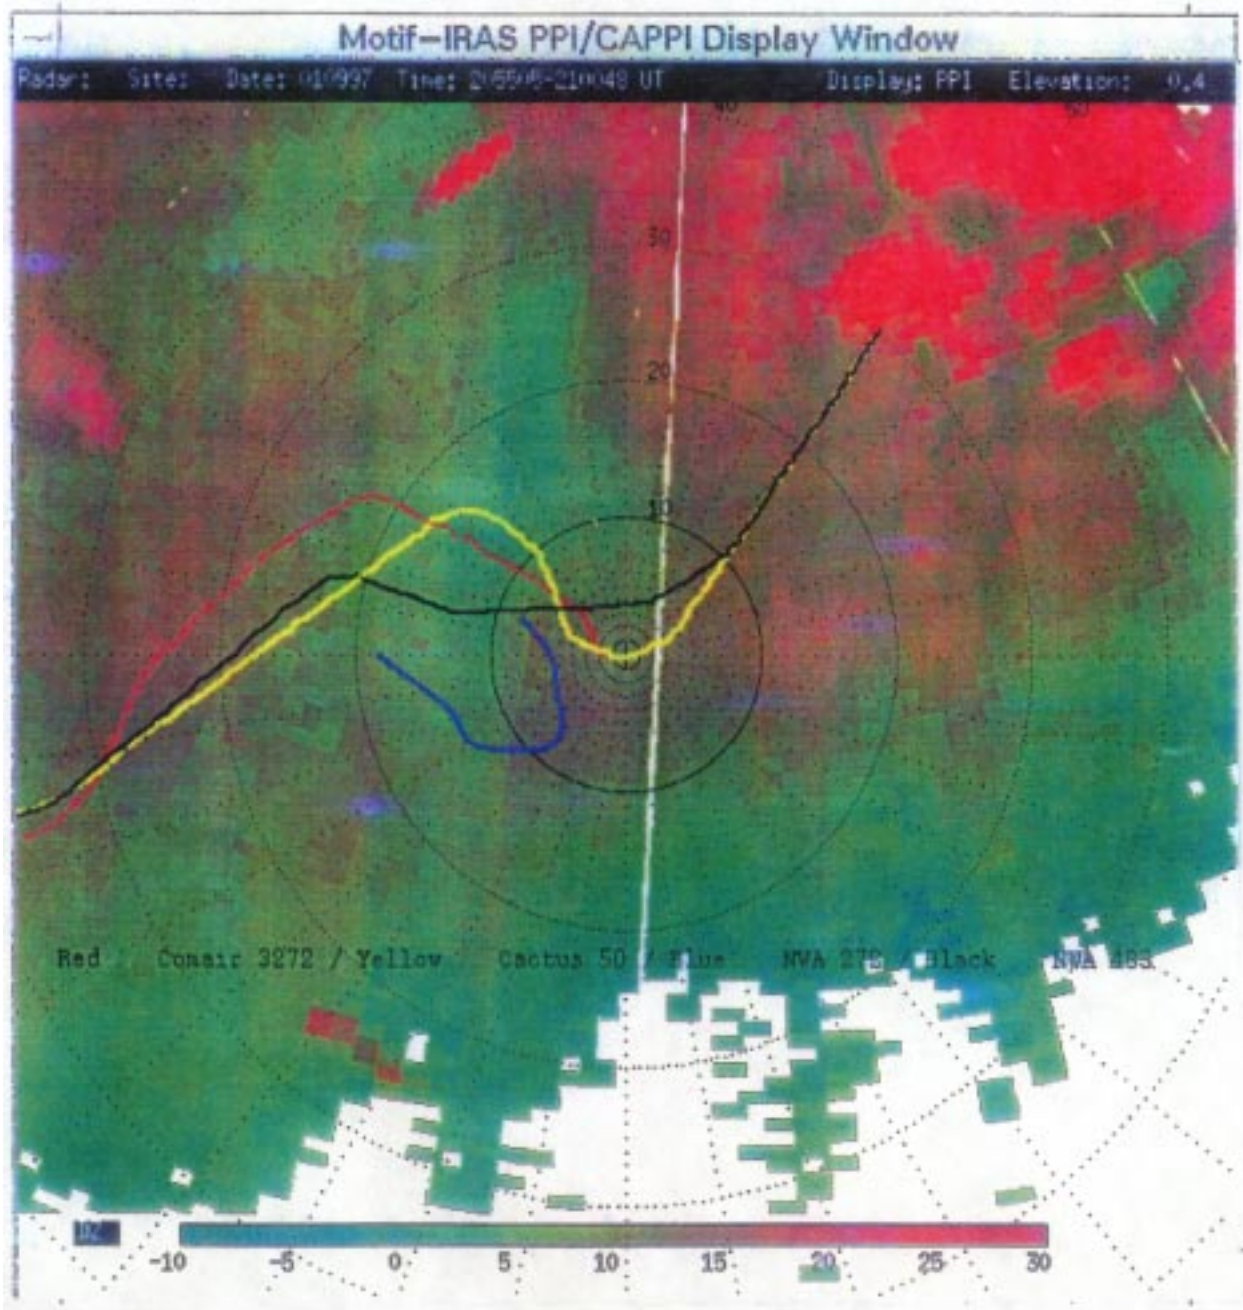
Figure 8.--Flightpath and weather radar echo information.

⁶⁵ Radar data for Comair flight 3272, NW flight 272, Cactus 50, NW flight 483, and NW flight 208 was overlaid on the weather intensity radar information.

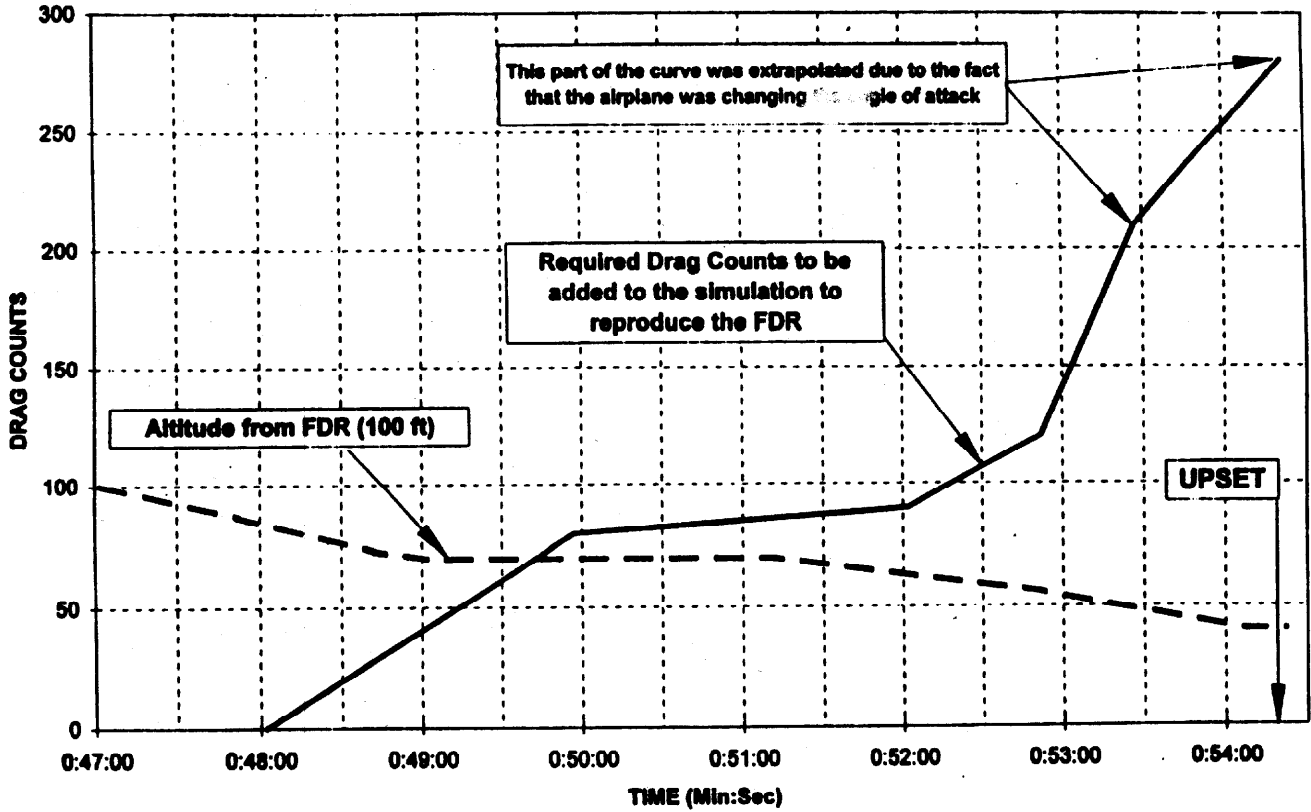
**FIGURE 5 - COMAIR FLIGHT 3272
DRAG INCREASE FROM COMPARISON - FDR AND SIMULATION -**

The analysis shows that the aerodynamic degradation started near DFDR time 48:00 and lasted for about 6 minutes. The increase in drag is not linear with time or altitude and a small variation is noticed during the period of time from 50:00 to 52:00. After that, the rate of increase in drag is pronounced, particularly between 52:50 and 53:30.
