Department of Transport and Regional Development
Bureau of Air Safety Investigation

INVESTIGATION REPORT
9503057

Fairchild Aircraft Model SA227-AC
VH-NEJ, Tamworth, NSW
16 September 1995

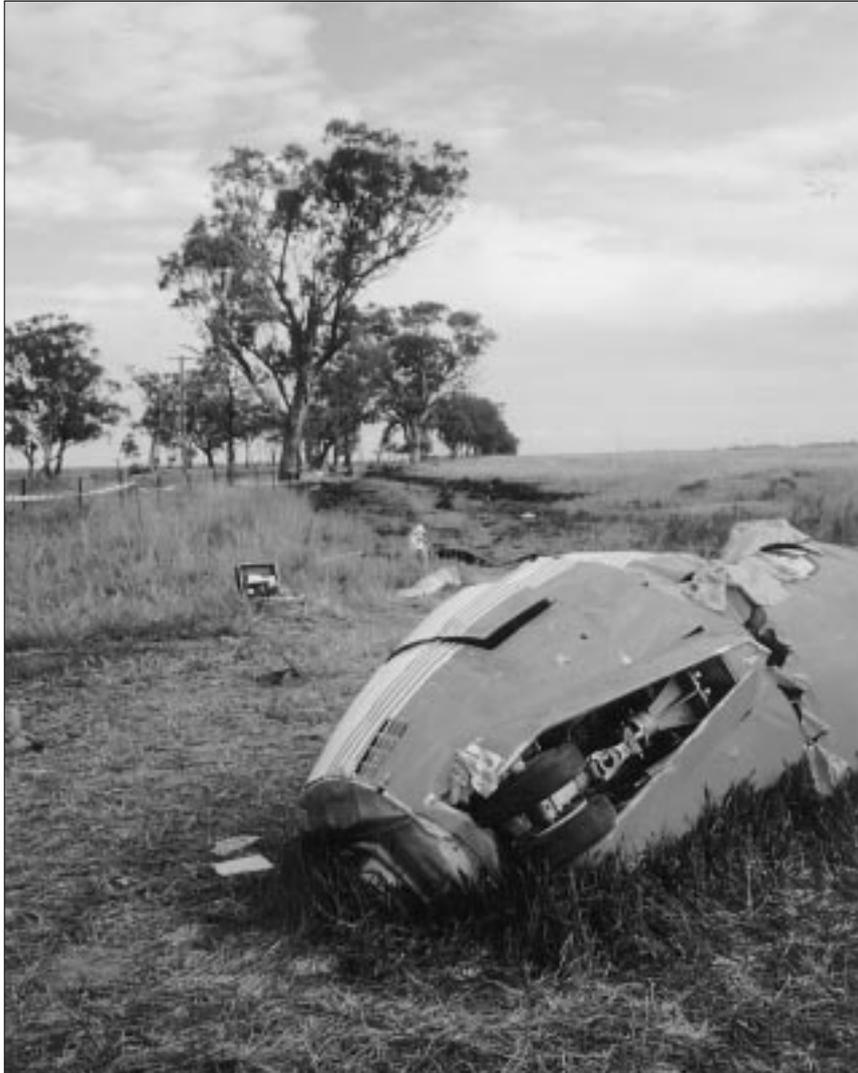
Except for the empennage and the nose section forward of the windscreen, the fuselage and wing centre section were burnt out, and the flaps partially destroyed. There were no witness marks on the remaining flaps structure to indicate their pre-impact position. The left wing flap actuator ram extension was 45 mm while the right ram extension was 19 mm.

FIGURE 2 Wreckage viewed back along the impact path

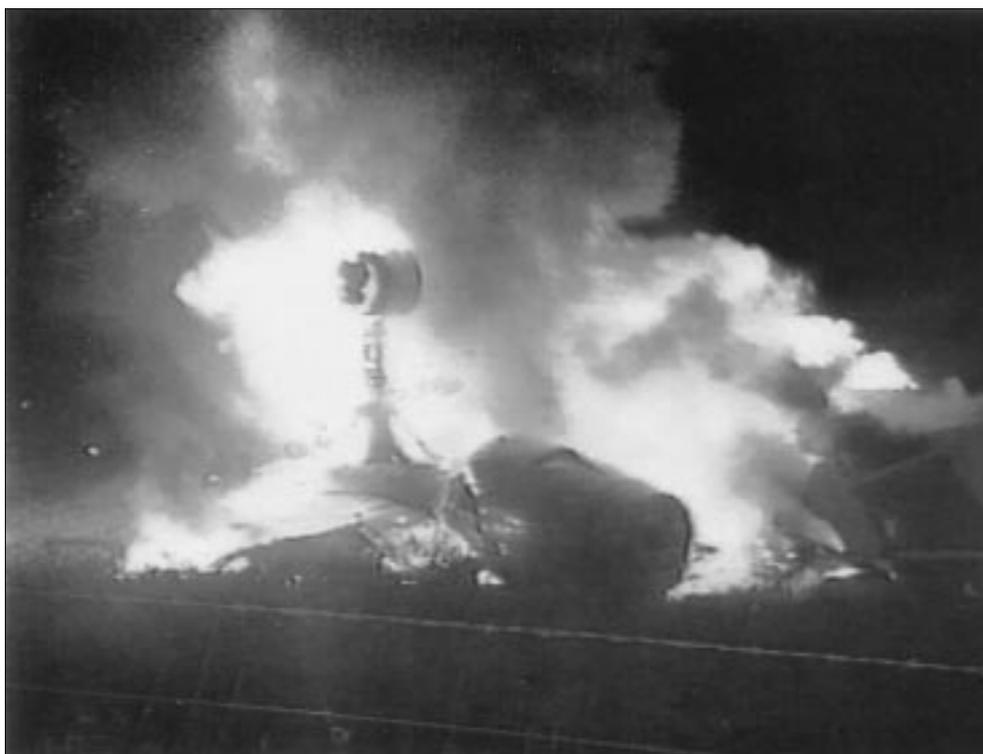
The position of the landing gear at impact could not be positively established.

A video recording taken shortly after the accident, while the aircraft was still on fire, showed the left main gear leg in what appeared to be the extended position. The right gear leg was not visible (see figure 3).

FIGURE 3 Image from video recording, showing the left main landing gear leg extending upwards from the inverted left wing

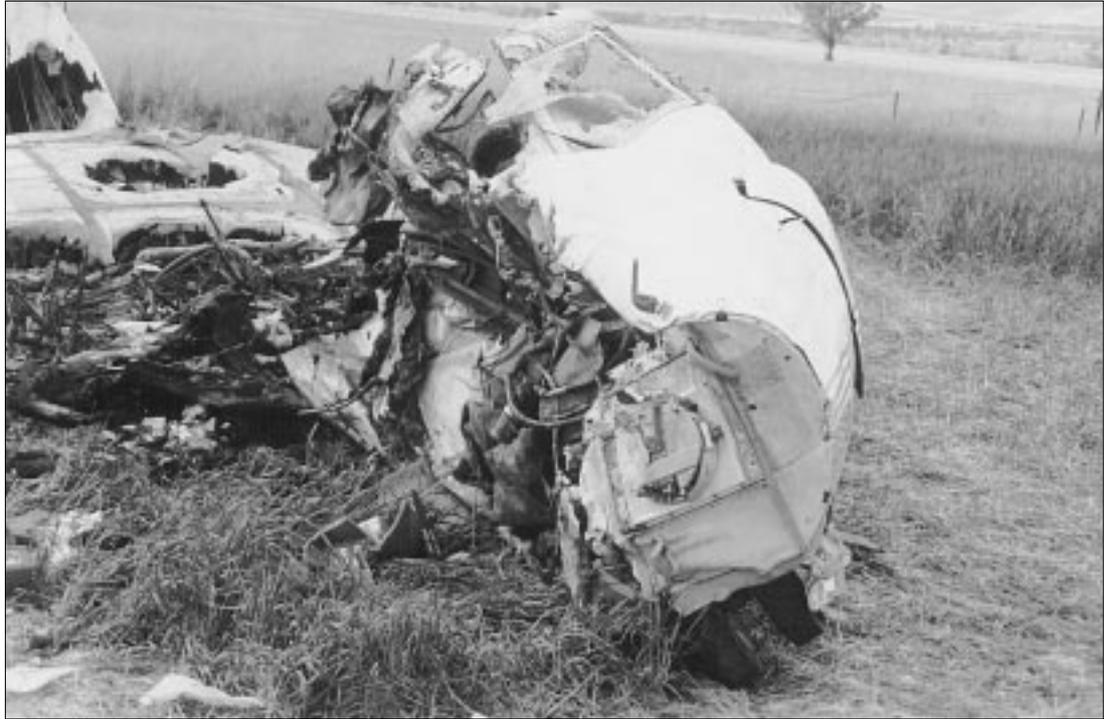
The post-mortem examination report on the co-pilot, and the degree of damage to the right side of the cockpit, indicated that he was unlikely to have survived the impact. There was evidence that the other trainee survived the impact but was overcome by the effects of smoke and fire.

During the impact sequence, the aircraft structure received progressively more damage as it contacted trees, powerlines, and the ground. Evaluation of the impact forces under such conditions was not practicable due to the difficulty in assessing the values of the different collisions during the crash sequence. Survivability was, however, compromised by the damage to the right side of the cockpit and by the fire (see figure 4).

FIGURE 4 Nose section of aircraft, showing impact damage to right side

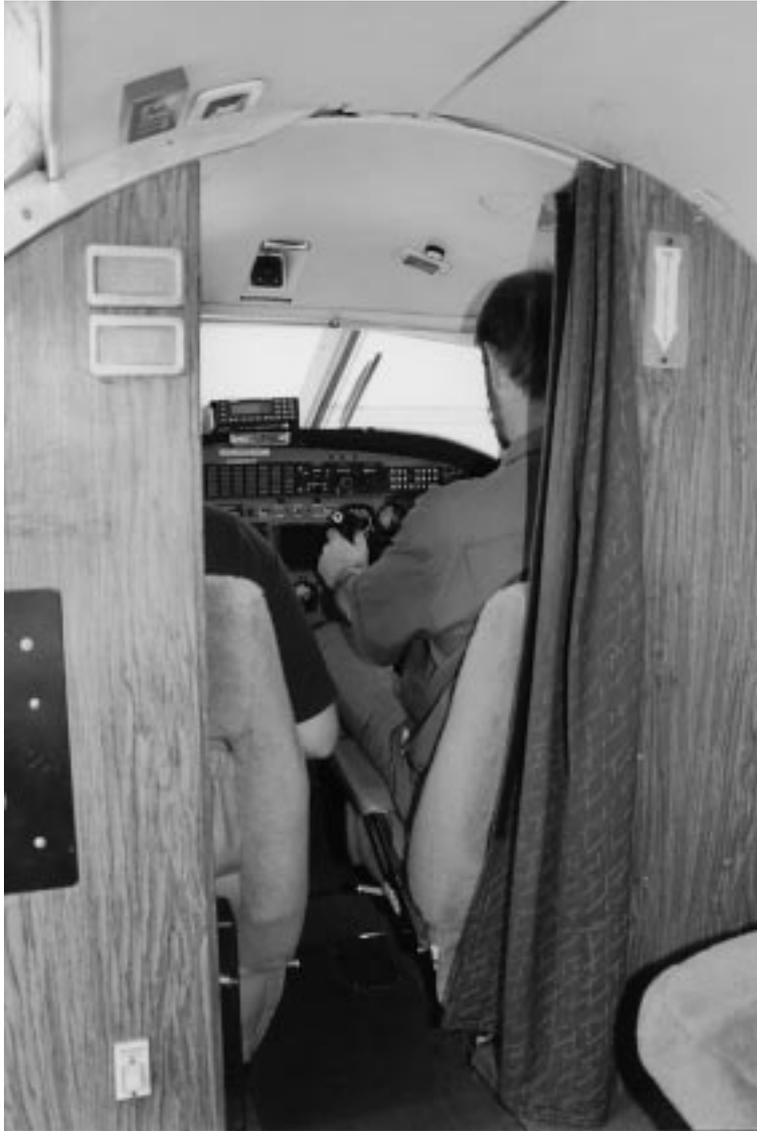
The interior configuration of the Metro III aircraft includes a partition immediately behind the cockpit seats. A central opening allows crew access to the cockpit. Probably because of the limited space available, there is no jump-seat fitted. The normal procedure in Tamair was for additional trainees to occupy the front left passenger seat. This allowed a limited view of the cockpit (see figure 5). Trainees also wore headphones to listen to crew activity but were not provided with a microphone.

FIGURE 5 View into cockpit from front row, left side passenger seat
