Report C 1998:23e

The Swedish Board of Accident Investigation (Statens haverikommission, SHK) has investigated an aircraft accident which occurred on 7 June 1997 at Stockholm/Arlanda airport, AB county, Sweden, involving an aircraft with registration YR-BCM.

Report C 1998:23e**L-36/97**

<i>Aircraft: registration and type</i>	YR-BCM, BAC 1-11 525 FT
<i>Owner</i>	TAROM, Bucharest, Romania
<i>Time of accident</i>	7 June 1997 at 13.50 hours in daylight
	<i>Note:</i> All times in the report are given in Swedish summer time (SST) = UTC +2 hours
<i>Place</i>	Stockholm/Arlanda airport, AB county, Sweden (pos 5939N 1755E, 121 ft (37 m) above sea level)
<i>Type of flight</i>	Scheduled traffic
<i>Weather</i>	Arlanda 13.50 hrs: wind 160°/13kts, visibility > 10 km, no clouds below 5 000 ft, temp./dewpoint +24°/+4°C, QNH 1025 hPa
<i>Numbers on board:</i>	Crew: 3/3 Passengers: 20
<i>Personal injury</i>	None
<i>Damage to aircraft</i>	Substantial
<i>Other damage</i>	Limited on grass
<i>Commander's age, and licence</i>	48 years, Airline Transport Pilot's Licence (ATPL) with instructor's rating
<i>Commander's total flying hours</i>	Around 12 500 hours of which 12 000 hours on the type
<i>First Off

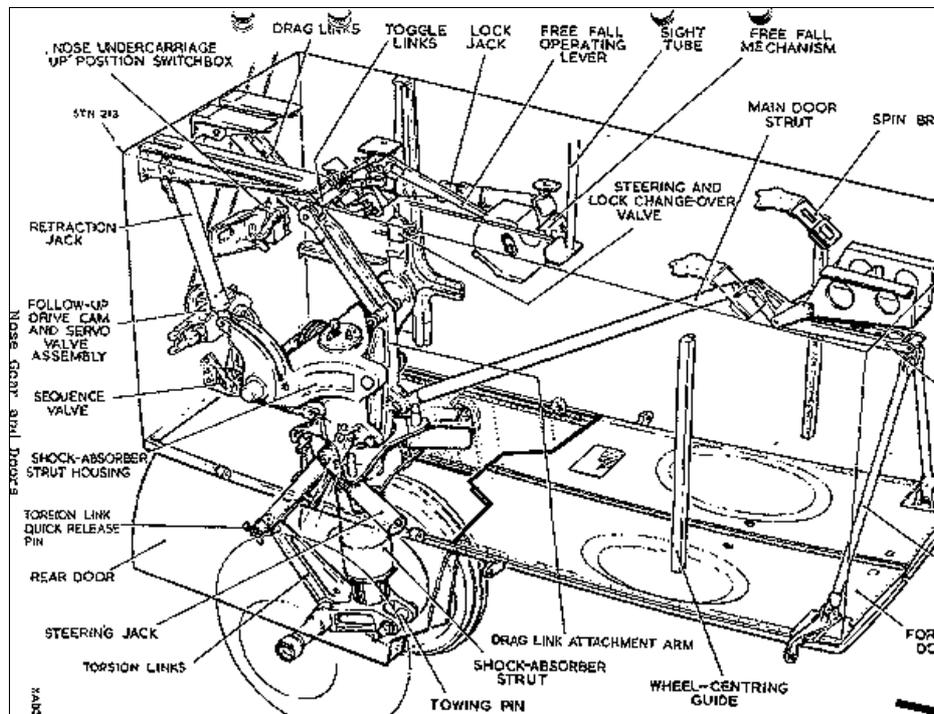
The aircraft type has a hydraulically operated nose gear, hinged in two pins and retracted forward. The two bearing supports are riveted to the aircraft structure.

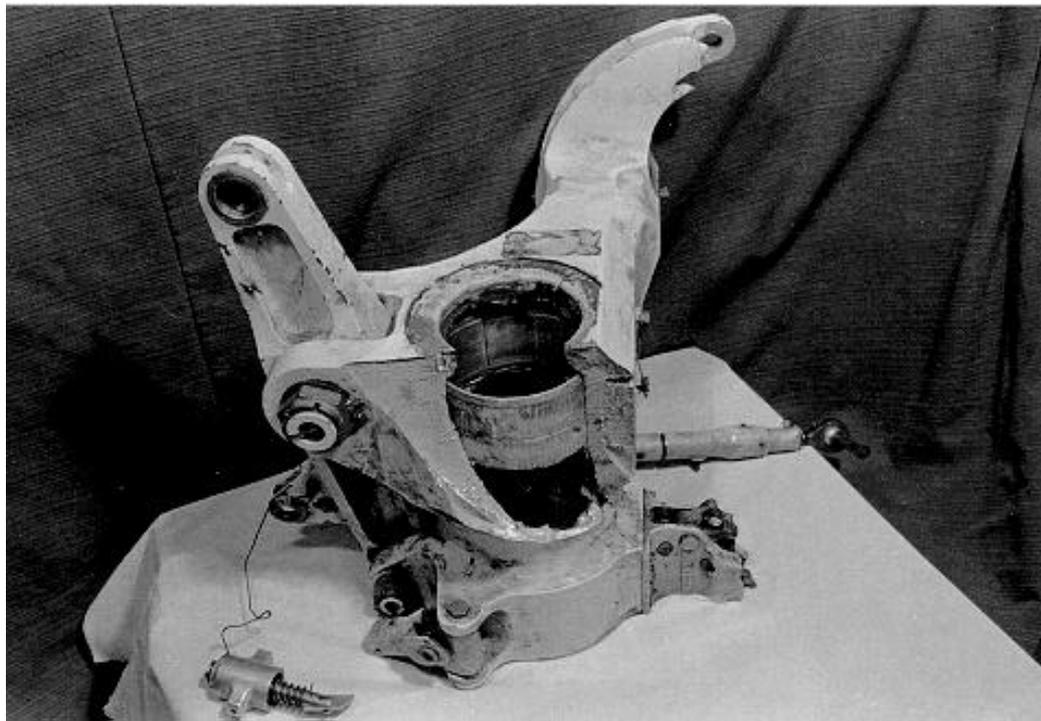
The examination of the nose gear showed that the primary failure had occurred in the shock-absorber strut housing, which is a central construction element of the landing gear. Besides this damage extensive secondary damage had occurred in the nose gear well.

The shock absorber strut housing was first examined by experts from the metallurgic laboratories of Volvo Aero Engines Services. It was subsequently sent to British Aerospace Airbus Limited Materials Laboratory in Filton/England for examination. The outcome of these examinations made it unequivocally clear that the housing was manufactured and maintained following current specifications and that it had no defects or damage before the accident which may have contributed to the course of events. The failure was a result of one or more overloadings.

Metallurgic examinations of the nose gear disclosed no faults on it before the accident. Everything therefore points to the primary fracture of the nose gear leg being caused by the overloadings on the nose wheel during the two touchdowns.
