Report 99-002

Fletcher FU24-954

ZK-EMV

near Riversdale, Wairarapa

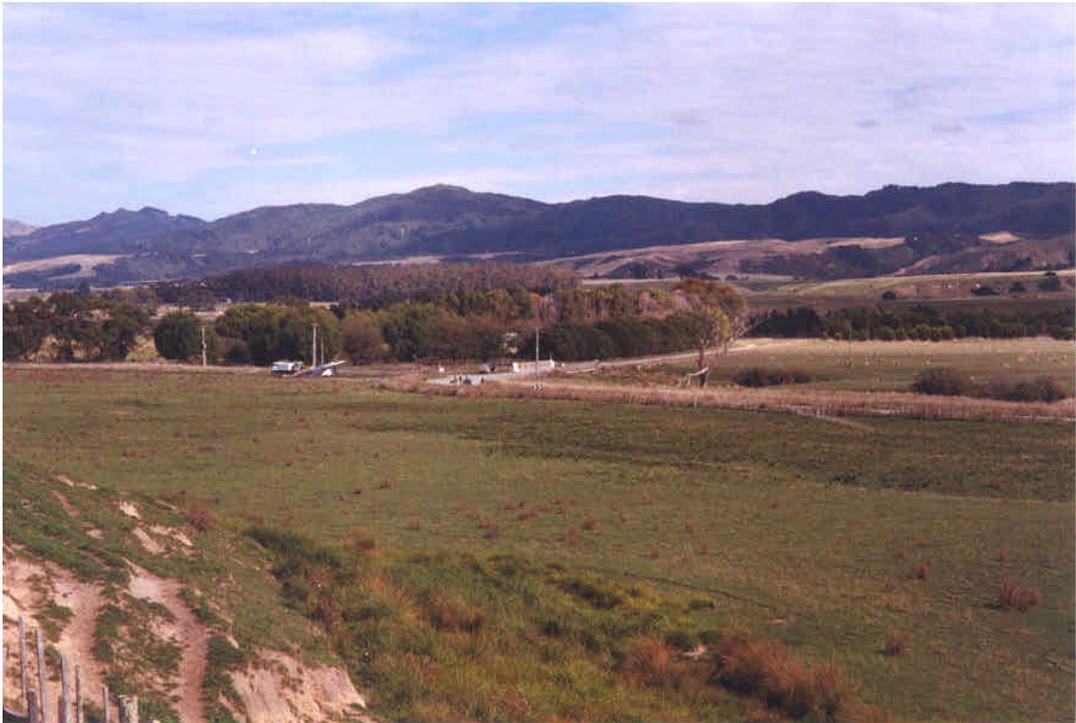
Accident site

- 1.2.1 The aircraft initially struck a fence on a heading of about 240° M. It then ballooned into the air, rolled inverted to the left and landed heavily on the engine and cockpit area, heading about 180° M. The accident was not survivable and the aircraft was destroyed.

- 1.2.4 The aircraft struck the ground a second time about 115 m past the initial impact point, sliding a further 30 m before coming to rest. The cockpit and engine area bore the brunt of the impact forces, with little additional damage to the rest of the aircraft. The pilot was restrained by his harness and was not wearing a helmet. No fire occurred.
