Foreword

This document is based on the data collected on the circumstances of the accident, which then has been analysed for the investigation. The focus of the investigation of the tragic accident to GF-072 has been to establish what happened, to analyse how and why the occurrence took place, and from this analysis to determine what the occurrence reveals about the safety health of the aviation system. Such information is used to arrive at conclusions and make safety recommendations aimed at reducing or eliminating the probability of a repetition of the same type of occurrence, and where appropriate, to increase the overall safety of the aviation system.

Executive Summary

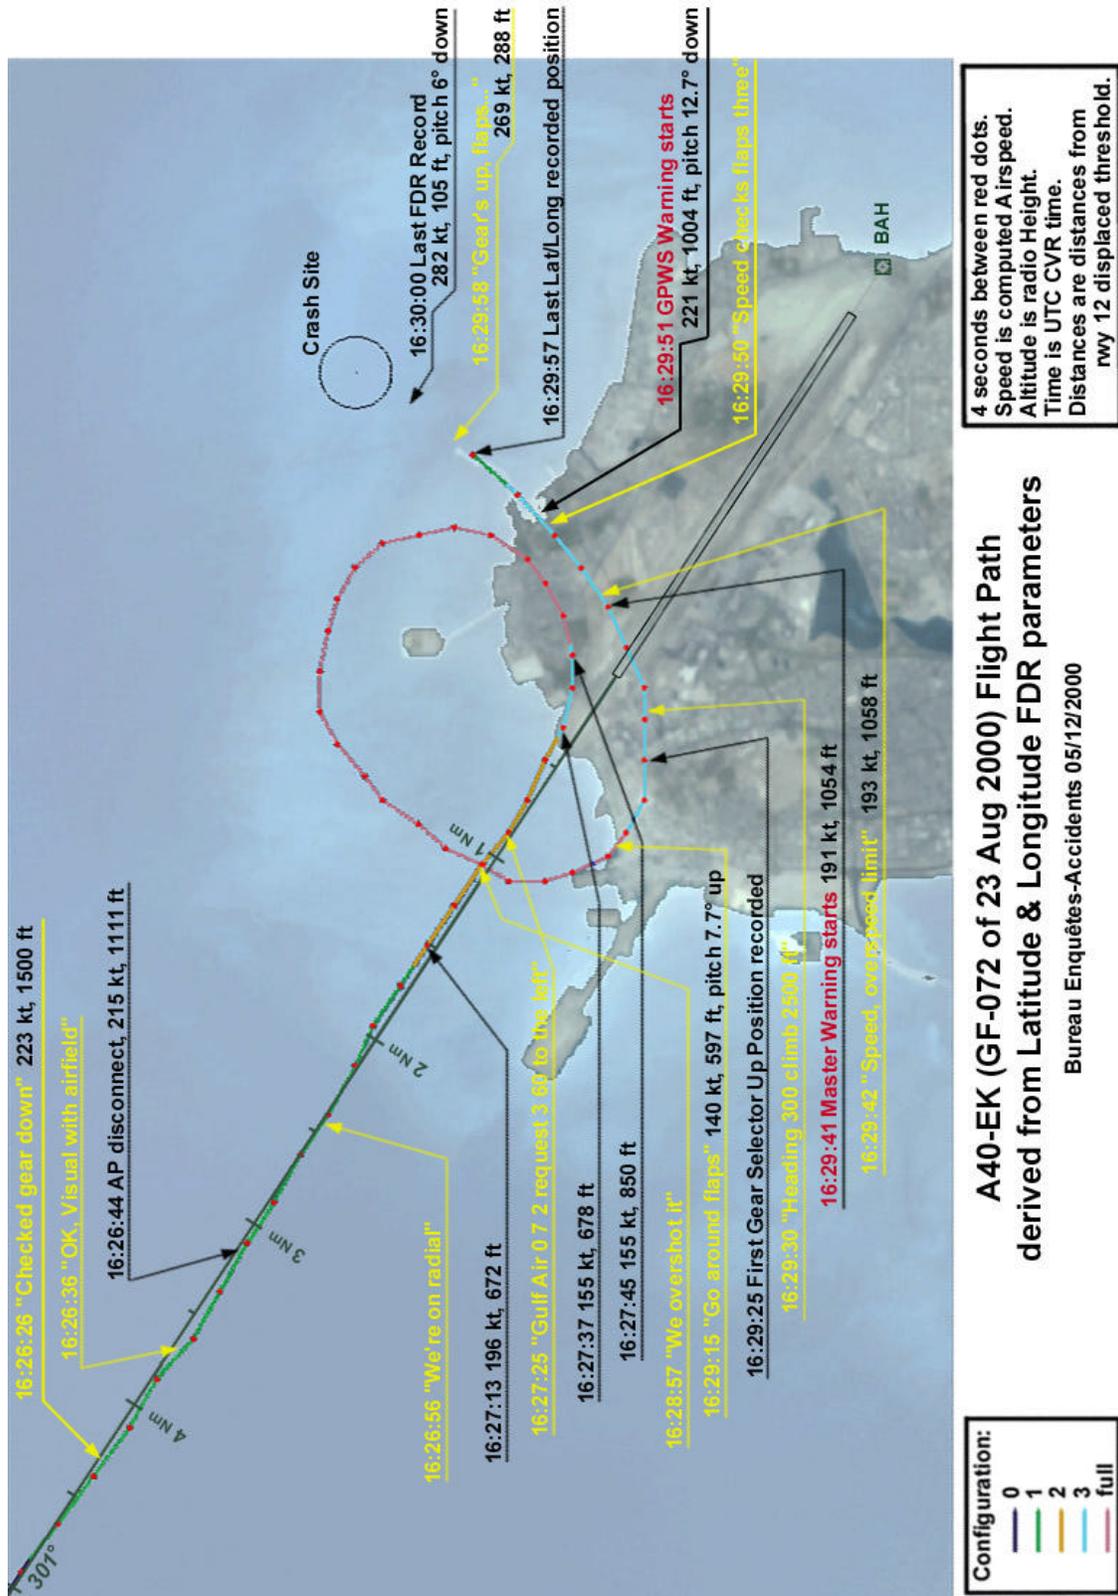
Figure 2. Overhead view of GF-072 trajectory with selected FDR, CVR, and ATC communication excerpts.

About 1929:41, with the airplane at 1054 feet AGL, at an airspeed of 191 knots, and having just crossed over the runway, the CVR recorded the beginning of a 14-second interval of the aural Master Warning¹¹ (consistent with a flap-overspeed condition), followed by the statement from the first officer, “speed, overspeed limit...” Approximately two seconds after the beginning of the Master Warning, FDR data indicated a forward movement of the captain’s side stick. The captain’s side stick was held forward of the neutral position¹² for approximately 11 seconds, with a maximum forward deflection of about 9.7 degrees¹³ reached. During this time, the airplane’s pitch attitude decreased from about 5 degrees nose-up to about 15.5 degrees nose-down, the recorded vertical acceleration decreased from about +1.0 “G”¹⁴ to about +0.5 G’s, and the airspeed increased from about 193 knots to about 234 knots.

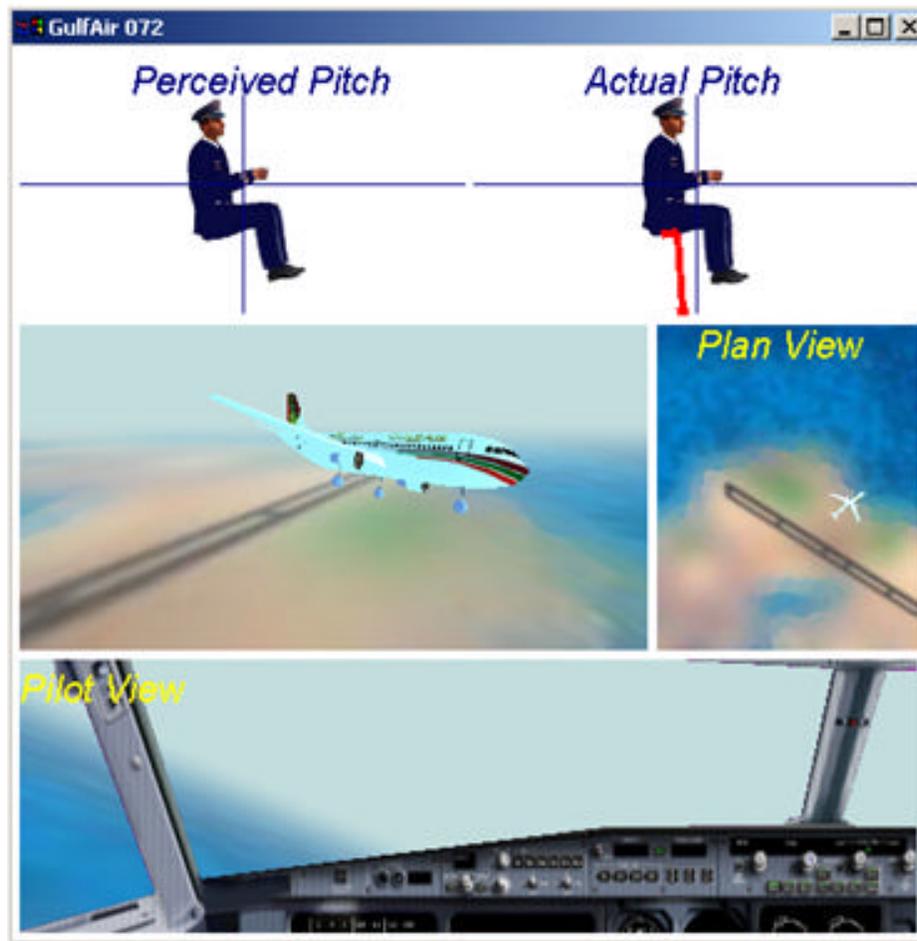
Figure 1: Perceived Pitch versus Actual Pitch just prior to stick forward (t=1929:43)
(Red Arrows in Actual Pitch panel are the Gx and Gz acceleration vectors)

There are many in-flight forces that can produce a sensation of pitch up. It was an unfortunate condition of this flight that the pilots of Gulf Air 072 were exposed to several physical factors all acting in concert and some synergistically to produce a significant false pitch up sensation of approximately 12 degrees when in reality the aircraft was only pitched up 5 degrees (Figure 1, upper left, Perceived Pitch).

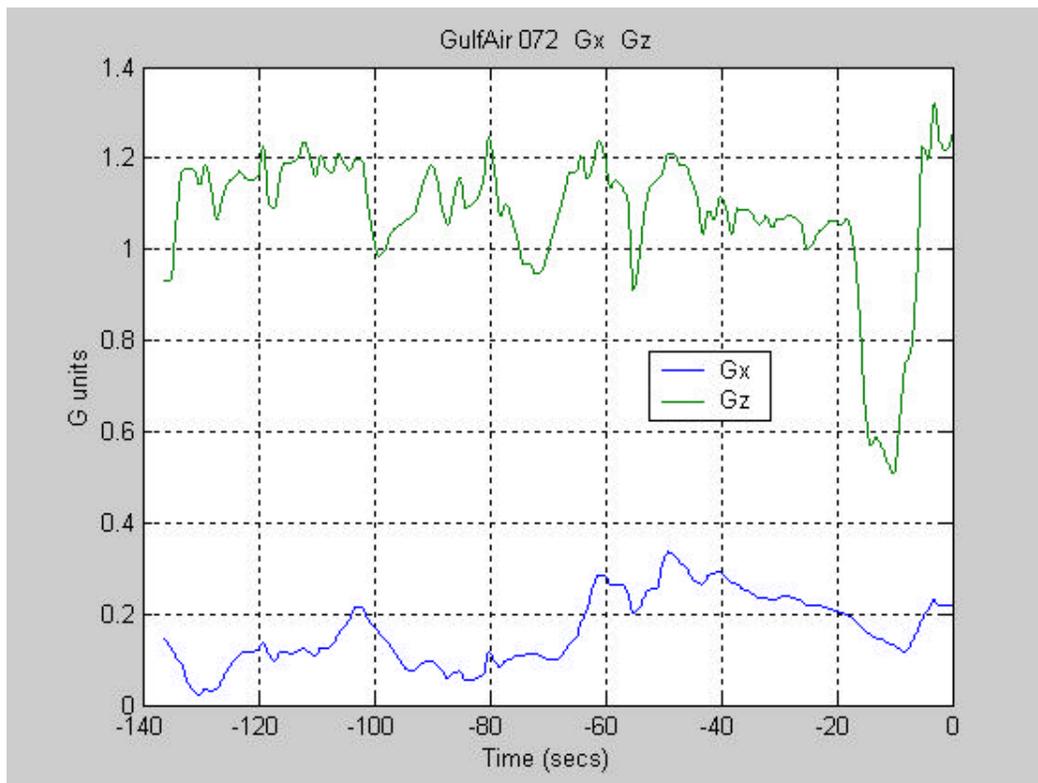
Figure 2: G_x and G_z Forces versus Time to impact

- 1) The aircraft was linearly accelerating from the beginning of the second go-around maneuver ($t= 1929:07s$) until impact (Figure 2, G_x). This contributed to changing the direction of the resultant force vector from directly in-line with the vertical torso of the pilot to a rearward direction (Figure 4, blue arrows). This force contributes to the somatogravic illusion, a misperception of attitude that results in frequent mishaps. There is a time lag associated with this perception and so the time of loss of visual orientation cues is important. A secondary effect of the maintained linear acceleration is to increase the magnitude of the overall resultant vector (gravito-inertial force (GIF)), which contributes to the G-excess effect.

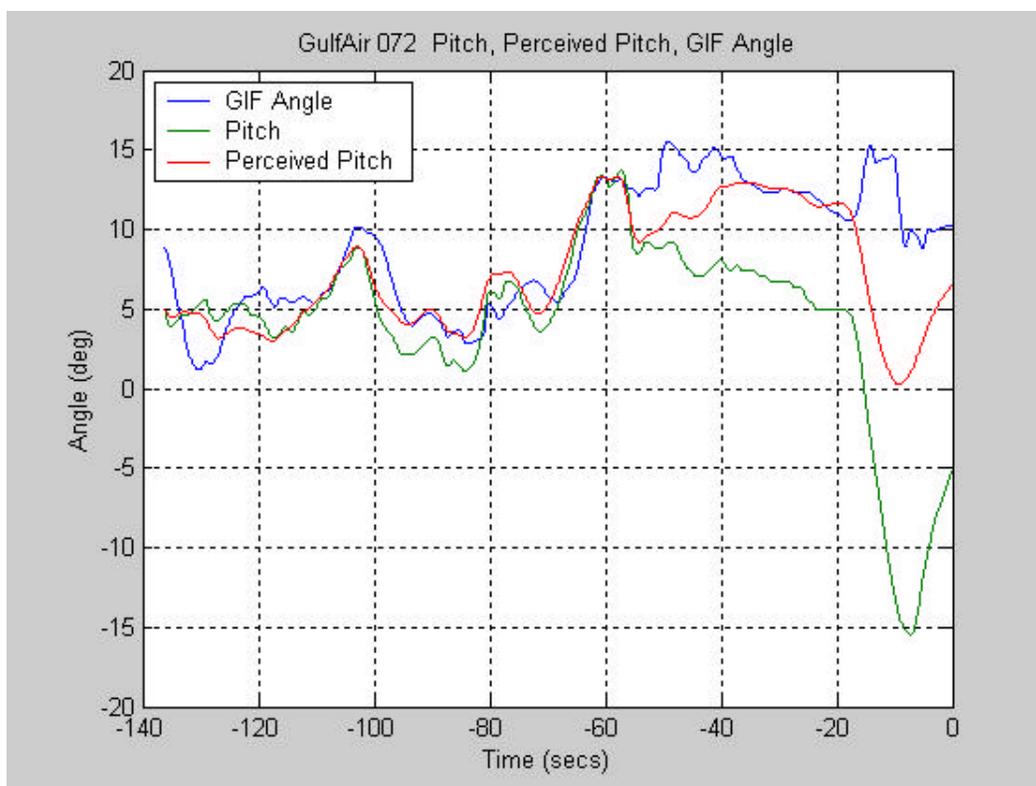
Figure 3: Pitch, Perceived Pitch, GIF Angle versus Time to Impact

- 4) Angular acceleration due to changes in aircraft pitch synergistically affects the somatogravic pitch illusion when the angular acceleration acts in the same direction as the somatogravic pitch illusion. On the other hand, strong linear acceleration can block the affects of the angular displacement (McGrath, 1990). In this mishap, the overall resultant force vector was rapidly decreasing in magnitude at the same time the aircraft pitched down resulting in a pitching forward perception (Figure 3). This explains why in Figure 3 the perceived pitch sensation does NOT follow the GIF angle. The preceding turn associated with the second go around contributes to this difference in two ways – first from the direct G excess pitch up and secondly by contributing to a larger change in the overall magnitude of the GIF.

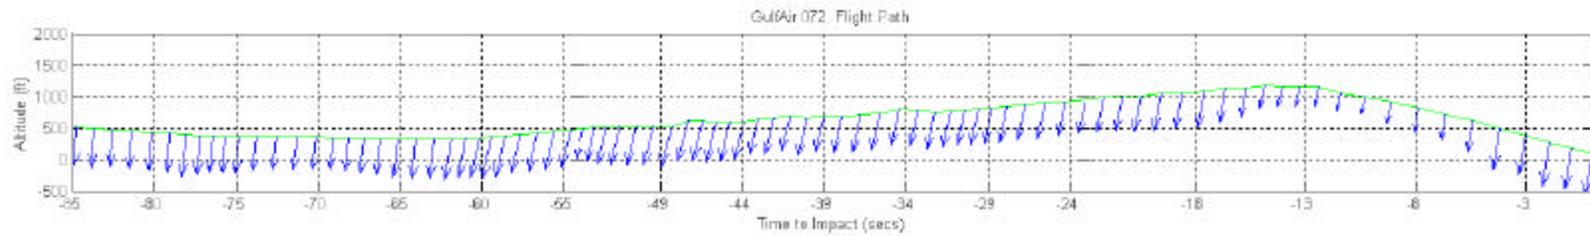
Figure 4: Flight Path of Gulf Air 072 versus Time to impact and Resultant Force Vector (GIF)

The dynamics of the first three physical forces mentioned above are summarized in the time course plot (Figure 4) showing the magnitude of the resultant force vector (GIF) and the angle this vector makes with respect to the upright (head-to-seat) axis of the seated pilot. The only factor missing is the pitch stimulus associated with angular acceleration about the pitch axis (# 4 physical force above).

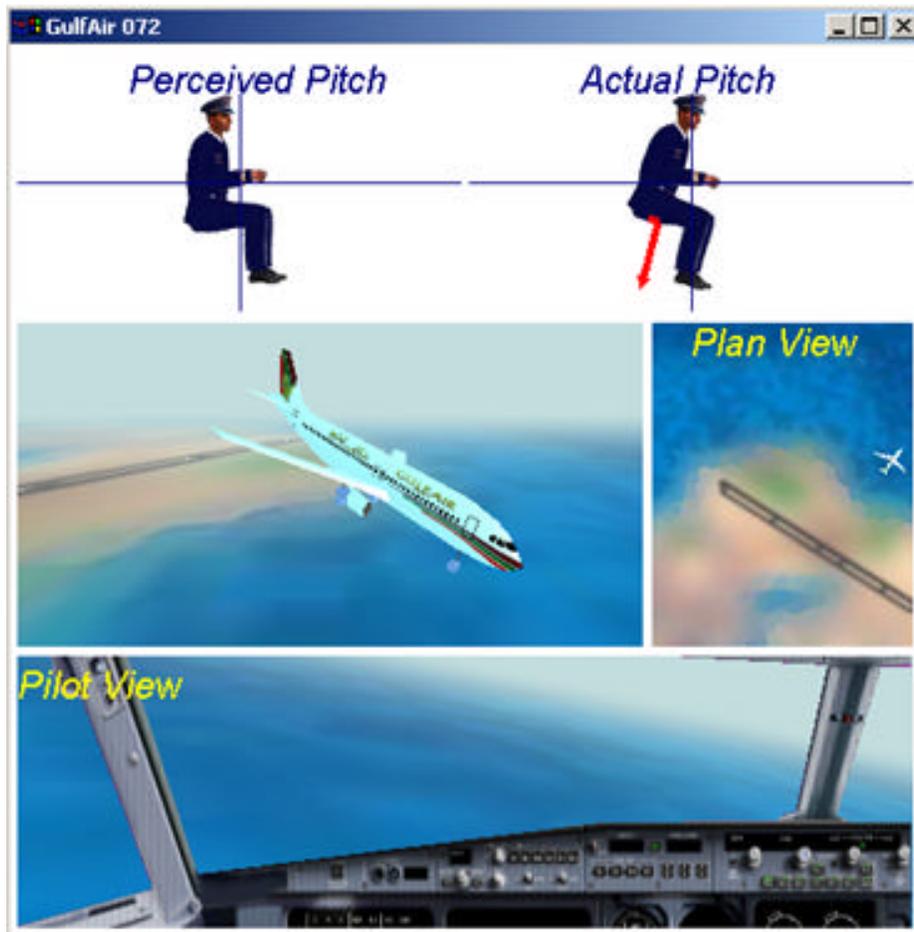
Figure 5: Perceived Pitch versus Actual Pitch just prior to stick back (t=1929:53)

The overwhelming nature of the pitch illusion is evidenced by the fact that the pilot in command did NOT follow the recommended GPWS procedure of “Pull up to full back stick and maintain”, since he believed he was approximately level and so only partially pulled the stick, (Figure 5; i.e. he pulled to approximately 11.7 degrees aft vice the maximum capability of 16 degrees aft, Figure 6)

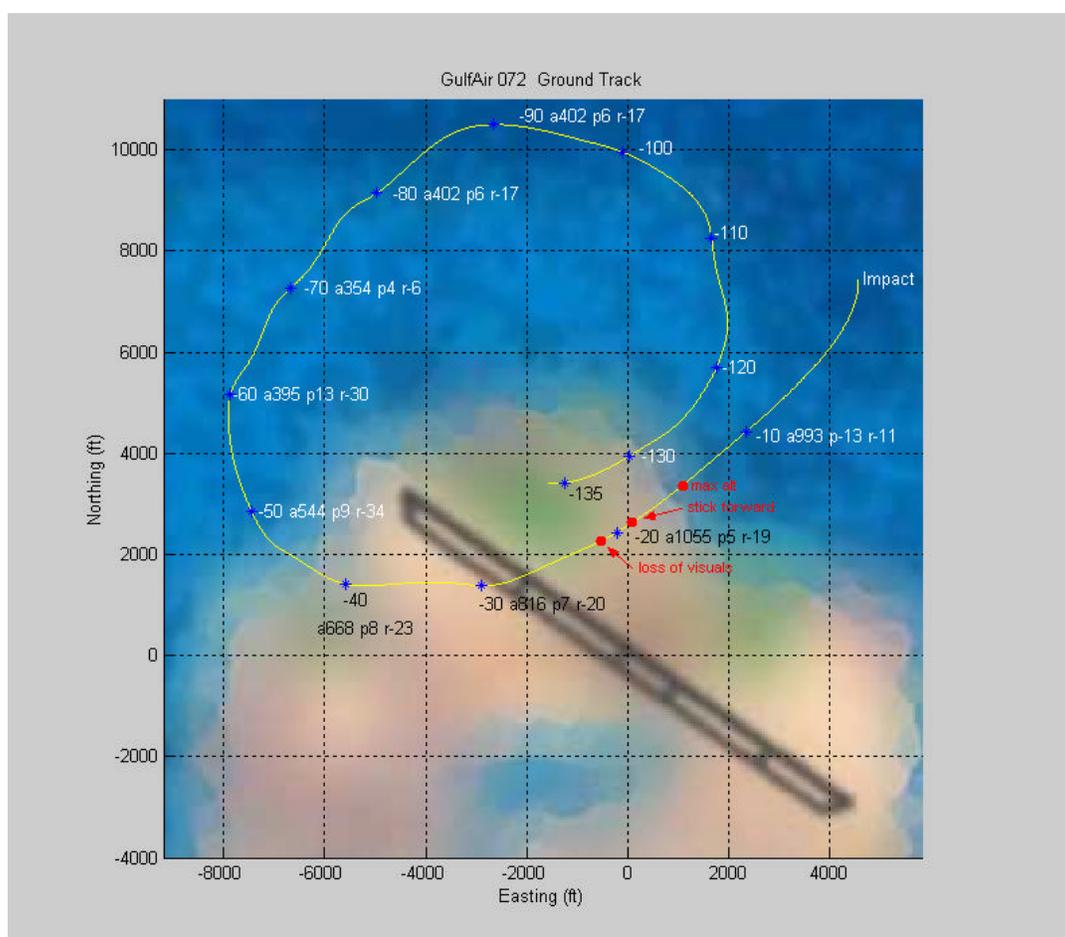
Figure 7: Flight Path (time to impact, altitude, pitch, roll)

reasons: – first the highest angle of bank occurs at this point and the G excess effect contributes to the early portion of the pitch up sensation, thereby “setting the stage” for the somatogravic illusion; secondly, the go around is associated with other physical forces mentioned in the above section. These forces have a synergistic influence on perceived pitch during the final 18 seconds when the GIF influence on the pitch sensation decreases as the canal input from the pitch forward comes into play.
