INVESTIGATION REPORT
200101903

**Parachuting accident involving
Cessna Caravan VH-MMV
at Nagambie, Victoria**

29 April 2001

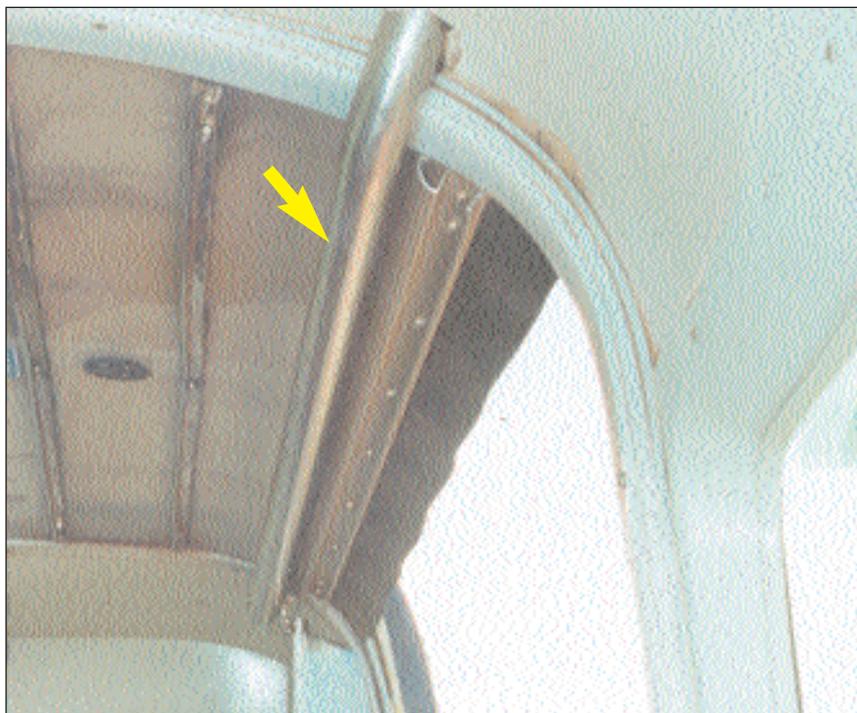
A tubular steel handrail was located inside, and at the top, of the cargo doorway. That handrail was for the parachutists to hold while positioning prior to exiting the aircraft (see fig. 1).

FIGURE 1:
Handrail located inside aircraft

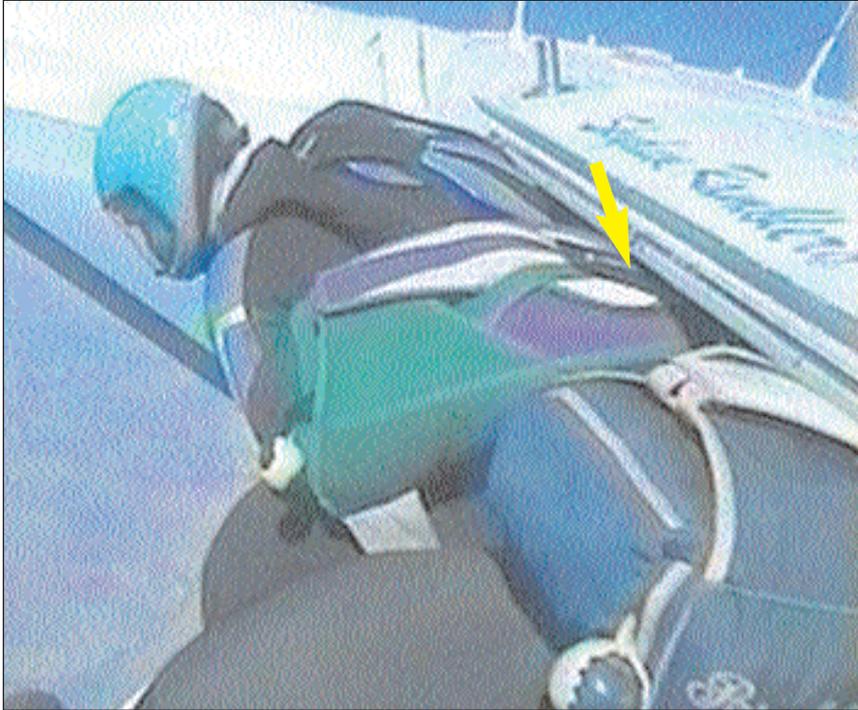
FIGURE 2:

members of the incident. The video of that descent showed that the parachutist used an exit position similar to that used on the accident flight. The parachute container was in contact with the top of the doorframe/handrail (see fig. 2, 3 and 4).

A previous jump – exit readiness position with parachute container against door

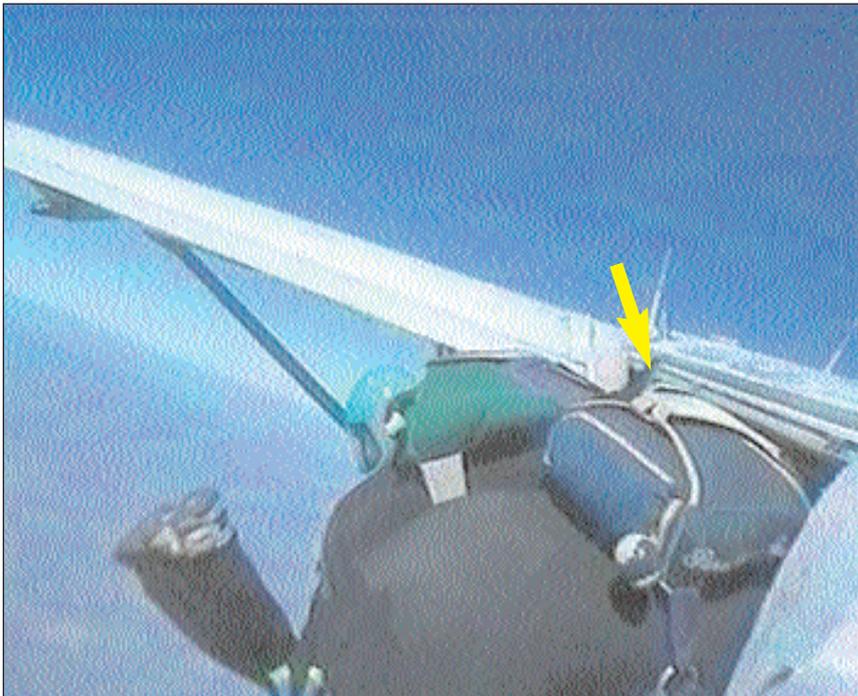
FIGURE 3:

On an earlier flight on the day, the panel covering the parachutist's reserve parachute release mechanism opened during the exit from the aircraft. The parachutist continued that descent normally and, after landing, was advised by the other team

A previous jump – loose release mechanism panel on exit

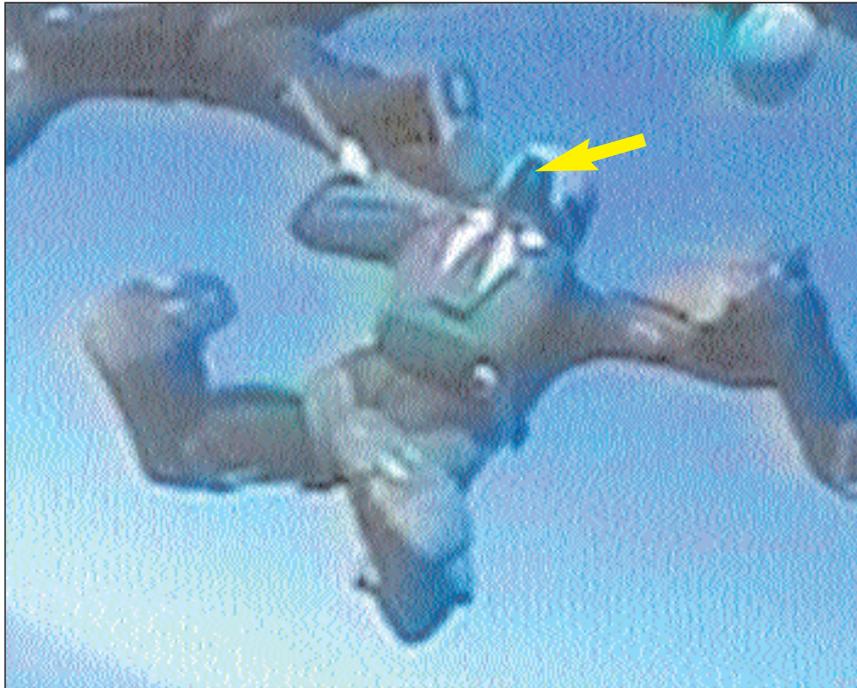
FIGURE 4:
A previous jump – loose release mechanism panel during freefall

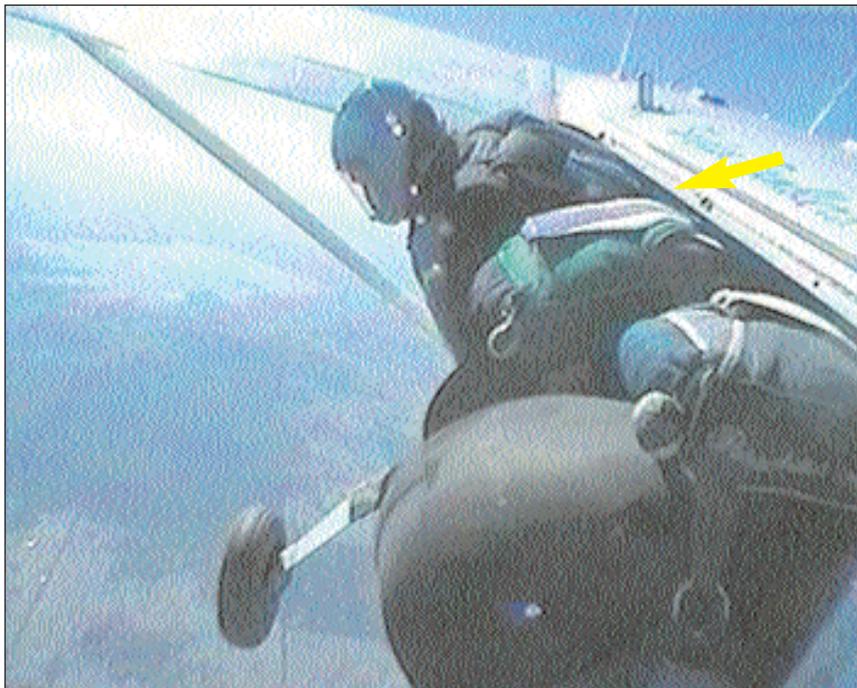
A video of the accident flight showed the parachutist in the aircraft doorway in a position in which the parachute container, instead of the helmet, was in contact with the top of the doorframe/handrail (see fig 5). Subsequent frames from the video showed the deployment of the reserve parachute as the team exited (see fig. 6, 7 and 8).

FIGURE 5:
Accident jump – exit readiness position with reserve parachute cover against door frame

1. The parachutist's reserve parachute deployed prematurely, probably as a result of the parachute container coming into contact with the aircraft doorframe/handrail.
2. The reserve parachute risers and lines tangled around the horizontal stabiliser and elevator.
3. The reserve canopy partially filled, applying to the aircraft empennage a load that exceeded its design limits.
4. The empennage separated from the aircraft and the elevator separated from the empennage, releasing the parachutist and sending the aircraft out of control.

The Australian Transport Safety Bureau recommends that the Australian Parachute Federation advise its members of the need to use exit techniques and positions that avoid any contact between the parachute container and the aircraft.

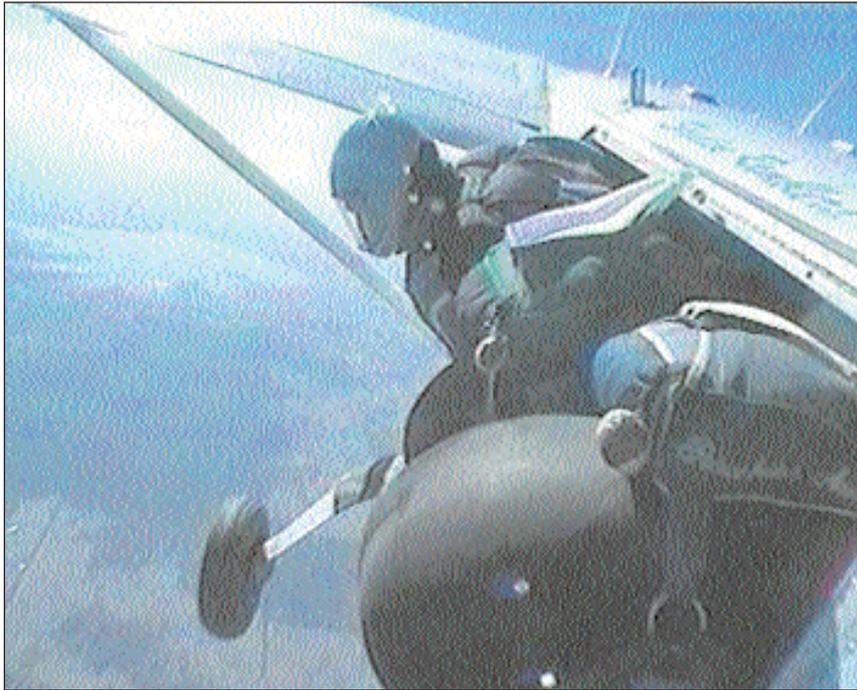
FIGURE 6:
Accident jump – pilot chute cover open

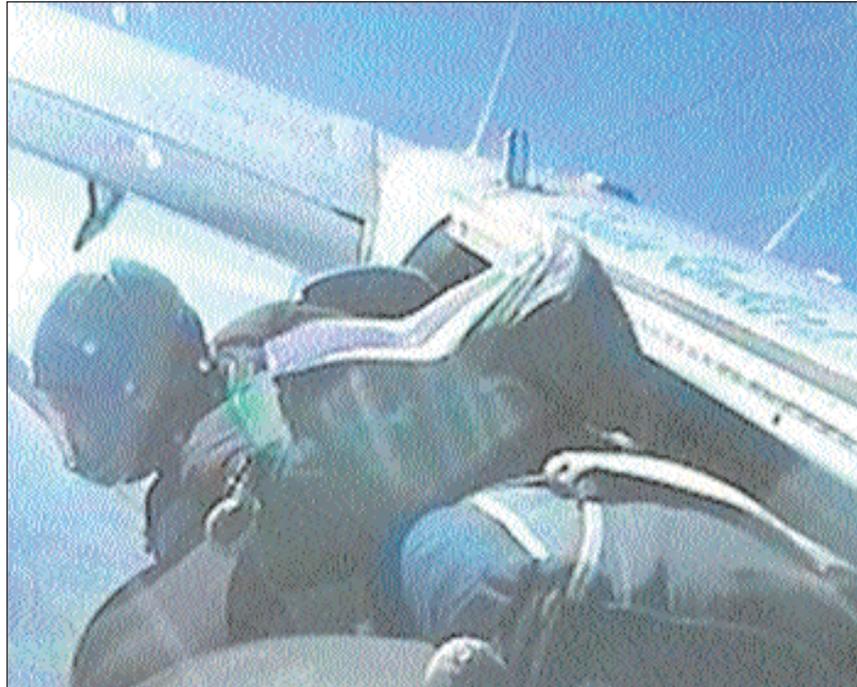
As the team exited the aircraft, the middle parachutist's reserve parachute's pilot chute deployed. Due to the bent over position of that parachutist, the action of the ejector spring in the pilot chute pushed the chute upwards and over the horizontal stabiliser of the aircraft, pulling the reserve canopy with it. The parachutist passed below the horizontal stabiliser resulting in the reserve parachute risers and lines tangling around the left elevator and horizontal stabiliser. Eleven seconds later, the empennage separated from the aircraft and the left elevator and the parachutist separated from the empennage. The parachutist descended to the ground with the reserve and main parachutes entangled and landed 800 metres west of the drop zone landing strip. A short section of the elevator was tangled in the parachute lines. The parachutist's rate of descent was estimated to be 3.6 times greater than that for an average parachutist under canopy.

FIGURE 7:
Accident jump – ejector spring deploys pilot chute of reserve parachute

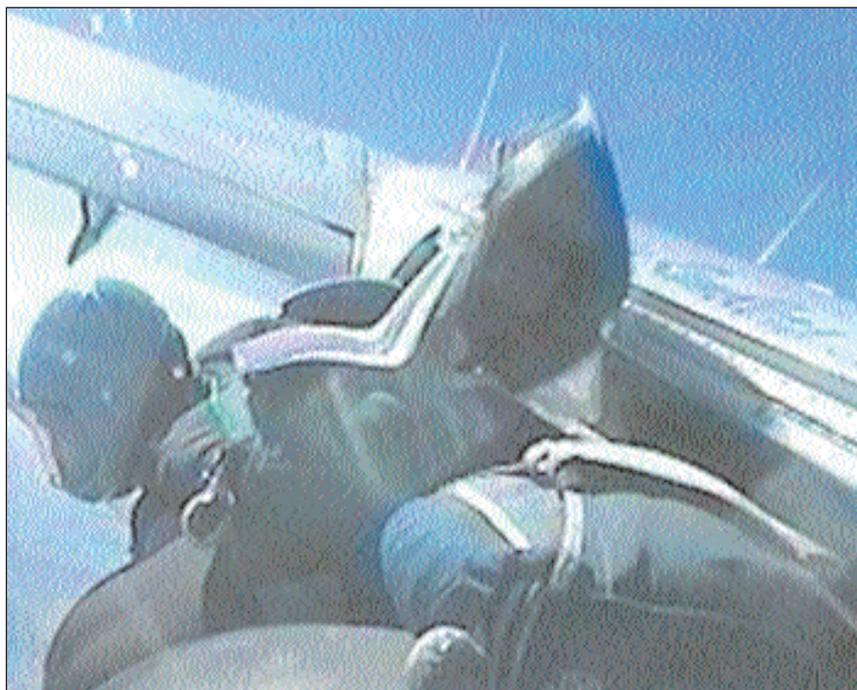
FIGURE 8:
Accident jump – pilot chute deploys

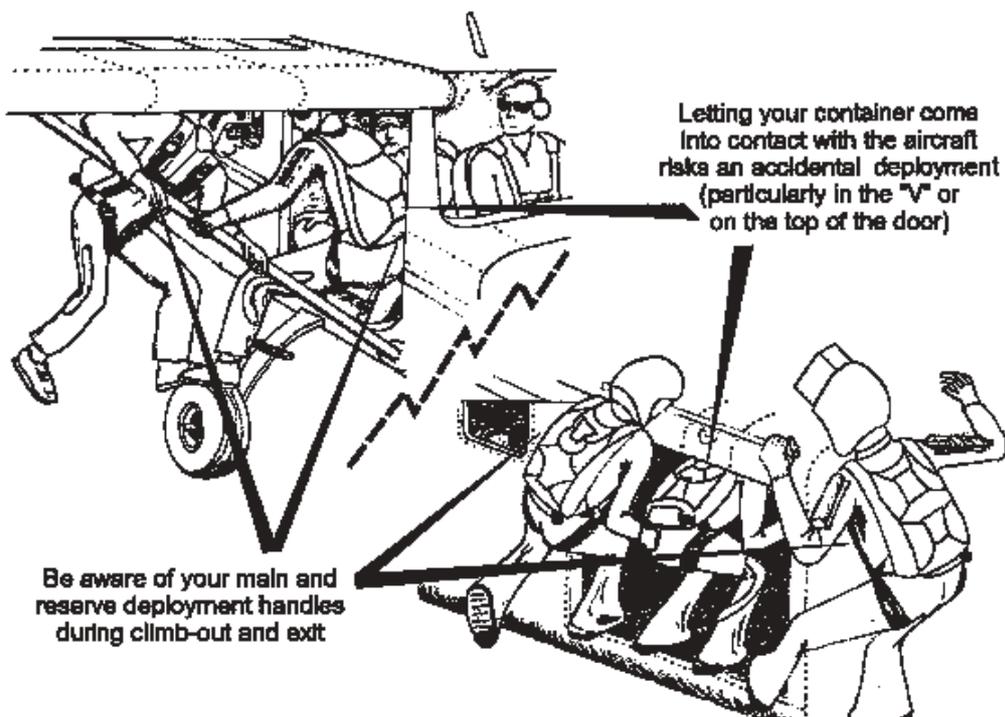
FIGURE 9:
Poster

Letting your container come into contact with the aircraft risks an accidental deployment (particularly in the "V" or on the top of the door)

A premature opening is hazardous at any time. It can be extremely hazardous if it occurs with an open door or during exit. The result can be major aircraft damage and serious, if not fatal, injury to the jumper.

The Australian Parachute Federation (APF) included a report of the accident that highlighted the dangers inherent in containers contacting parts of aircraft in Issue No. 6 (July 2001) of the Australian Skydiving magazine and the Federation's News-Sheet No 119 (July 2001). A follow up article and drawing was included in issue No. 7 (Sept 2001) of the magazine. The APF also issued a warning poster (see fig. 9) to personnel at drop zones and instructors.
