# Loss of control and collision with terrain involving Cessna 441, VH-XMJ

4 km west of Renmark Airport, South Australia on 30 May 2017

**ATSB Transport Safety Report**  
Aviation Occurrence Investigation  
AO-2017-057  
Final – 30 April 2020

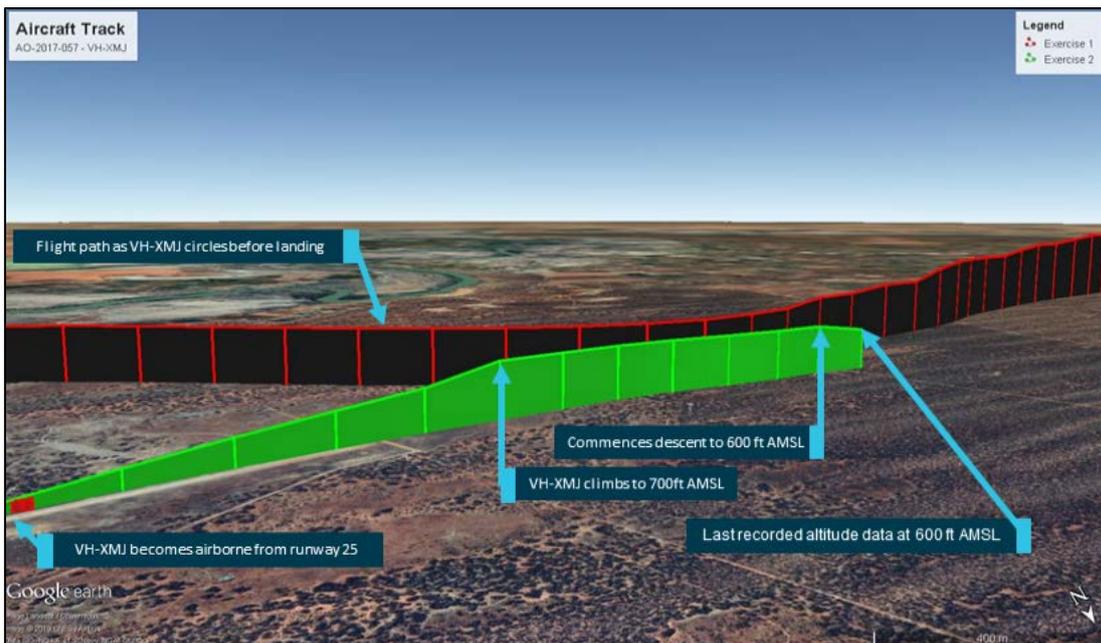
**Figure 2: Altitude information of VH-XMJ (each vertical line represents 5 seconds)**

The aircraft maintained the runway heading until reaching a height of between 300-400 ft above the ground (see the section titled *Recorded flight data*). At that point the aircraft began veering to the right of the extended runway centreline (Figures 1 and 15). The aircraft continued to climb to about 600 ft above the ground (700 ft altitude), and held this height for about 30 seconds, followed by a descent to about 500 ft (Figures 2 and 13). The information ceased 5 seconds later, which was about 60 seconds after take-off.

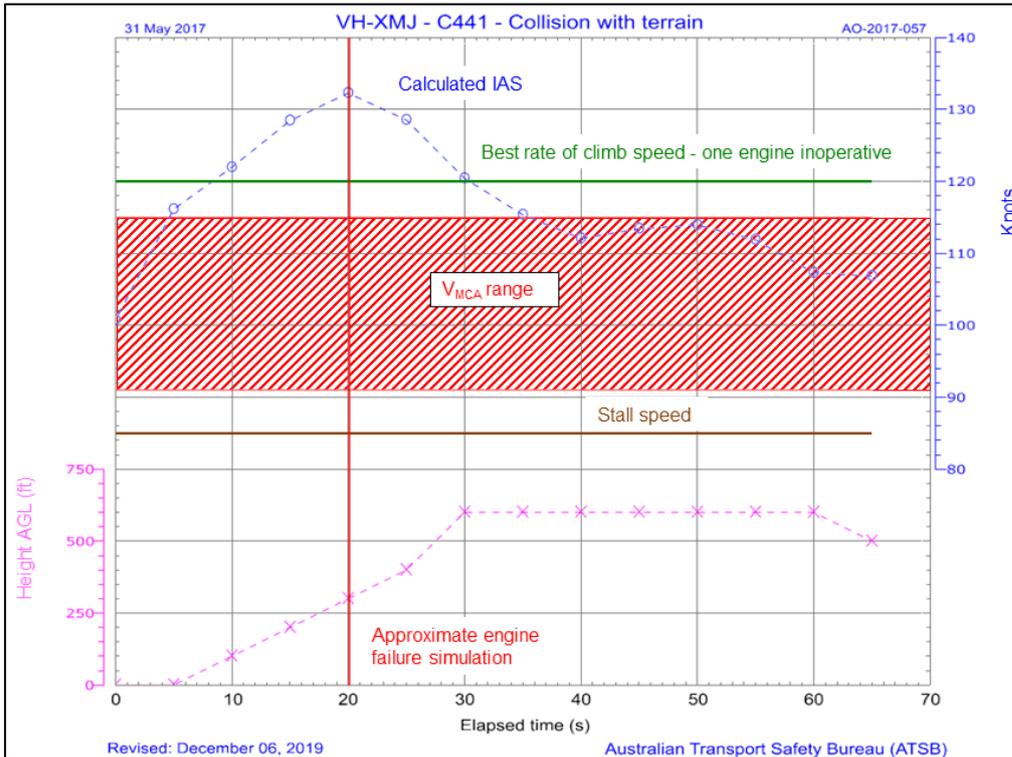
**Figure 13: Indicated airspeed and altitude variation over the final minute of flight**

The data showed a steady increase in airspeed up to about 132 kt, followed by loss of airspeed, brief stabilisation around 110-115 kt, then a further decrease to about 107 kt before the data ended. The maximum recorded airspeed was about 10 kt higher than published OEI best rate of climb speed  $V_{YSE}$  (120 kt, see the section titled *Asymmetric performance*) and occurred at a height of about 300 ft above ground level.

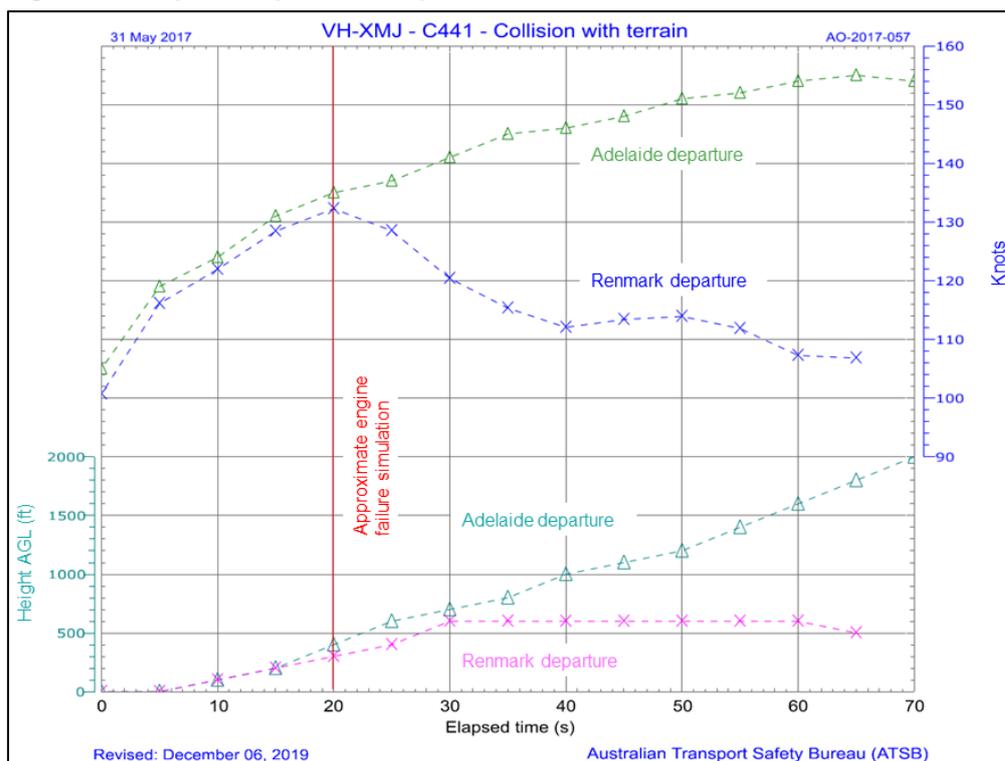
**Figure 14: Departure profile comparison**

Figure 14 illustrates the difference in the calculated IAS and height (above ground level) profiles between the departure from Renmark Airport and the earlier departure from Adelaide Airport.

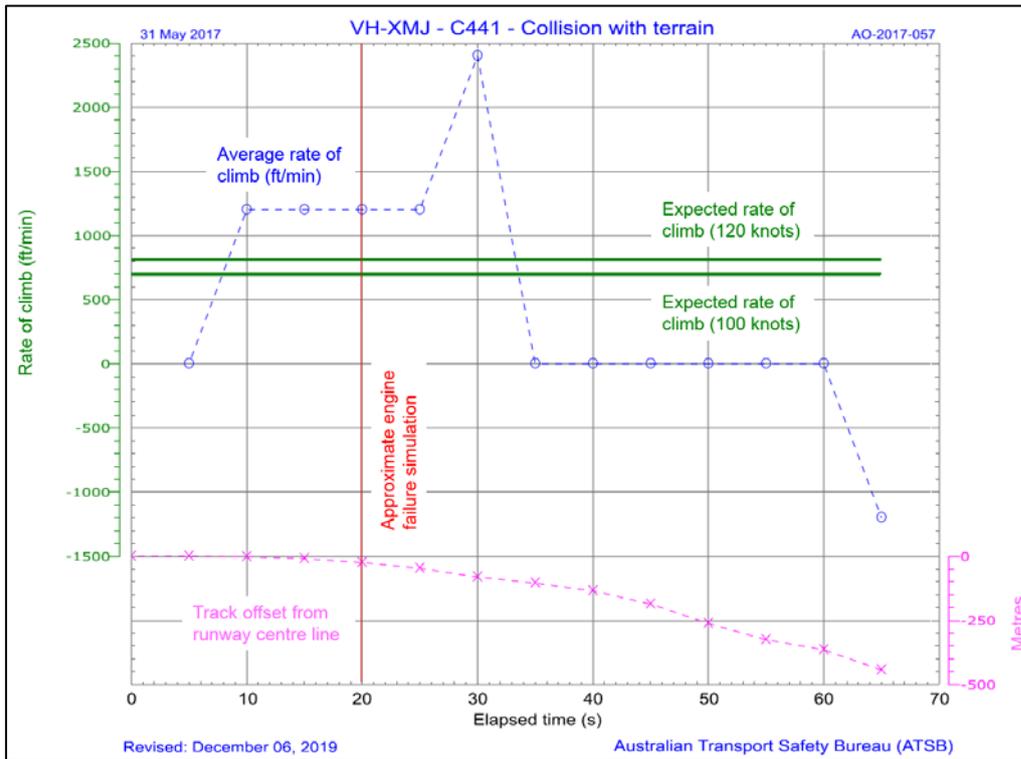
Figure 15: Rate of climb and track variation over the final minute of flight

In addition to the airspeed variation, the aircraft’s rate of climb was derived from the GPS altitude data and is shown, together with the aircraft’s track deviation from the runway heading in Figure 15. The data indicated that the aircraft initially climbed at greater than the expected OEI rate of climb before levelling and maintaining approximately level flight for 30 seconds until the data ended. A review of the airspeed over the same time period identified that it reduced during the peak increase in the rate of climb, suggesting that the aircraft was pitched up to reduce airspeed.

Analysis of the track variation identified that the aircraft deviated to the right of the runway centreline during the final minute of the flight. That movement was consistent with both the prevailing left crosswind component during the departure and a reduction in power on the right engine.

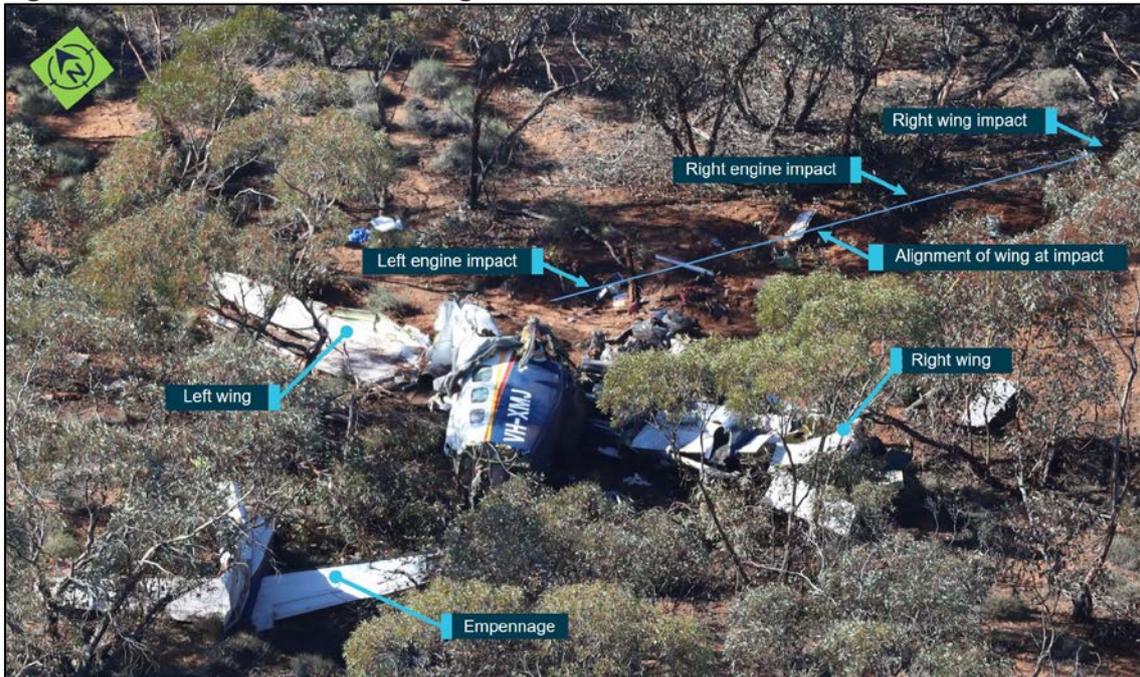
**Figure 19: Accident site and wreckage of VH-XMJ**

The aircraft was destroyed as a result of the ground collision. There was no subsequent fire, however, damage to the aircraft precluded a complete examination of a number of the aircraft systems. On-site examination of the wreckage and later examination of recovered components did not identify any pre-impact faults that could have contributed to the accident.
