AIRCRAFT ACCIDENT INVESTIGATION REPORT

ALL NIPPON AIRWAYS
BOEING 767-200, JA8254
SHIMOJI-SHIMA AIRPORT, OKINAWA, JAPAN
JUNE 26, 2002

November 28, 2003

Aircraft and Railway Accidents Investigation Commission
Ministry of Land, Infrastructure and Transport

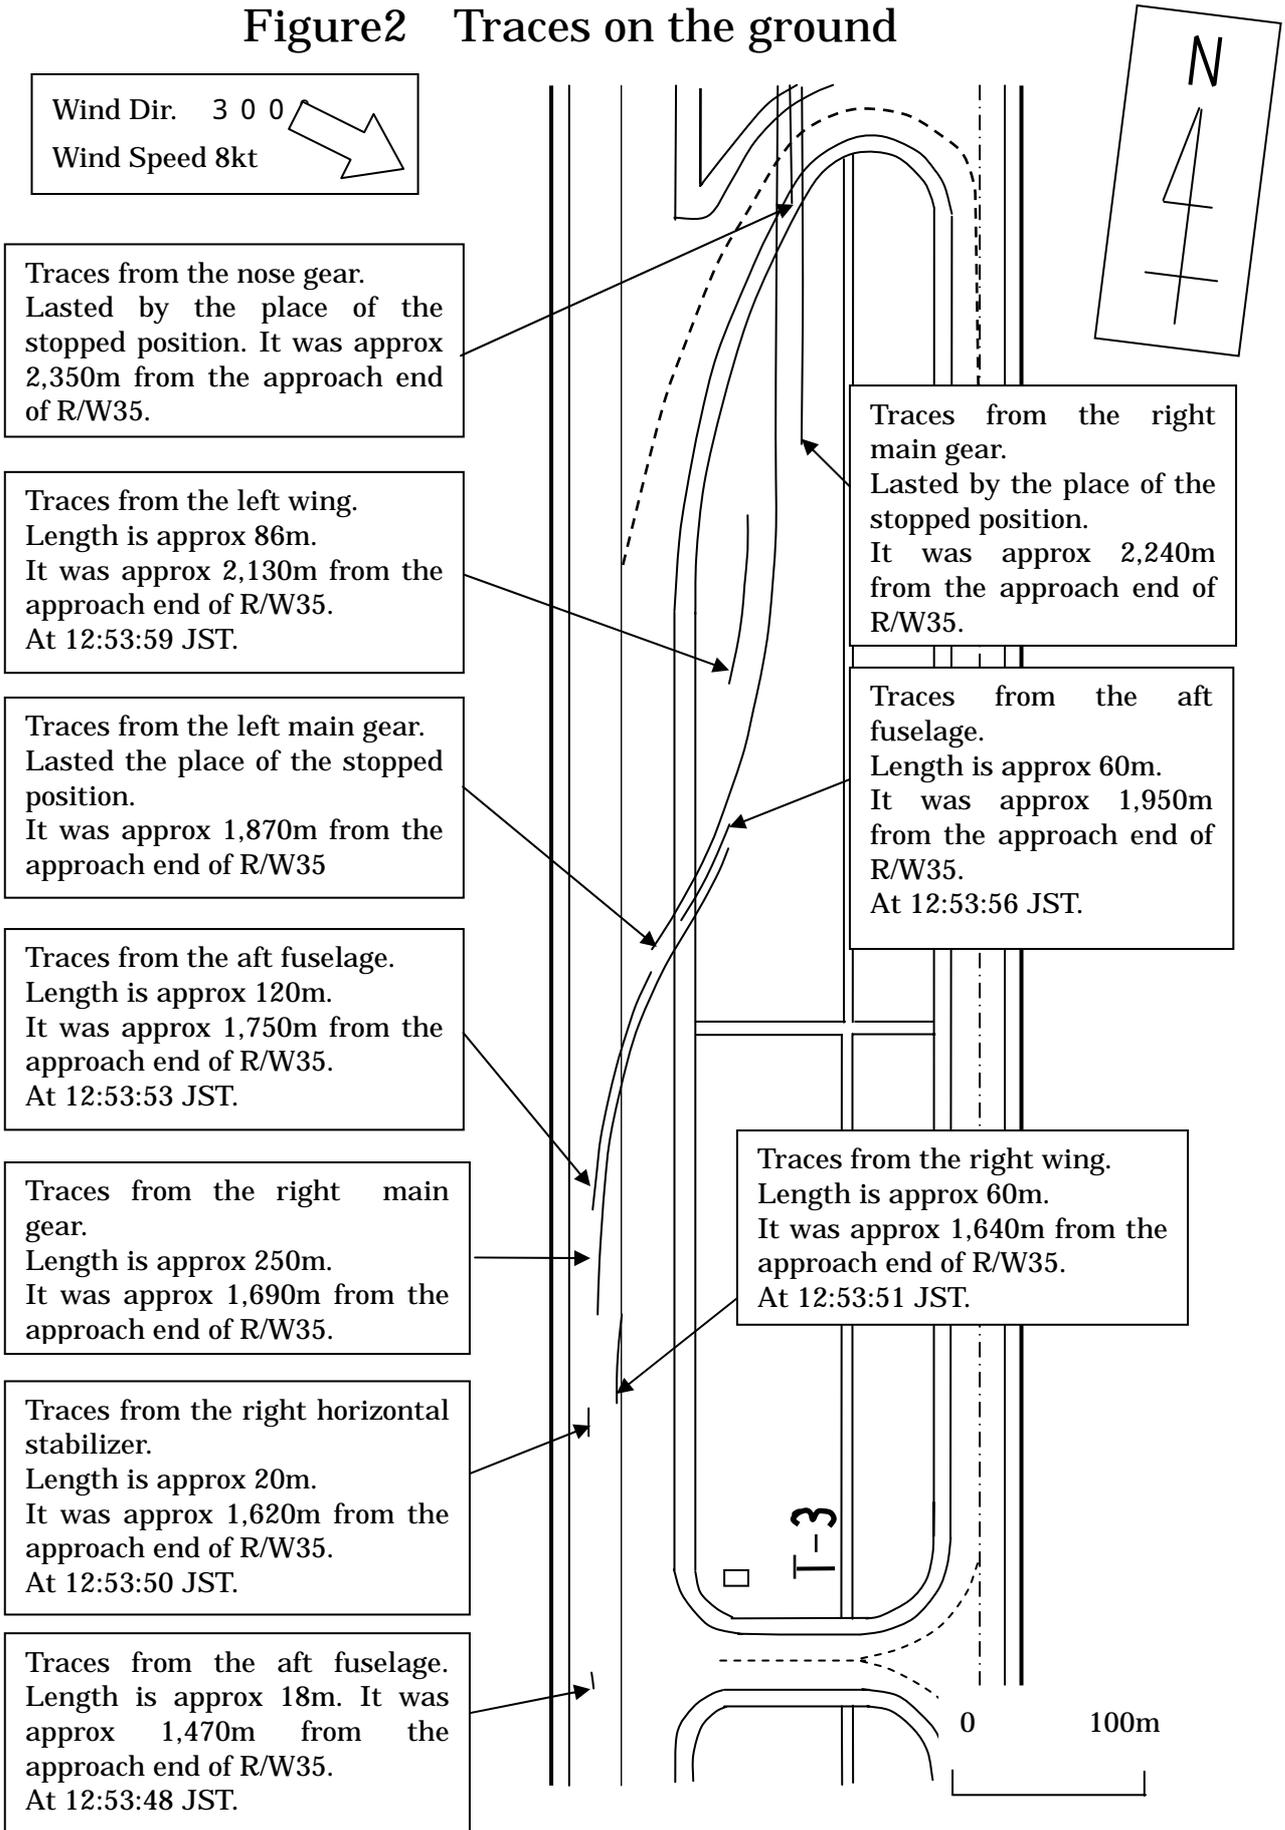
Figure2 Traces on the ground

Traces on the ground thought to have been caused by abrasion of the aircraft's aft fuselage, right wing and right horizontal stabilizer, and tracks from the left and right main landing gears were found in an area extending from the vicinity of the No. 5 DML of runway

35 to approximately 100 m north of the No. 4 DML. Furthermore, tracks from the left and right main landing gears and nose gear and traces from the aft fuselage and left wing were found in the grass area east of runway 35 from this position to place where the aircraft had come to a stop.

Scratches around 60 m in length caused by contact of the right wing with the ground started around 1,640 m beyond the threshold of runway 35. It is estimated that these were created at 12:53:51, when the pitch angle was 13.3° and the roll angle was 17.9° to

the right. Honeycomb material from the wing internal structure were found adhered to the scratches over the first half of their length, and the scratches were sharply excavated over the latter half of their length.

The next scratches started from around 1,750 m beyond the threshold of runway 35 and continued for around 120 m. Judging from the position of the traces described in above, these were caused by contact of the aft fuselage with the ground. It is estimated that these were created at 12:53:53, when the pitch angle was 14.5° and the roll angle was 10.7° to the right.

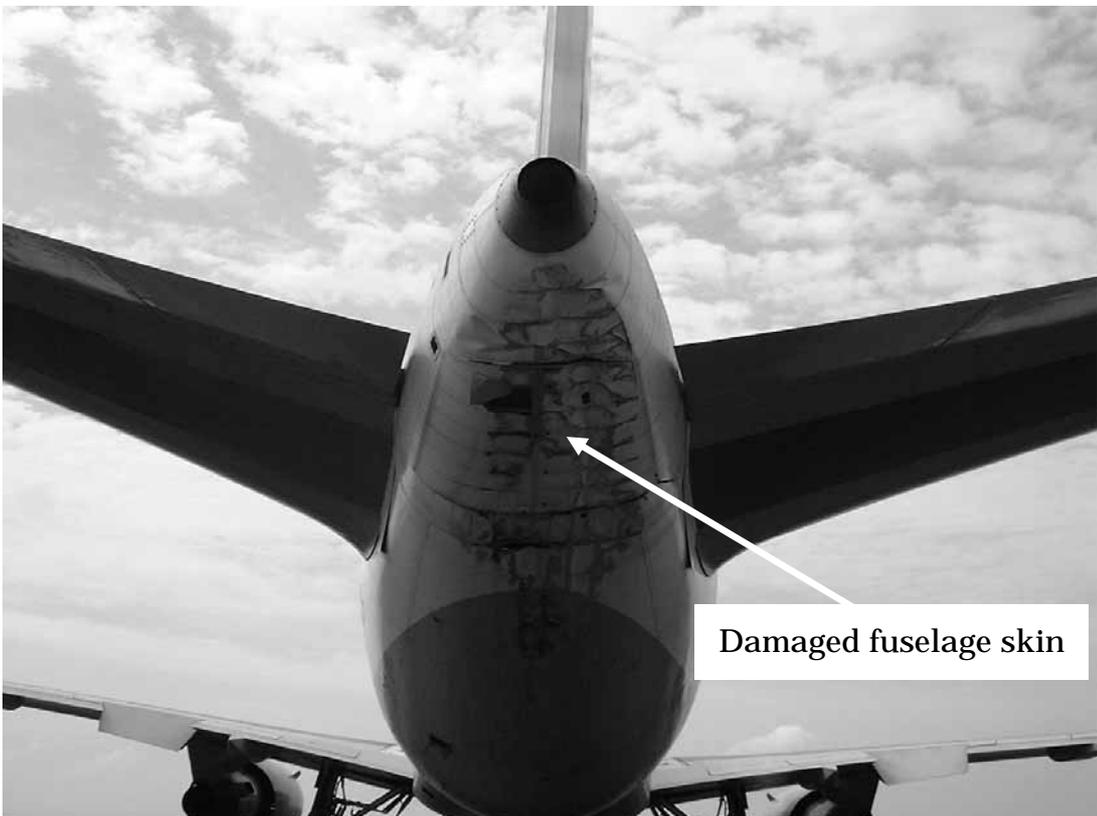
Photograph 2 Damage of the aft fuselage

Abrasions considered to have resulted from contact with the ground were found on the lower skin of the aft fuselage extending from STA.1629 to approximately 8 m aft (between STA 1629–1702), with parts of some skin panels folded or perforated in places. Scooped up grass and mud was found in the skin perforations and where the skin panels had been folded. The frames and stringers between STA1725–1809.5 were buckled and deformed.

APU door was folded and deformed, and the APU attaching mount was damaged.

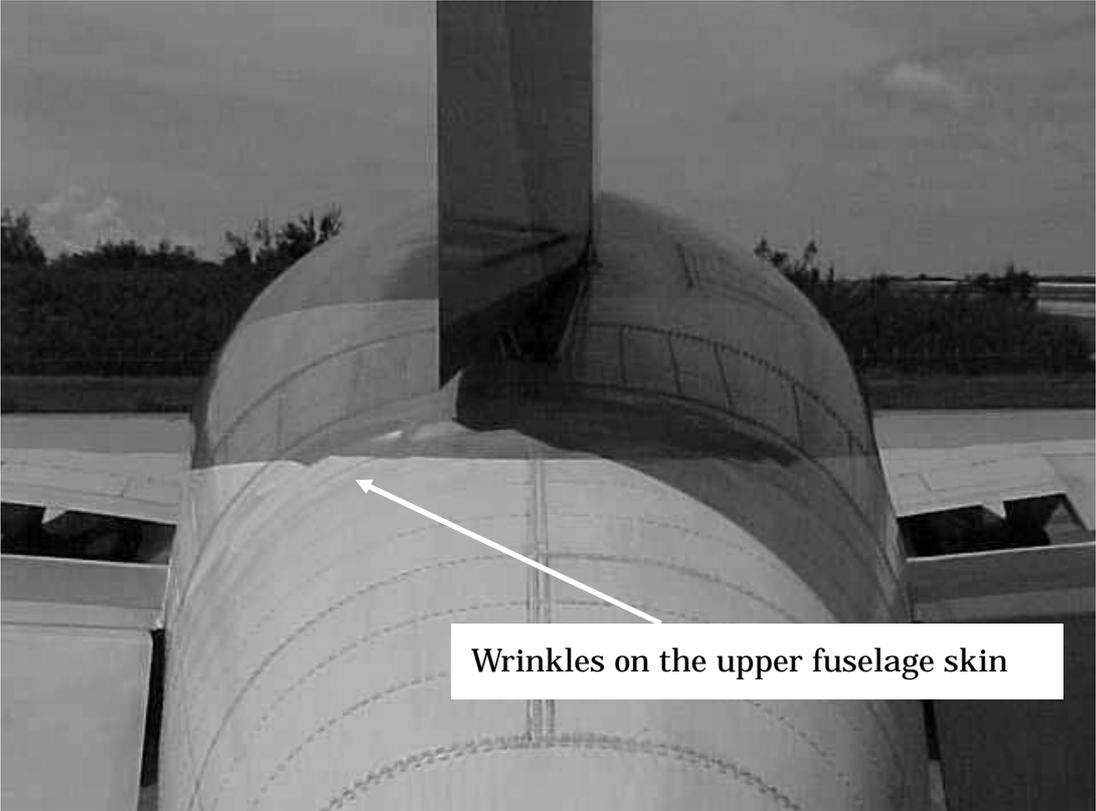
Photograph 3 Wrinkles on the upper fuselage skin

Wrinkles were found in the skin on the right side of the aft fuselage between the horizontal stabilizer and vertical stabilizer.

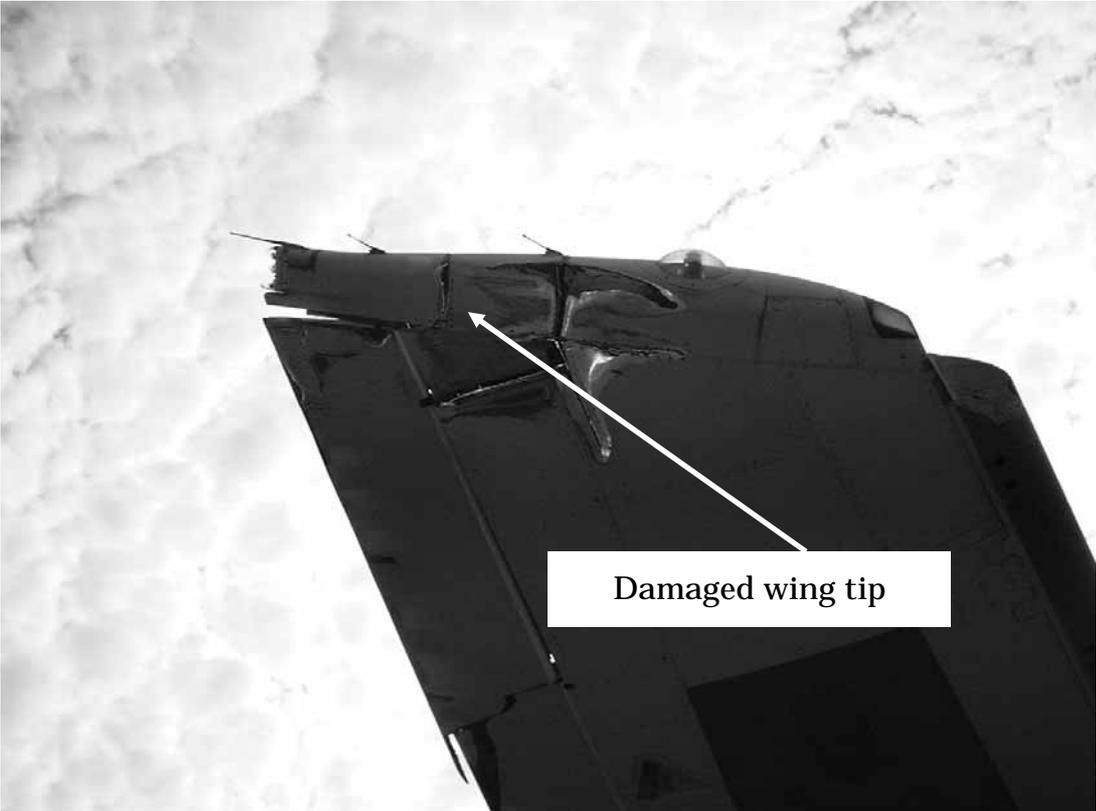
Photograph 4 Damages of the right wing

The right outboard aileron was broken and abrasions were found on its lower surface. Furthermore, the hinges on the aircraft were damaged.

Fuel leakage was found from the right wing fuel tank.

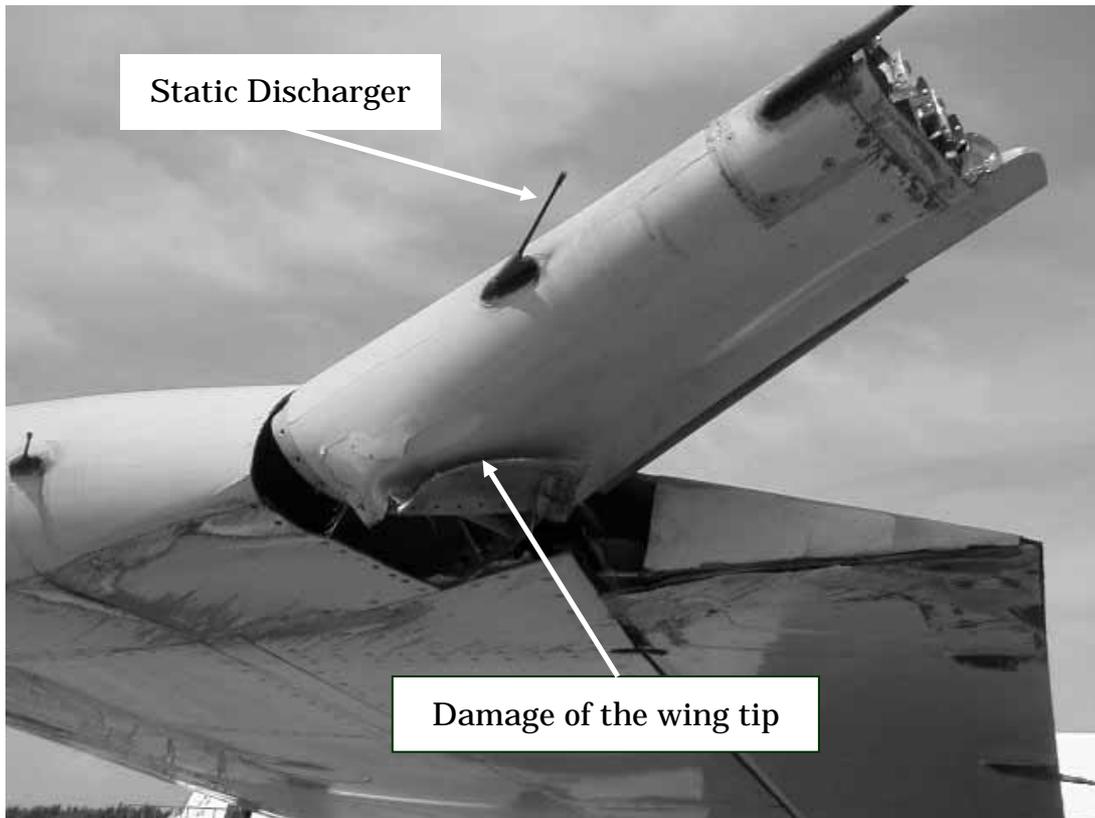
Photograph 5 Damage of the left wing

Abrasions were found on lower surface of the left outboard aileron.

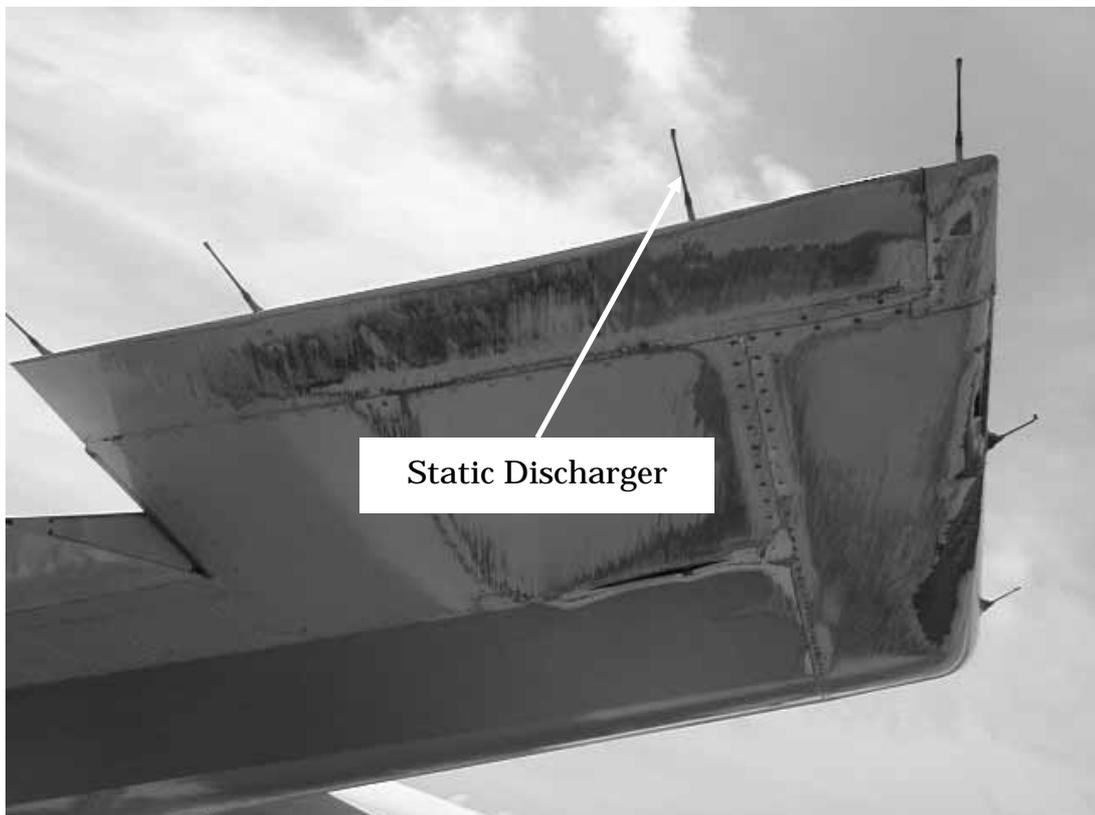
Photograph 6 Damage of the right horizontal stabilizer

Abrasions were found on the lower surface of the right horizontal stabilizer, and rear spar was deformed in tip area.

Wrinkles were found in the upper skin of the right horizontal stabilizer.
