# Aviation safety investigations & reports

## Raytheon Aircraft B200C, VH-AMR, 6 km NE Coffs Harbour Airport, 15 May 2003

200302172

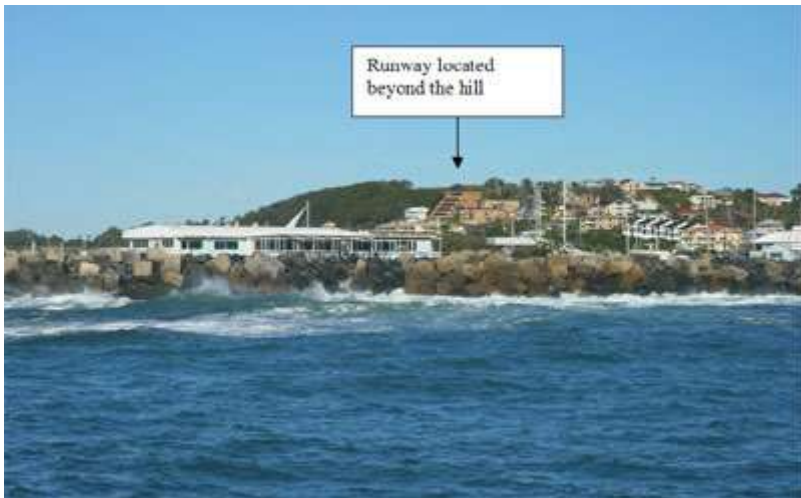
**Figure 1.** View of Coffs Harbour boat harbour northern breakwater from north-east.

Witnesses on the northern breakwater of the Coffs Harbour boat harbour observed an aircraft appear out of the heavy rain and mist from the north-east. They reported that it seemed to strike the breakwater wall and then passed over an adjacent restaurant at a very low altitude before it was lost from sight. Wheels from the left landing gear were seen to ricochet into the air and one of the two wheels was seen to fall into the water. The other wheel was found lodged among the rocks of the breakwater.

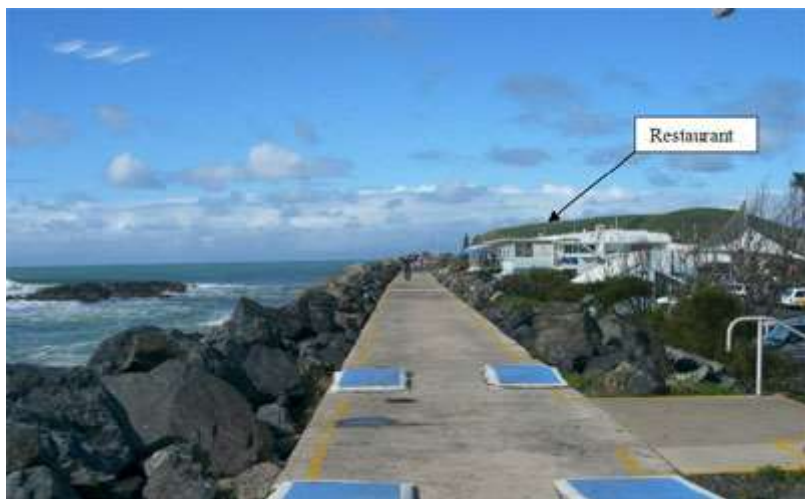
**Figure 2.** Northern breakwater of Coffs Harbour boat harbour. King Air flight path was from left to right of picture.

The likely trajectory of the King Air over the restaurant indicates that the aircraft overflew the breakwater at sufficient height for any attached landing gear to clear it. Therefore, the left main landing gear was dislodged, and the right main landing gear was impacted, prior to the aircraft passing over the breakwater. Although the lack of impact marks on the tyres suggests impact with water, contact with an outlying reef could not be ruled out. Whatever the surface, the impact force probably had a similar effect to a 'bounced' landing, and helped impart sufficient upward momentum to the aircraft to allow it to clear the buildings on the breakwater as it overflew them in the go-around. Had the aircraft not bounced, it may not have had sufficient height to clear the breakwater, and as a result it could have impacted the buildings with catastrophic consequences. Additionally, had the aircraft not been in the go-around attitude and the nosewheel impacted the water, it may have resulted in the aircraft cartwheeling into the breakwater.

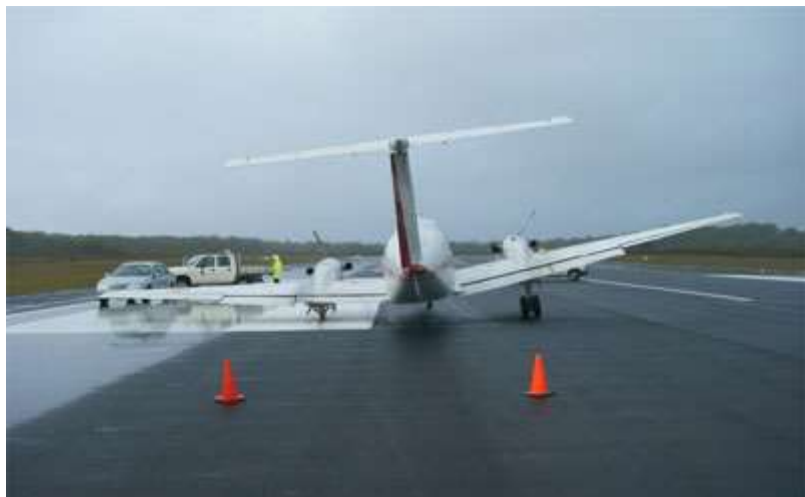
The left main landing gear oleo strut was severed, consistent with rapid rearwards bending. It was located in the water about 25 m to the north of the breakwater, with only one of the two wheels attached. The other wheel was found among rocks at the base of the breakwater. There were no impact marks on the tyres. The separation of the left main landing gear from the aircraft damaged the left inboard flap and resulted in an average flap asymmetry of 9 degrees. The impact force bent the right main landing gear rearwards about 5 degrees, but it remained attached to the aircraft. The nose landing gear and propellers displayed no evidence of impact damage.

**Figure 3.** King Air on runway 21 at Coffs Harbour.

The structural damage resulting from the impact with the sea or reef was consistent with damage sustained in a heavy landing. The impact forces damaged both engine nacelles and main landing gear wheel wells. The wing centre-section outboard ribs rear of the main spar and the lower fairing skins were buckled, and both ailerons were buckled outboard of the inboard hinge points. All of the upper and lower inboard wing assemblies were distorted. The inboard lower fuel tank linings were wrinkled and some fuel tank lining skins were cracked. The inboard wing leading edge upper skins were cracked, and the left wing leading edge upper skin and stringer were wrinkled.

The damage to the tips of the left propeller was consistent with their contact with the runway during the subsequent landing. About 40 mm of the upper left landing gear was ground away during the landing.
