AVIATION SAFETY INVESTIGATION REPORT  
BO/200105769

**Raytheon Beech 200C,  
VH-FMN**

**Mount Gambier, SA  
10 December 2001**

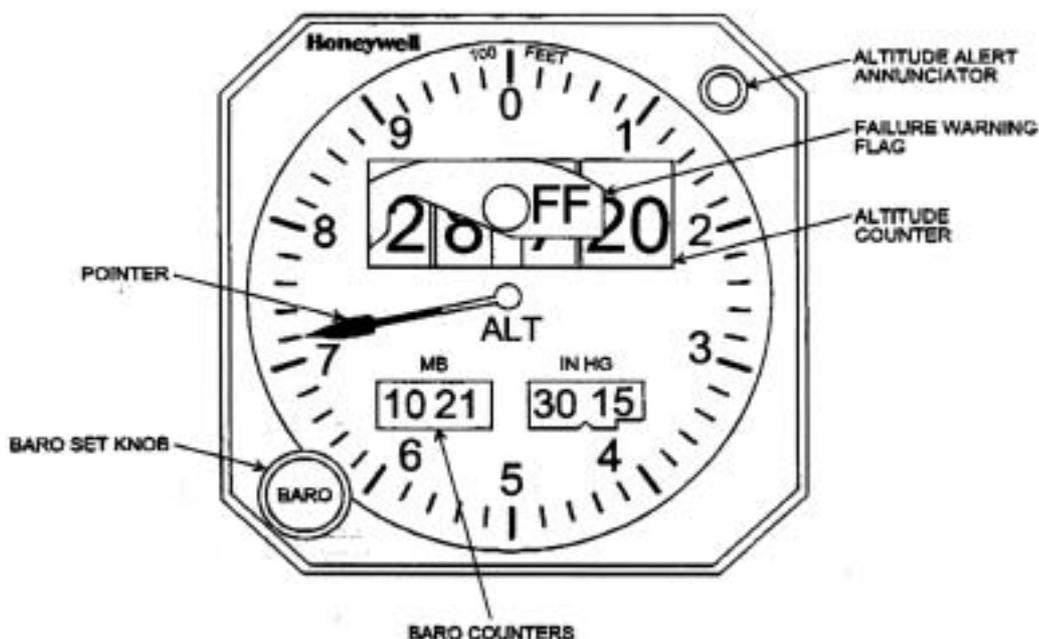
**FIGURE 2:**  
**Sperry BA-141 encoding altimeter**

The altimeter and pitot-static system was last inspected on 19 January 2001, with no anomalies noted. The BA-141 altimeter is depicted at fig. 2.

The aircraft was fitted with a Sperry BA-141 encoding altimeter that displayed altitude on a counter drum in addition to a pointer. Both the counter and pointer were calibrated in 20-ft increments. Failure warning was indicated by a large warning flag that obscured the counter drum when activated. The design of some older altimeters that used different altitude display methods, had been misread by pilots in previous occurrences. The BA-141 altimeter fitted to the occurrence aircraft did not use those display methods. Additionally, the pilot was familiar with the occurrence aircraft. The investigation therefore considered that it was unlikely that the pilot misread the altimeter fitted to the aircraft.

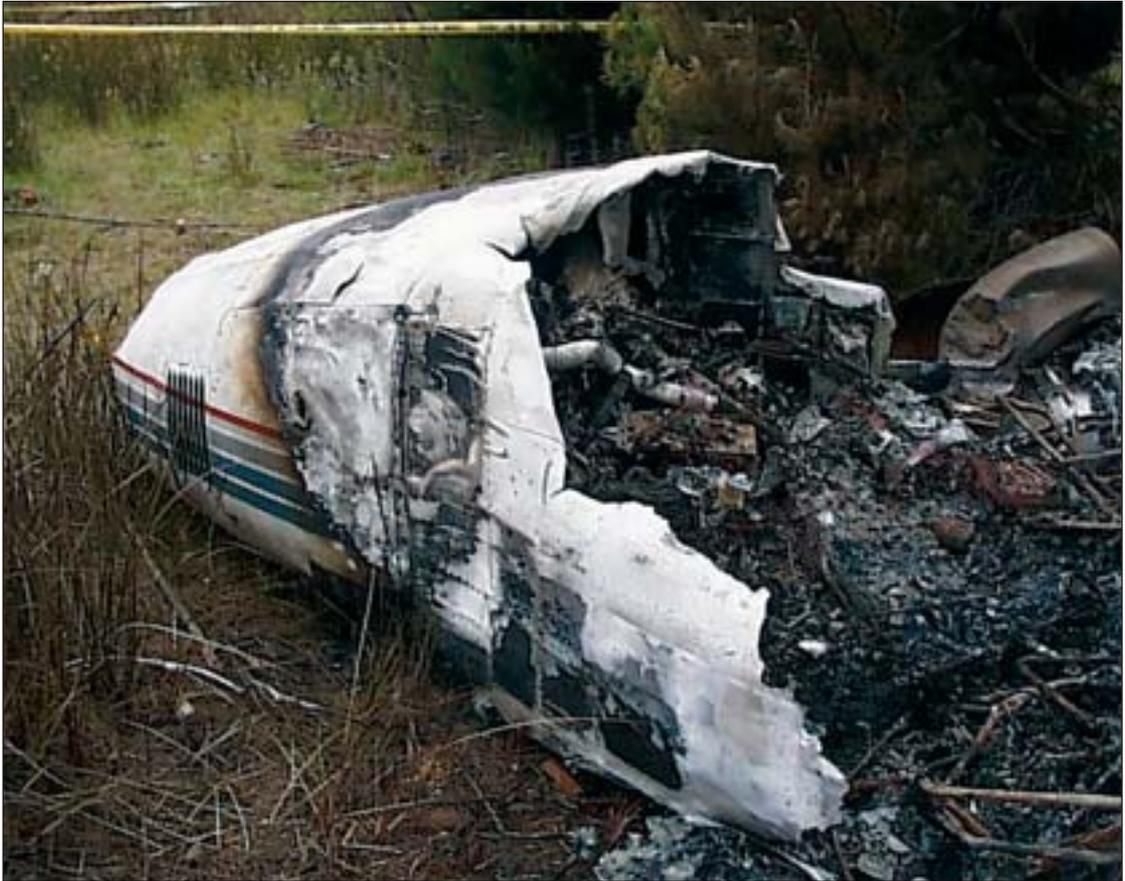
**FIGURE 4:**  
Extent of fire damage to cockpit area

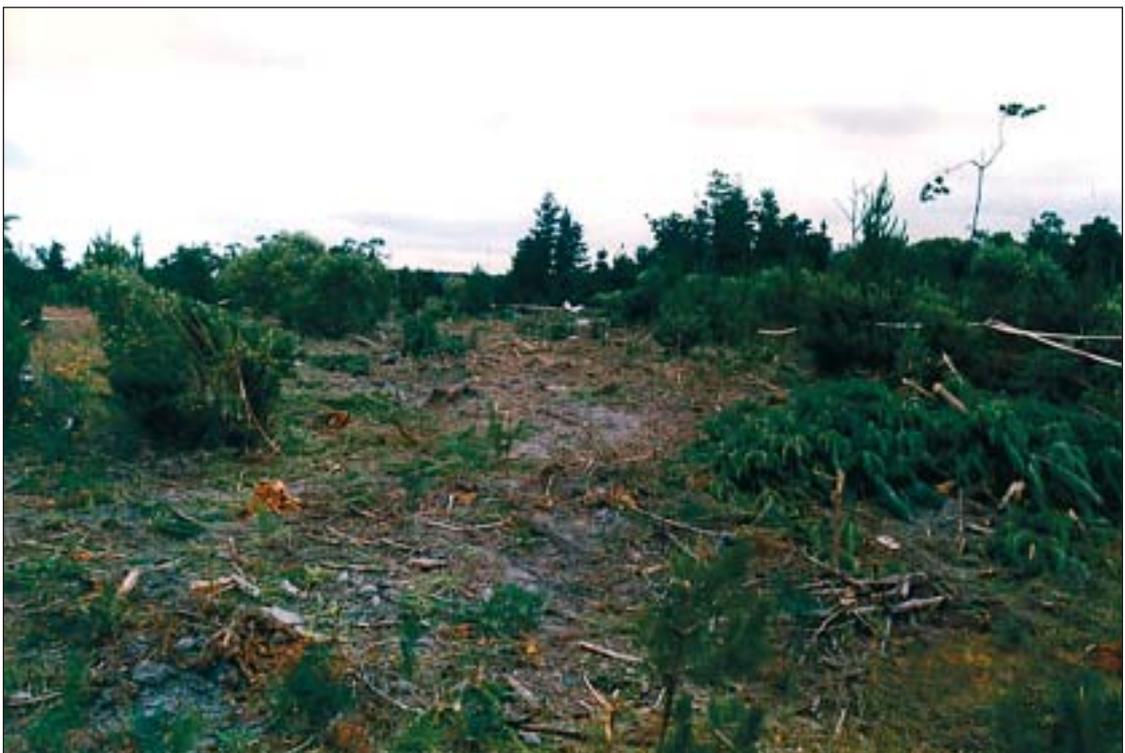
Ground vegetation consisted of a cleared pine plantation, with some secondary growth to a height of about 5 metres. Damage to trees in the approach path indicated an aircraft approach angle of about 10 to 13 degrees. The operator estimated that such an approach angle would

**FIGURE 5:**  
Impact swathe viewed from point of initial impact to final position

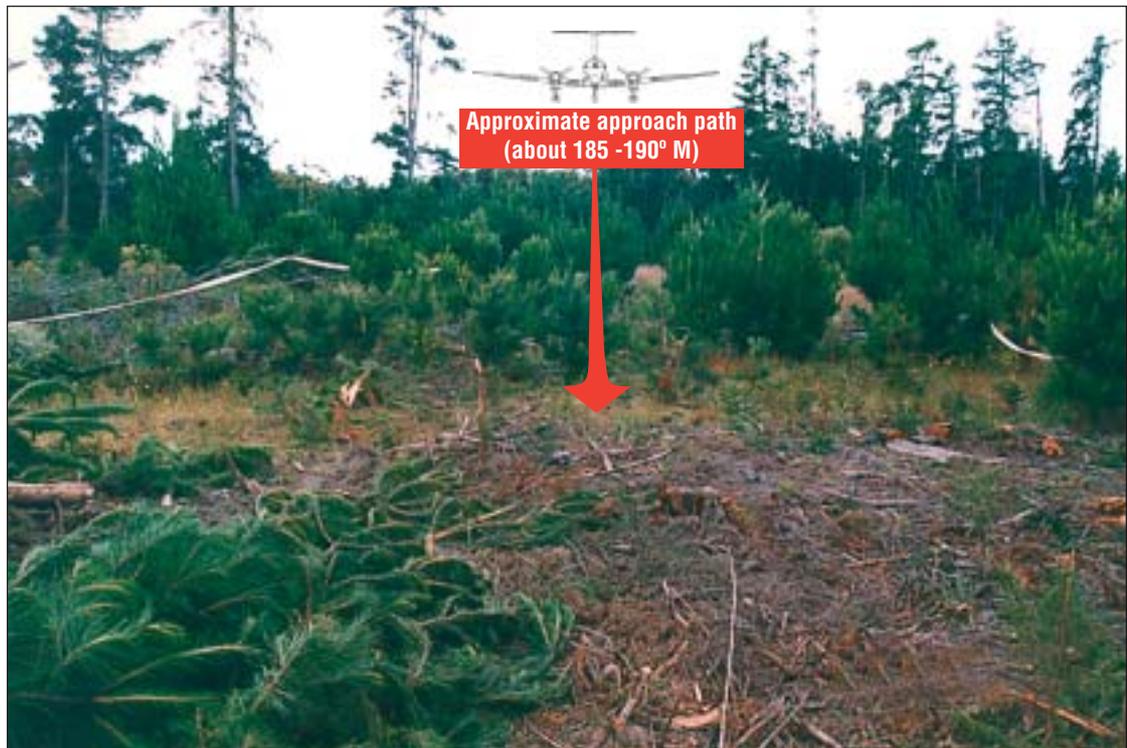
**FIGURE 6:**  
**Approximate aircraft approach path, looking back along flight path**

have required an aircraft attitude of about 5 degrees nose-down on the aircraft attitude indicator and a rate of descent of about 1,500 to 2,800 ft per minute, dependant upon indicated airspeed and wind effect. The aircraft's approach path is depicted at fig. 6. Due to impact and fire damage, no information was able to be obtained from cockpit instruments and flight control positions.

- The aircraft rate of descent at the point of impact was in excess of the 3 degree AT-VASIS glideslope. Damage to trees in the approach path indicated an aircraft approach angle of about 10 to 13 degrees. The operator estimated that such an approach angle would have required an aircraft attitude of about 5 degrees nose-down on the aircraft attitude indicator and a rate of descent of about 1,500 to 2,800 ft per minute, dependant upon indicated airspeed, wind effect and other factors. It is possible that the pilot remained at 1,200 ft or above until 5 NM from the VOR.
