Report 01-007

Partenavia P68B

ZK-DMA

double engine power loss

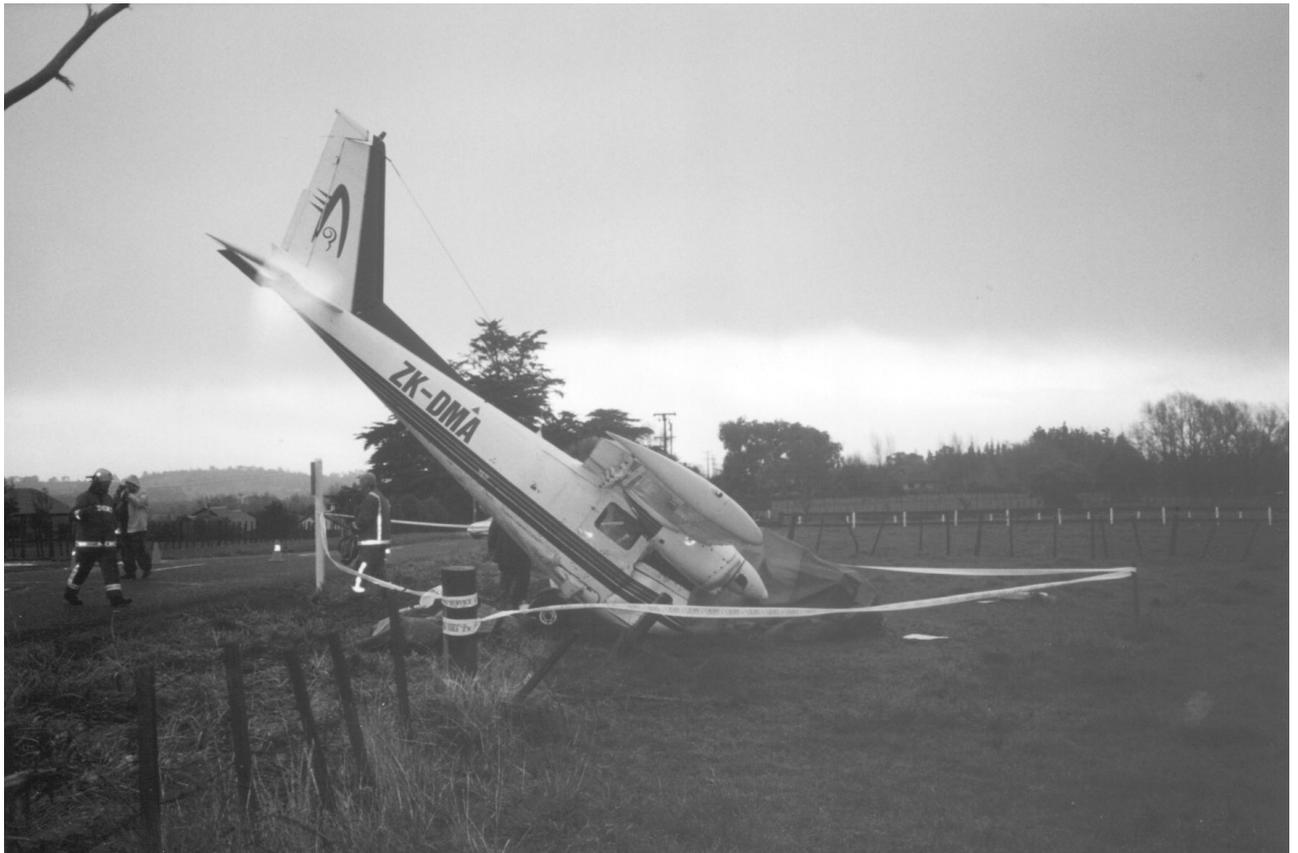
Partenavia ZK-DMA after the accident

- 1.4.1 The nose section, nose undercarriage and cockpit were destroyed in the accident. Some wing buckling was evident inboard of the engines. Both engines were intact and undamaged. The left wing tip struck a fence post. The left propeller was feathered and undamaged. The right propeller was not feathered, and one blade sustained tip damage. The damage was indicative of a low power contact.
