AIRCRAFT ACCIDENT 01/04

FINAL REPORT

FINAL REPORT ON THE ACCIDENT INVOLVING KISH AIRLINES FOKKER F27 MK.050, IRANIAN REGISTERED AS EP-LCA ON APPROACH TO SHARJAH INTERNATIONAL AIRPORT, UNITED ARAB EMIRATES ON 10 FEBRUARY, 2004

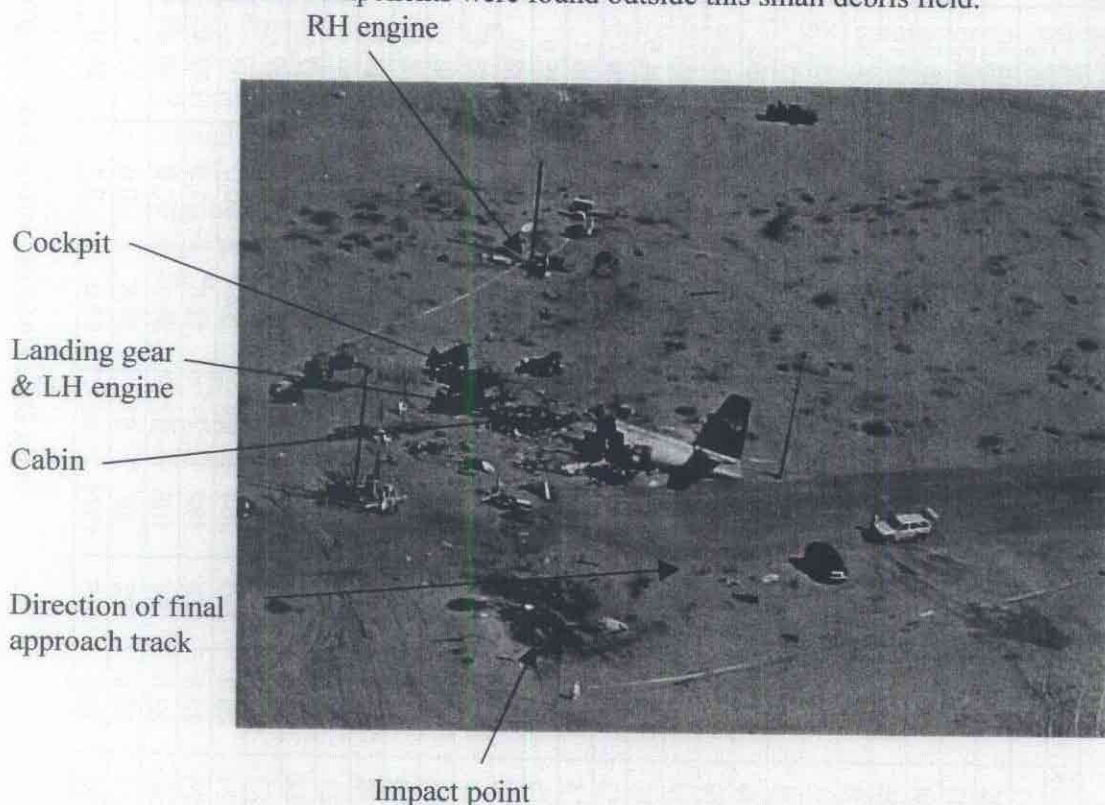
- 1.12.1 There was a single crater found in a flat sandy area on the opposite side of the road to where the majority of the wreckage was found. The scorched sand crater indicated an impact explosion but no impact information such as aircraft attitude or heading could be determined. As the wreckage of the cockpit, fuselage and tail section was located within 30m of the initial impact crater, it could be determined that the aircraft had a low horizontal velocity at the time of impact. There was evidence of scraping across the road in the direction of where the burnt out cabin was located indicating that the momentum of the aircraft on impact was towards 050° M. The severed tail section was aligned 330° M. whilst the burnt out fuselage wreckage indicated that the aircraft came to rest on a heading of 340° M. No aircraft components were found outside this small debris field.

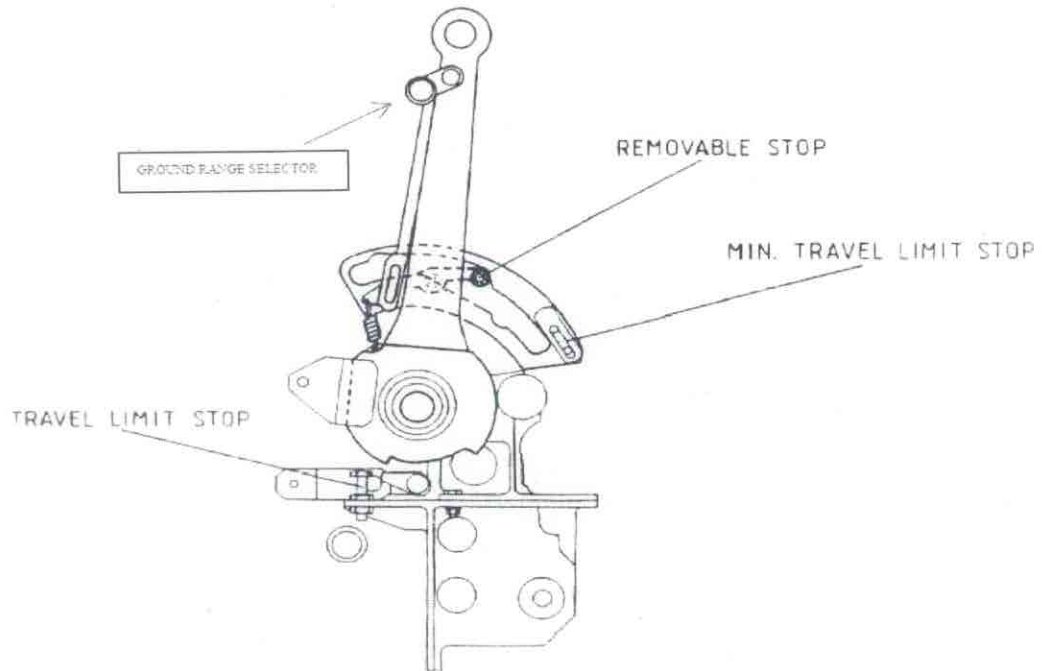
ILLUSTRATION 3

- (a) Mechanical flight idle stop (primary stop). To select ground control range after landing, the power levers must be in the flight idle position. The Ground Range Selector, which is fixed to the power levers, must be then physically lifted by a pilot to remove the mechanical stop so that the power lever can be moved backwards. This mechanism is designed to require a positive action by a pilot and cannot be accidentally moved. Refer to Illustration 3.

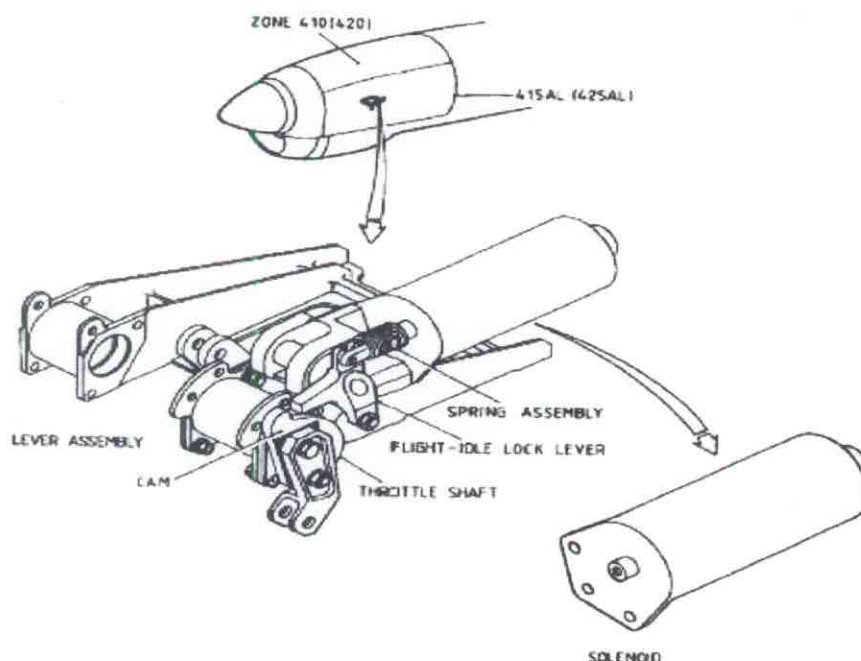
ILLUSTRATION 4

- (b) Electrical flight idle solenoid (secondary stop). Although not a requirement at the time the Fokker F27 Mk.050 was type certificated, there is an electrical flight idle solenoid (secondary stop) for each propeller located on each engine. Once energized the solenoid removes a flight idle lock lever. Each solenoid is powered through one Skid Control Unit and/or the Ground/Flight switches (refer paragraph 1.16.5 and Illustration 5). The solenoid prevents the corresponding power lever from moving from the flight idle position into a ground control range. Refer to Illustration 4.

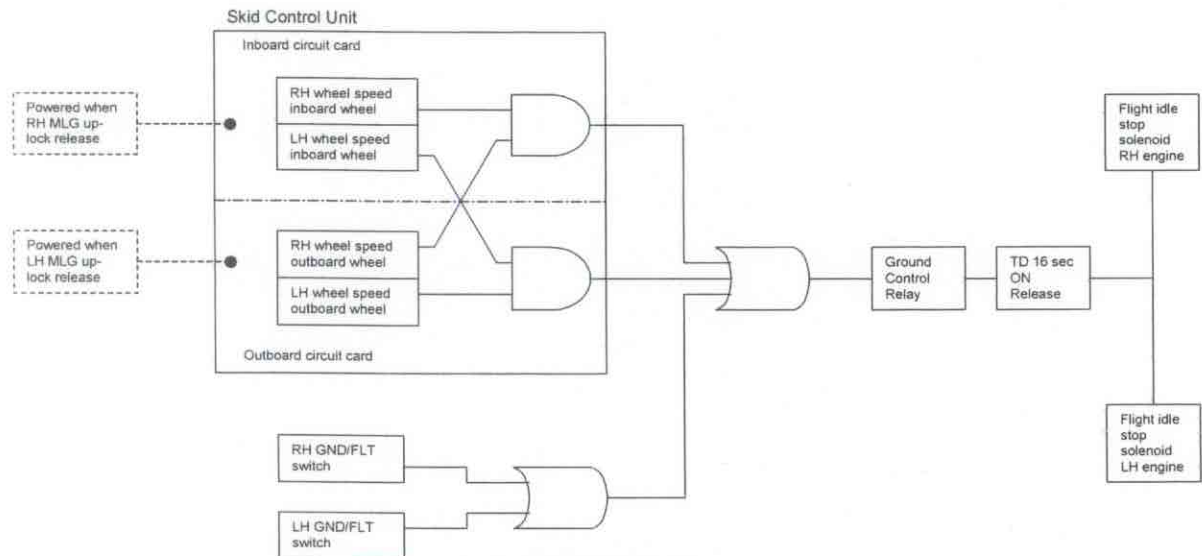
ILLUSTRATION 5

The latter two wheel speed signals are obtained from the Skid Control Unit. The Skid Control Unit is basically designed to provide optimum brake operation for all runway conditions. One of the basic inputs for this is the wheel speed of the different MLG wheels, sensed by the wheel speed sensors in each wheel axle. Hence, by using the wheel speed discretes from the Skid Control Unit, the Skid Control Unit forms a part of the system to control the Flight Idle Stop solenoids. The following Illustration 5 shows the relationship between the SCU and an electrical flight idle solenoid.

1.16.5.3 Undesired System Behaviour. The Skid Control Unit contains two channels which are electrically powered separately. The inboard card is powered when the RH MLG comes out of the up lock position and the outboard card when the LH MLG comes out of the up lock position.
