SL Report 2007/23

**REPORT ON THE AIRCRAFT ACCIDENT AT BODØ AIRPORT ON 4
DECEMBER 2003 INVOLVING DORNIER DO 228-202 LN-HTA, OPERATED
BY KATO AIRLINE AS**

June 2007

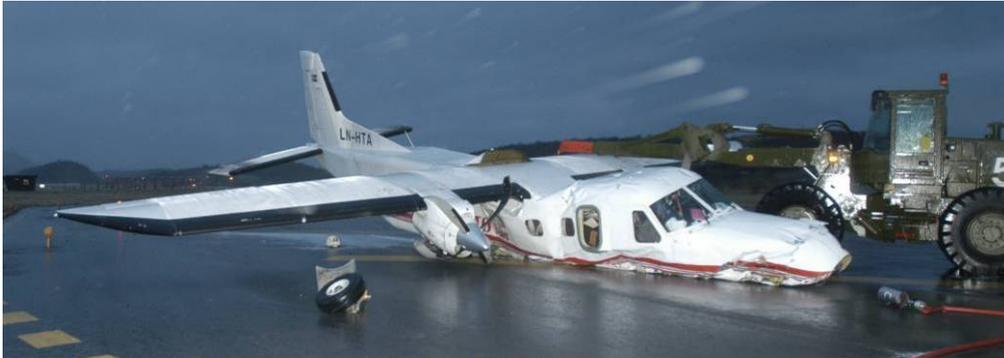
1.12.2.1 The aircraft's flight data recorder registered up to 8.4 G on impact. The landing was so forceful that the aircraft's nose wheel leg broke off and both main landing gears were pushed in, then twisted back and came loose. The force of impact pushed the aircraft's wing so far down into the cabin that the propellers on both engines were badly bent after contact with the ground. In addition, the whole of the aircraft's underside was compressed, particularly at the front. (See figures 4 and 5). This forced up the floor of the cockpit by about 20 cm, resulting in somewhat restricted legroom. Powerful vertical forces were transferred to the pilots and passengers via all the seats. These forces were most powerful in the front part of the aircraft, resulting in injuries to the pilots' back, buttocks area and neck.

Figure 4: The wreckage (photo taken by armed forces)

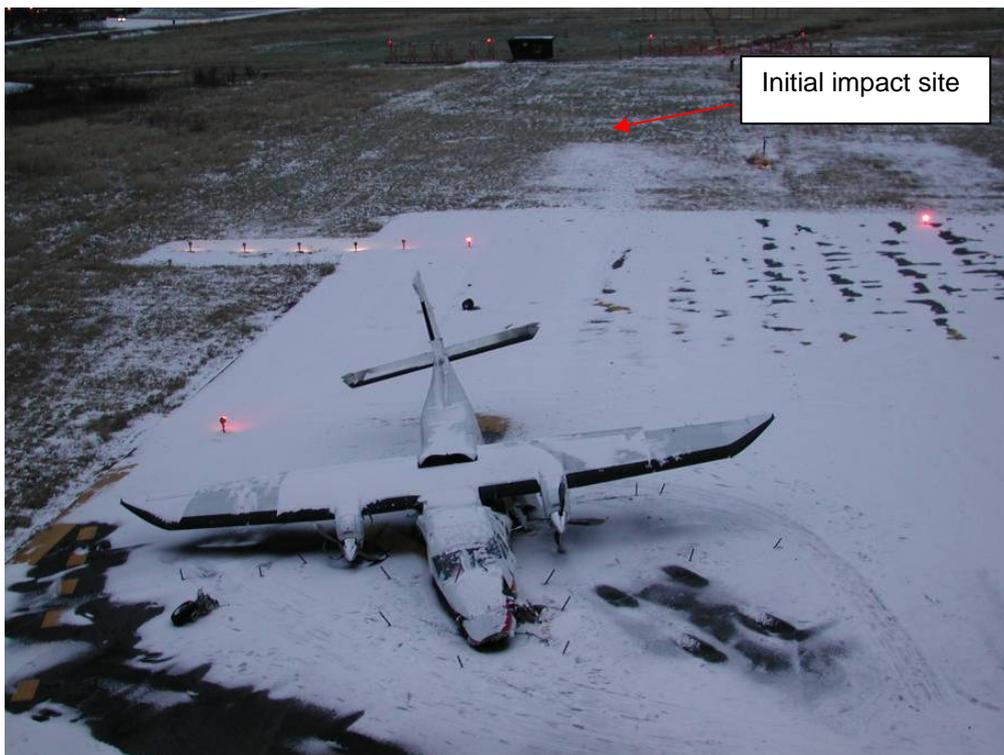
Figure 5: The wreckage (photo taken the day after the accident)

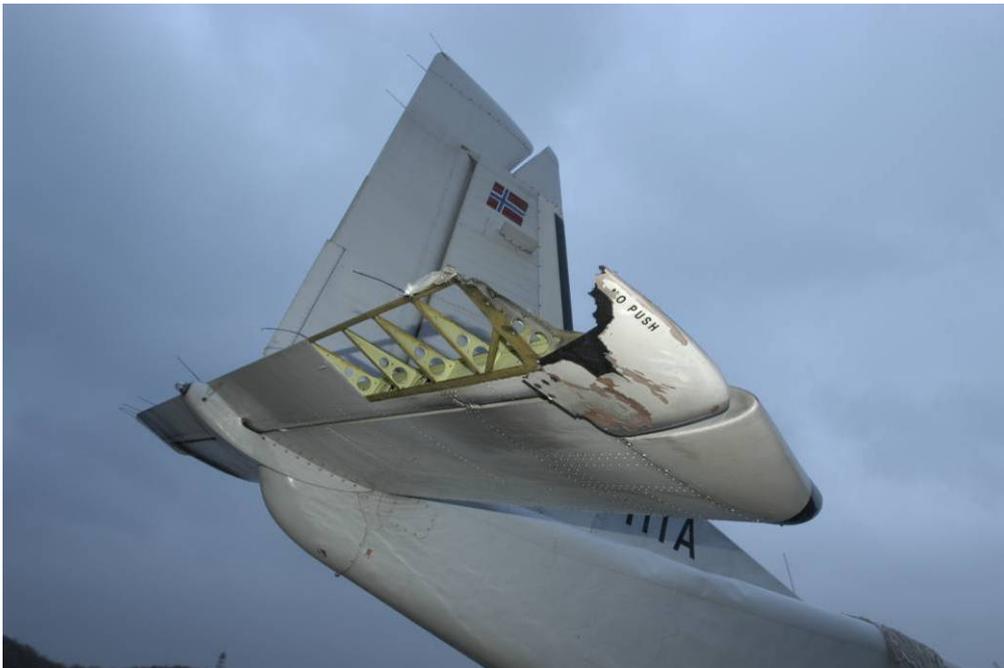
- 1.12.2.4 It was decided to remove the right elevator, the broken rod and the bondings between the fuselage and the horizontal tail surface for closer examination. During the dismantling of the elevator, damage to one of the four bolts holding the two halves of the right elevator together was also discovered. The bolt which also holds the corner where the elevator rod was fixed had gradually melted.

Figure 6: Damage to the right elevator (photo taken by armed forces)

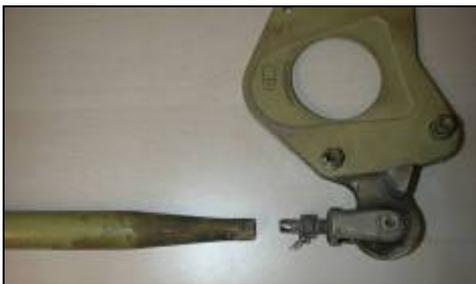
1.12.2.3 On the morning of 5 December, the aircraft was moved to one of the Norwegian Armed Forces' shelters for closer examination. It was then discovered that there was a break in the elevator control rod in the end that was connected to the elevator. The right elevator was missing approximately half of its fabric covering. About half of the carbon fibre cover on the end was also missing, including the elevator's outer static discharger (see figure 6). The outer right corner of the elevator's aluminium structure was also burnt off. With the help of an ohmmeter, a break in the electric connection between the elevator and the fuselage was discovered. Closer examination revealed several breaks in the bonding connections between the elevator and the fuselage (see figures 8 and 10). Almost the entire bonding on the outer bonding connection to the right elevator was missing. In addition, both nails holding the bracket to the bonding had melted leaving the bracket loose in the space between the elevator and the horizontal tail surface (see page 2 of Report by Norwegian Armed Forces, appendix B). It was also discovered that there was no electric connection between the horizontal tail surface and the fuselage. The reason for this was found to be that the tail surface was fixed by means of bearings with Teflon

Figure 7: Broken elevator transfer rod

The strength of the current which passed through the aluminium elevator rod melted one end of the thread part in the actual rod. The end parts, which are coated with high alloy steel, withstood the loads. In order to calculate the strength of the current which passed through the rod, it was decided to measure the electrical resistance in the intact end. However, the first measurements also revealed that the apparently undamaged end had suffered damage to the thread part and the counter nut had loosened. After the thread part was cleaned and the counter nut retightened, the electrical resistance was measured at 0.7 - 1 m Ω (milliohm). Aerotech Telub's calculations showed that the thread part in question could have melted during loads from an A pulse (see figure 3).

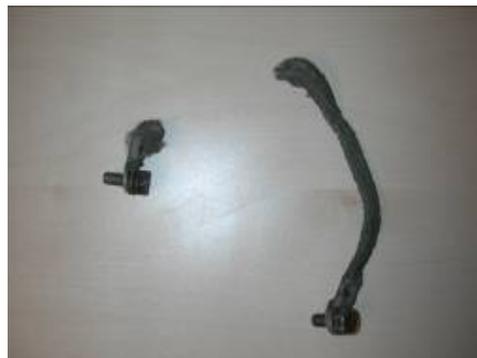
Figure 8: Burnt bonding

- 1.16.3.1 Both bondings between the horizontal tail surfaces and the fuselage were found to be broken in two. To ascertain the condition of the bondings before the aircraft was hit by lightning, parts of the two bondings were sent to the Armed Forces' laboratory services at Kjeller for analysis. A bracket from the outer bonding connection from the right elevator was also analysed with the bondings. The results were documented in "Technical Report no. 04012.03" (see appendix B). The report's conclusion was as follows:

The bondings we received had reduced conductivity as a result of mechanical wear (worn conducting wires) and considerable corrosion.

It is highly likely that the bondings burned off due to an electrical overload resulting from the lightning strike. The observed damage is consistent with observations made during experiments conducted by FOLAT/EMC and the Kraftforsyning laboratory.”

1. Ensure that the attachment of the bonding jumpers as described above are clean and without grease and/or dirt and control that the bonding jumpers are intact (not splintery) and correctly attached ref. MM chapter 23-61-00.
2. If the bonding jumpers are splintery or in other ways are incorrect they should be replaced by new approved bonding jumpers.

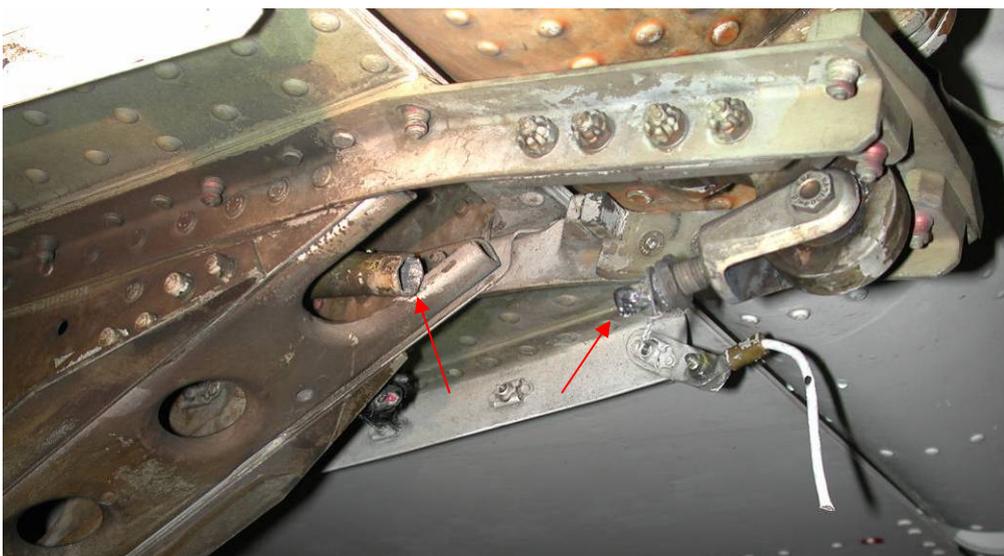
Figure 9: Broken rod transfer between cockpit and elevator

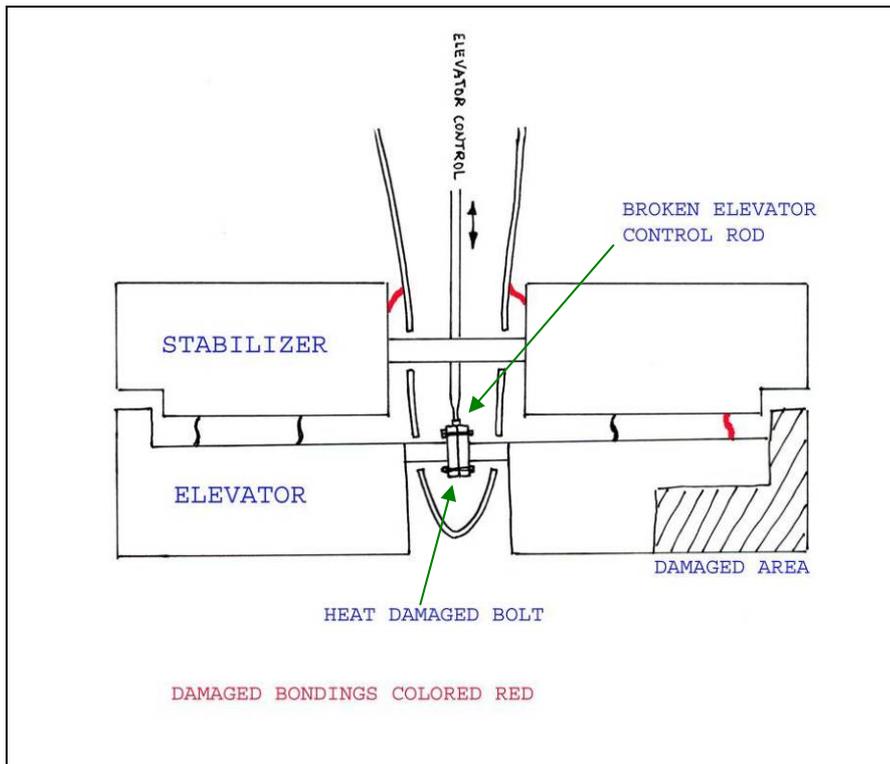
coating. Consequently, the horizontal tail surfaces became electrically isolated from the fuselage when the bonding connections broke.

Figure 10: Diagram showing damaged bondings

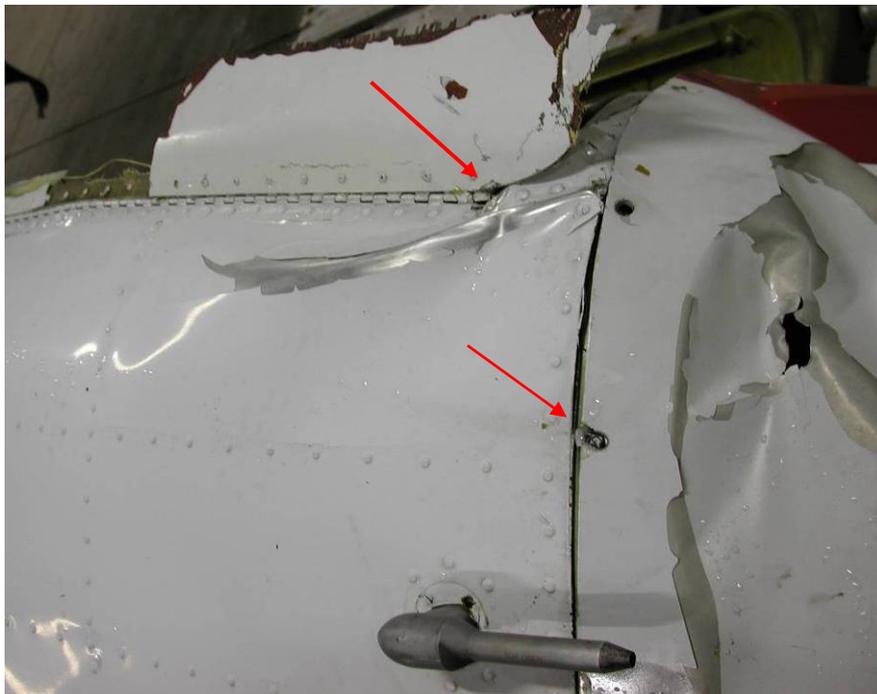
1.12.2.5 The aircraft was examined in order to identify the site of the lightning strike if possible. The only sign was two small marks high on the nose on the left (see figure 11). A small area (2 x 6 mm) in the left baggage door had melted in front of the handle. A nail head in the left pitot tube had melted in a similar way.

Figure 11: Photo of the aircraft's nose. Front of the aircraft is to the right. The red arrows show the impact points.

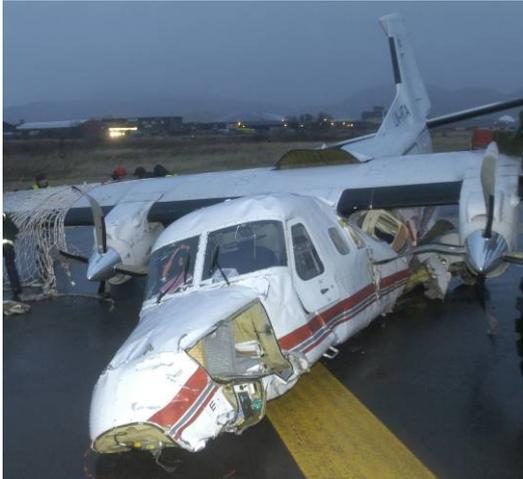
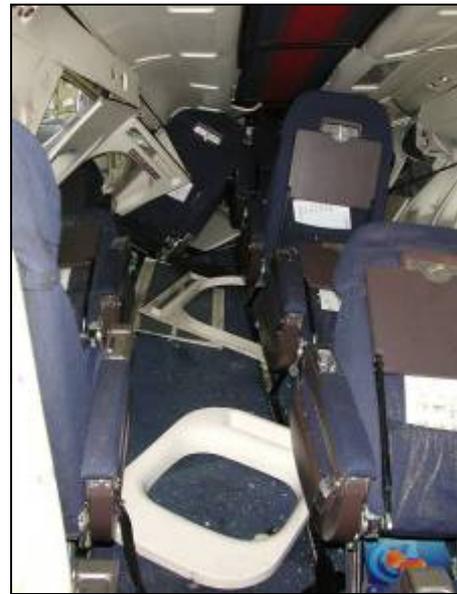
1.15.8 The front of the cabin had been forced up towards the ceiling and the two passengers had to crawl to the nearest emergency exit. There was torn metal in several places, which could have caused injuries to those onboard.

Figure 12: Compressed cabin (photo taken by armed forces) Figure 13: Front of the cabin.

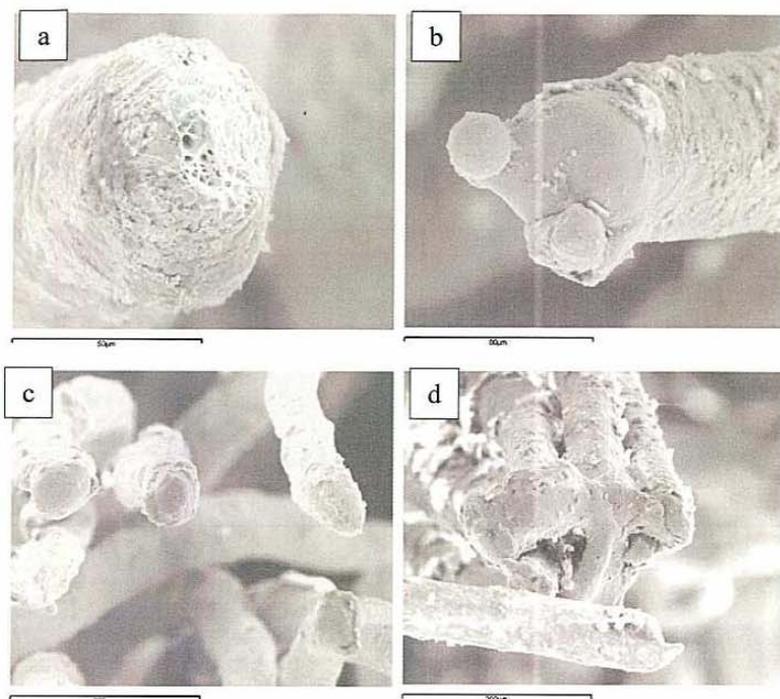
Figur 3 a: Tråd med dimpler i bruddflaten, b: Tråd med smelteperler, c: Oversikt-bilde av tråder med glatt overflate, d: Sammensmeltede tråder. (Leder i Figur 2A).

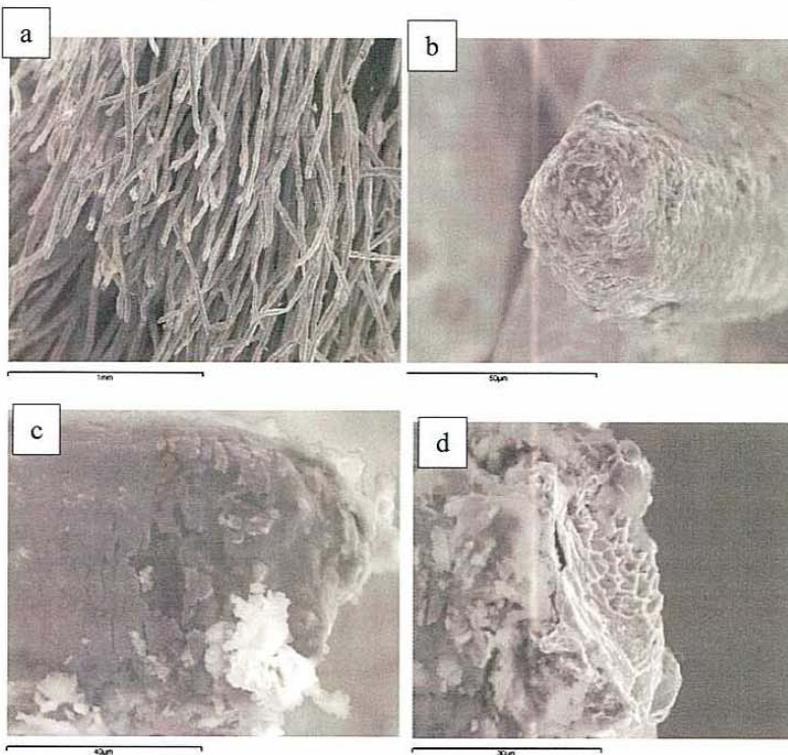
Figur 4 a: Oversikt-bilde av tråder, b: Tråd med innsnevring ut mot bruddflaten uten dimpler, b: tråd med glatt og oksidert bruddflate, d: tråd med dimpler i bruddflaten. (Leder i Figur 2B).

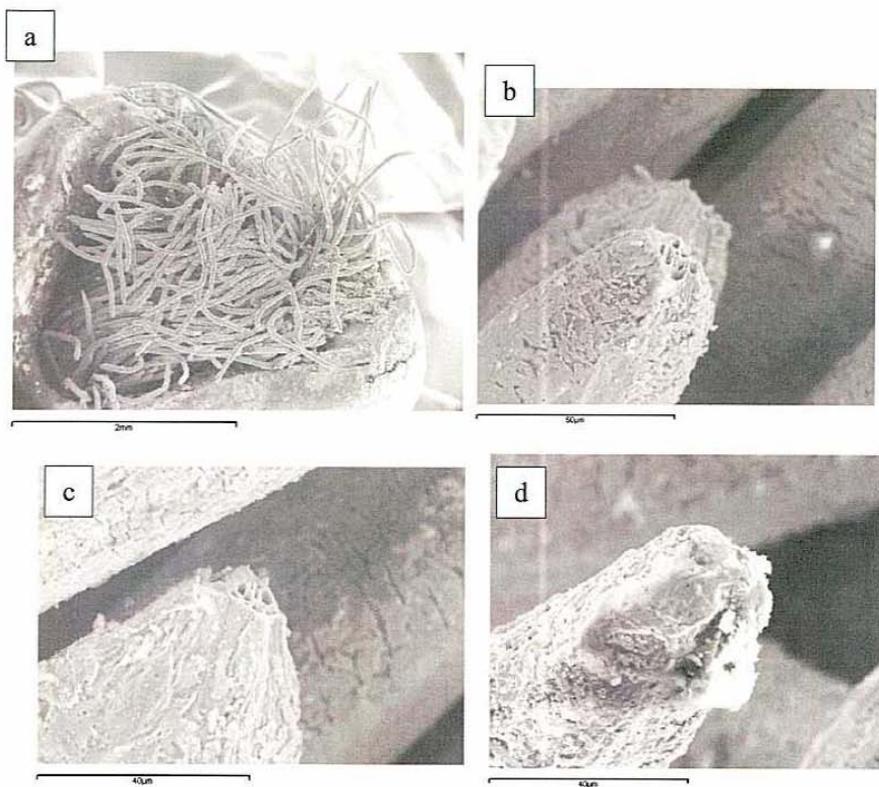
Figur 5 a: Oversiktsbilde av tråder, b: Tråd med dimpler i bruddflaten, c: Tråd med dimpler i bruddflaten, d: tråd med innsnevring ut mot bruddflaten uten dimpler. (Leder i Figur 2C).

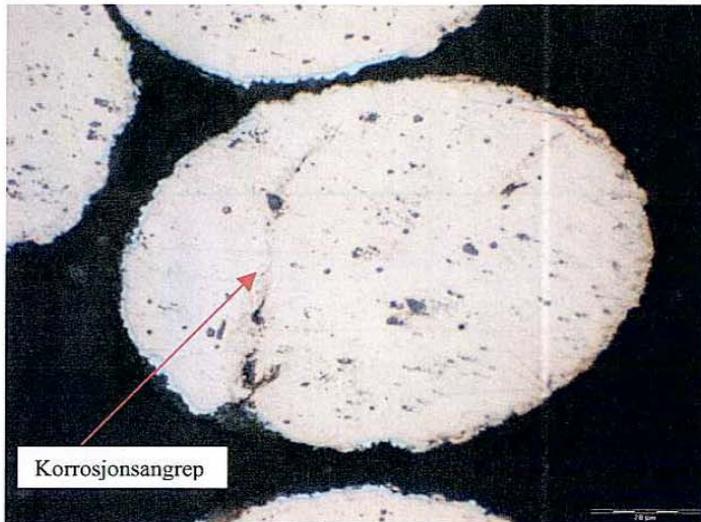
Figur 8 viser et bilde tatt i lysmikroskop gjennom et tverrsnitt av en tråd, bildet er representativt for lederne, og viser tydelig korrosjonsangrep. En tilsvarende tråd med tydelig pitting ble undersøkt med EDS i SEM, se hhv Figur 9 og Figur 10. Det fremgår av bildene at tråden består av rent kobber med et tynt tinnbelegg, spekteret fra roten av korrosjonsangrepet påviser klor.

Figur 8 Bilde av tverrslip gjennom en leder tråd med tydelig korrosjonsangrep.

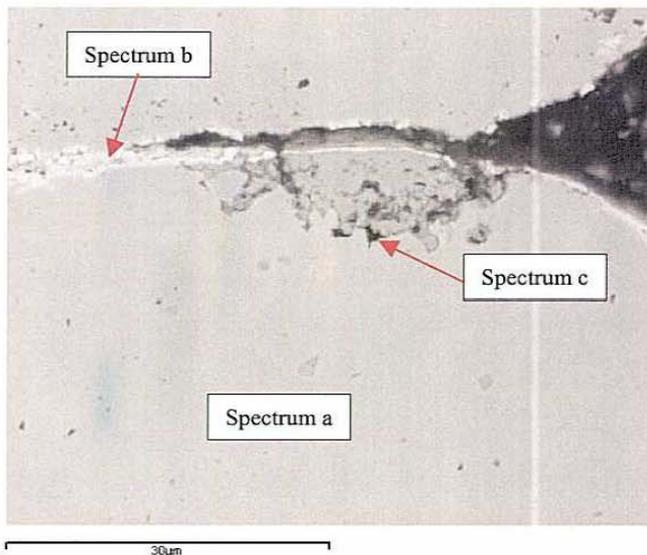
Figur 9 Bilde av tverrslip gjennom tråd med korrosjonsangrep. Bildet er merket med områdene for EDS spektrene vist i Figur 10.

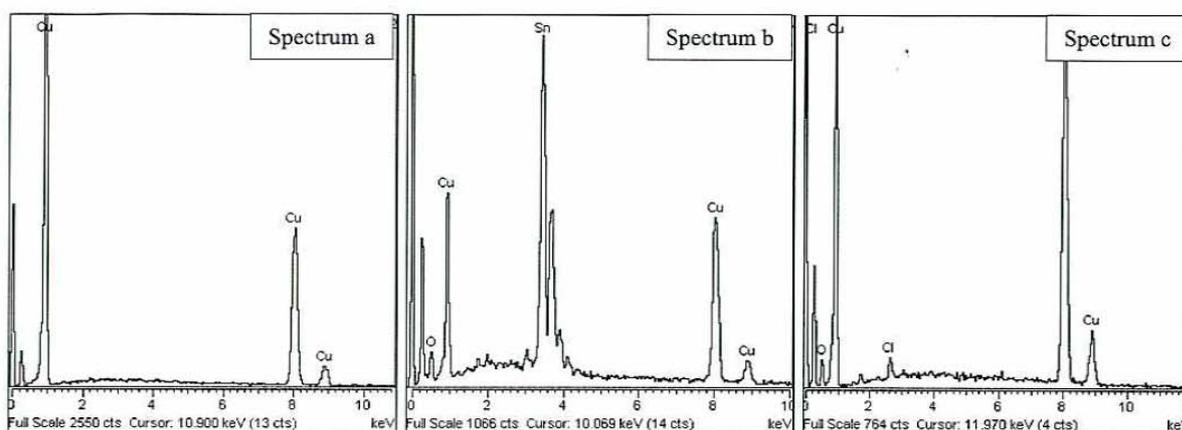
Figur 10 EDS spektre fra områdene avmerket i Figur 9. Spectrum a viser grunnmaterialet i tråden; kobber. Spectrum b viser belegg på tråden; tinn, Spectrum c viser forekomst av klor i korrosjonsgruppen.
