CA18/2/3/7906			
		SOUTH AFRICAN CIVIL AVIATION AUTHORITY ACCIDENT REPORT – EXECUTIVE SUMMARY			
Aircraft Registration	N7478S	Date of Accident	18 January 2005	Time of Accident	Unknown
Type of Aircraft	AEROSTAR 600		Type of Operation	Private	
Pilot-in-command Licence Type	(RSA) ALTP	Age	62	Licence Valid	Yes
Pilot-in-command Flying Experience	Total Flying Hours	5929.15		Hours on Type	Unknown
Last point of departure	Wonderboom Aerodrome (FAWB)				
Next point of intended landing	Springs Aerodrome (FASI)				
Location of the accident site with reference to easily defined geographical points (GPS readings if possible)					
Near the town of Cornelia in the Free State, Republic of South Africa. (GPS position South 27°17'38.4" East 028°50'16.5" at an Elevation of 5290 ft AMSL)					
Meteorological Information	Partly cloudy with isolated thundershowers				
Number of people on board	1+4	No. of people injured	0+0	No. of people killed	1+4

AIRCRAFT ACCIDENT REPORT

Name of Owner/Operator : Aquilla Air Inc
Manufacturer : Aerostar Aircraft Corporation
Model : PA-60-600
Nationality : United States of America
Registration Marks : N7478S
Place : Cornelia in Orange Free State,
 Republic of South Africa

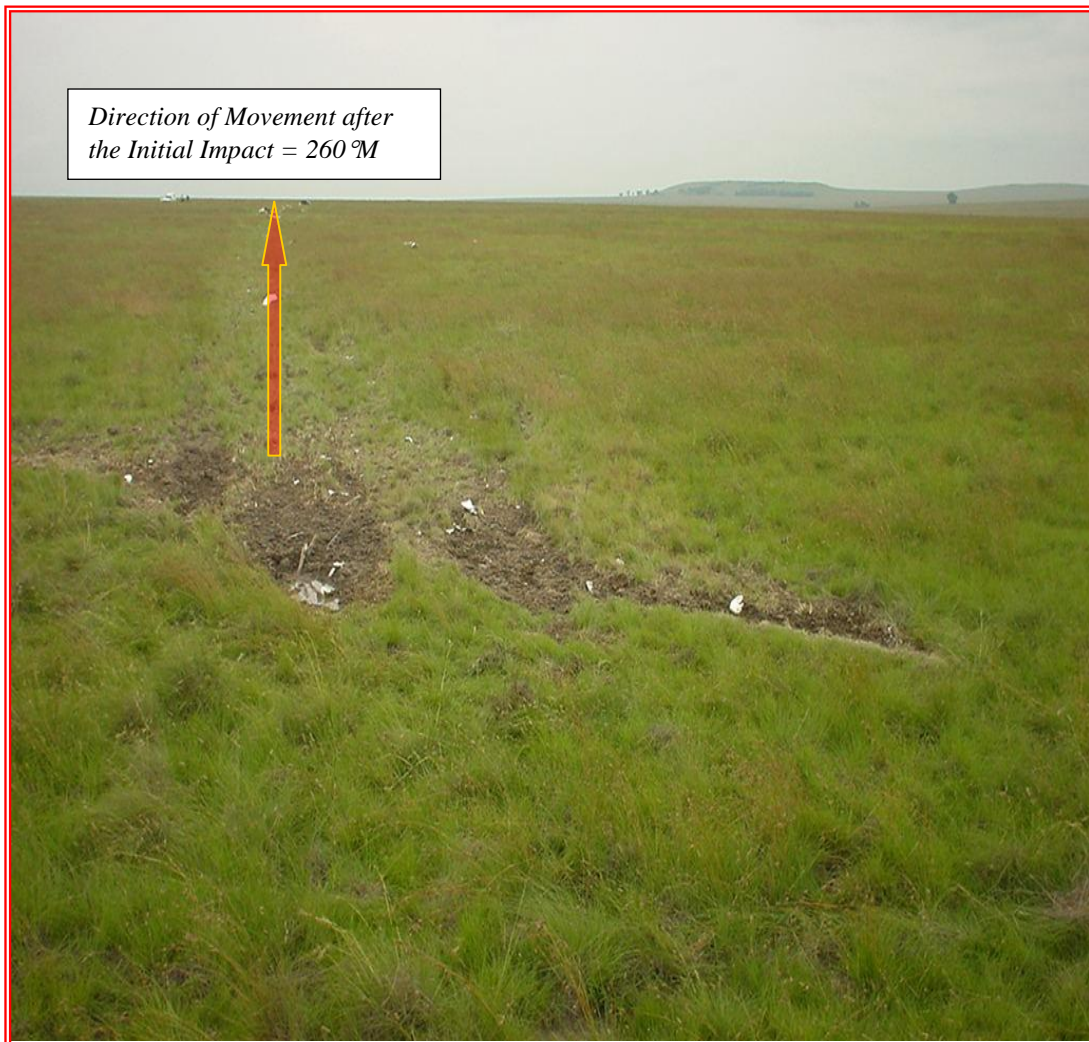
Photo 1: Initial Impact Mark. Heading 260°. It can be seen from the photo that the Aircraft was in a 30° right-wing low attitude during the initial impact.

1.12.2 The aircraft impacted the ground at a high descent rate and high speed on a heading of 260°M. The aircraft was in a 15° nose-down attitude during impact and the right wing was low by approximately 30°. Evidence on the scene indicated that the aircraft was in a right-hand turn during the initial impact.

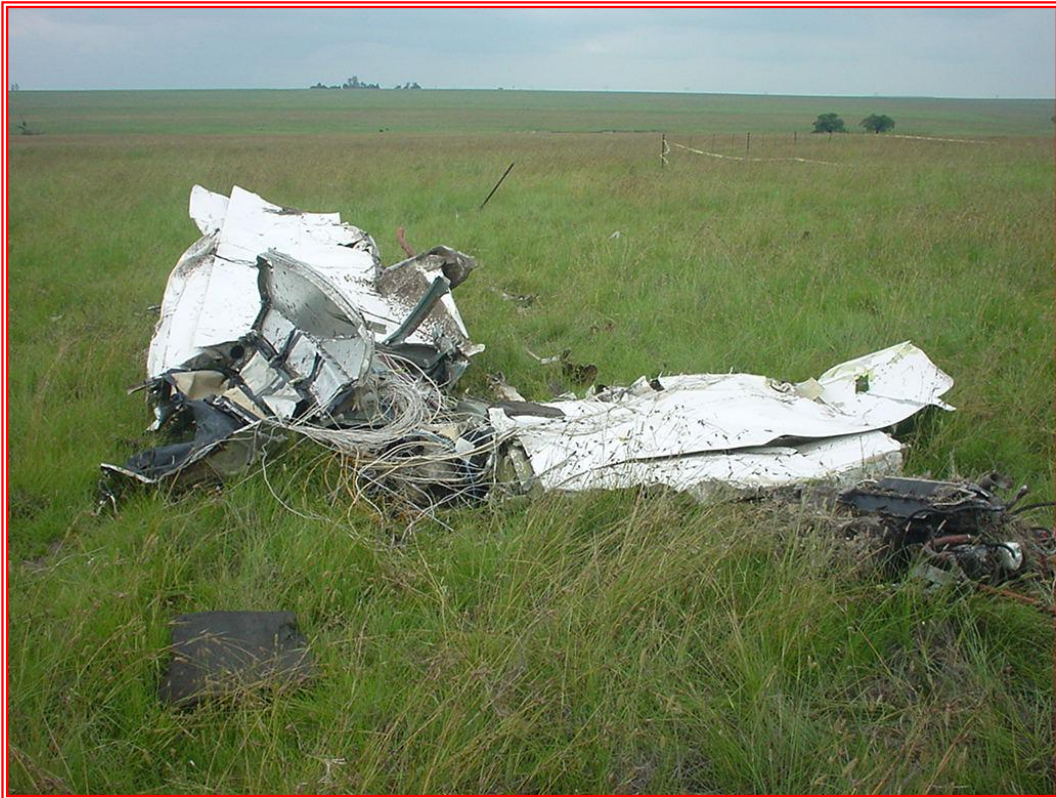
Photo 1: Wing Centre Section viewed from behind and R/H Engine on the right

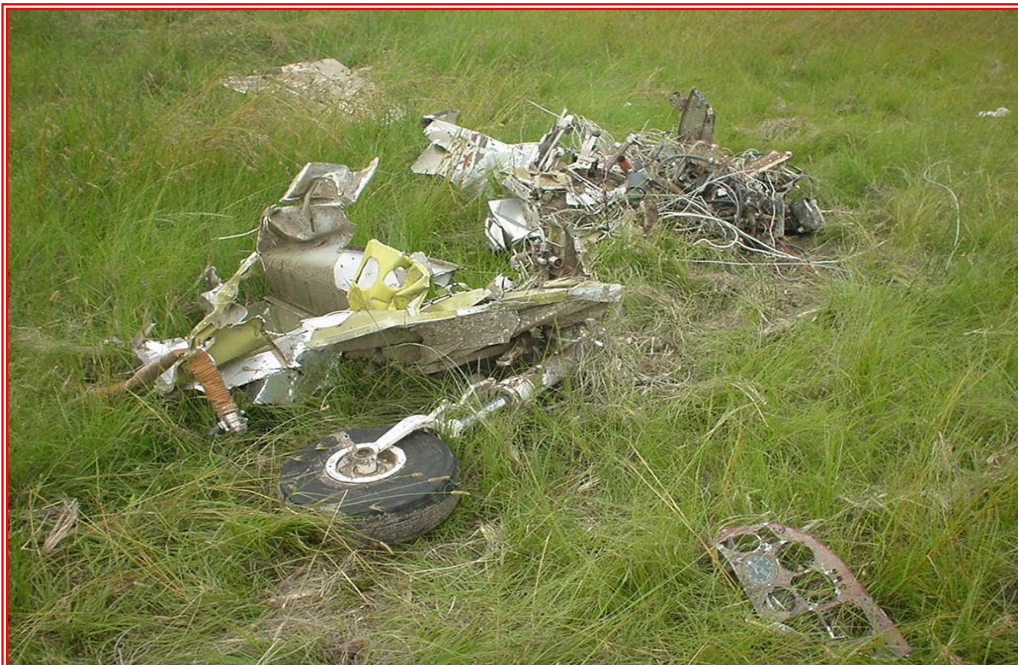
Photo 2: Nose Landing Gear

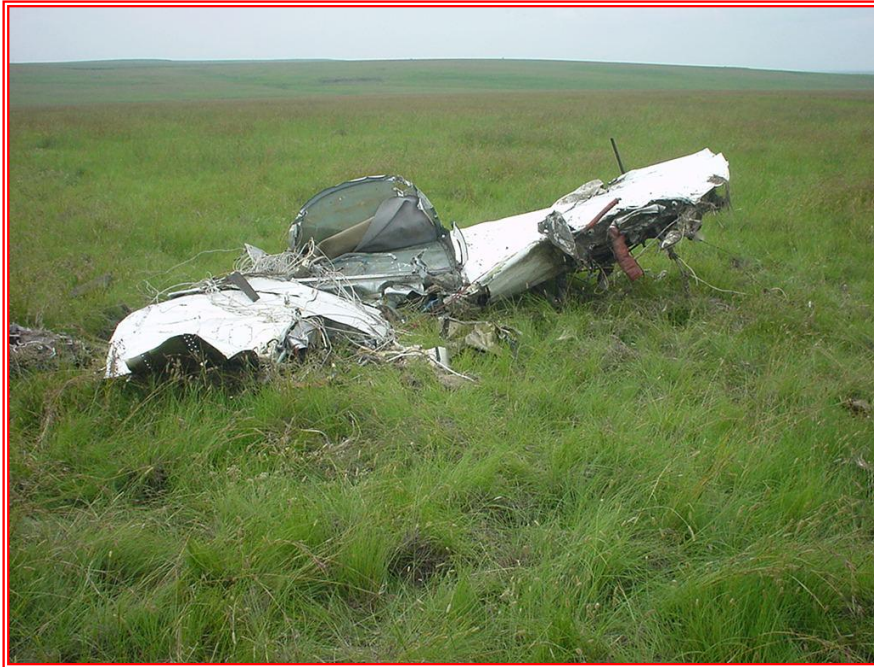
Photo 3: Wing Centre Section viewed from the front & R/H Engine on the left

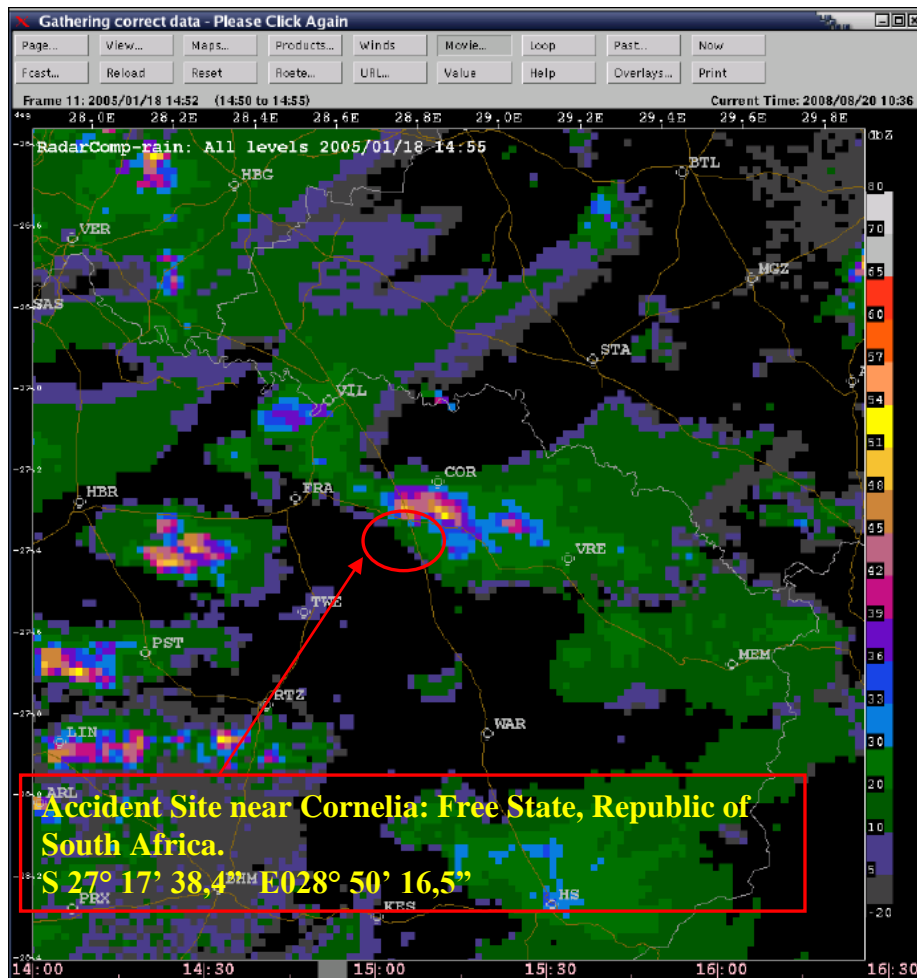
1.7.4.1 The satellite imagery shows thunderstorms in the Cornelia area.
