**AVIATION INVESTIGATION REPORT
A06P0010**

ENGINE POWER LOSS - FORCED LANDING

**SONICBLUE AIRWAYS
CESSNA 208B (CARAVAN) C-GRXZ
PORT ALBERNI, BRITISH COLUMBIA, 11 nm SSE
21 JANUARY 2006**

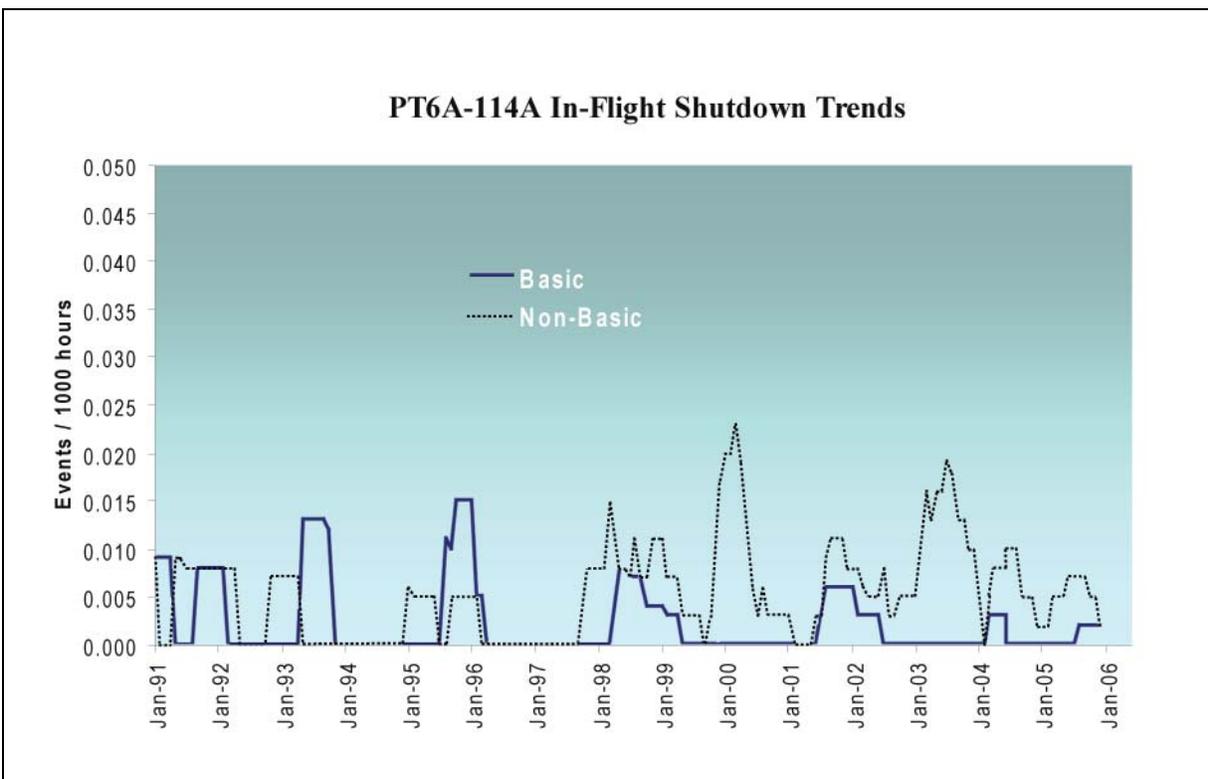
Appendix A – Pratt & Whitney Canada In Flight Shut Down Data – Rolling Six-Month Average

While the engine type that was involved in this accident met the established reliability standard, it is important to note that, had the total number of In Flight Shut Down (IFSD) events (that is, loss of propulsion for all causes) been considered, the failure rate for the entire propulsion system would not have met the CARs standard in 7 of the last 10 years.

A basic In Flight Shut Down (IFSD) is an IFSD caused by a malfunction directly related to the engine or an engine component (solid line). These events are used in mean time before failure (MTBF) calculations and include unsubstantiated events where investigations are still in progress to identify the primary part that caused the event.

A non-basic IFSD is an IFSD caused by a component failure not directly related to the engine (dotted line). These events are not included in the MTBF calculations.

The Department of Transport take into account all propulsion system failures when assessing the safety of single-engine commercial operations.
